AMERISPEC
INSPECTION SERVICES

Prepared for: Mr. & Mrs. Buyer
Property address: 123 Any Street, Kelowna BC
Inspection Date: March 01, 2019
Inspection #: 03188340
Prepared by: Murray Klingbeil CPBC#47501
Box 20035 Kelowna BC V1Y 9H2 bigmur@shaw.ca

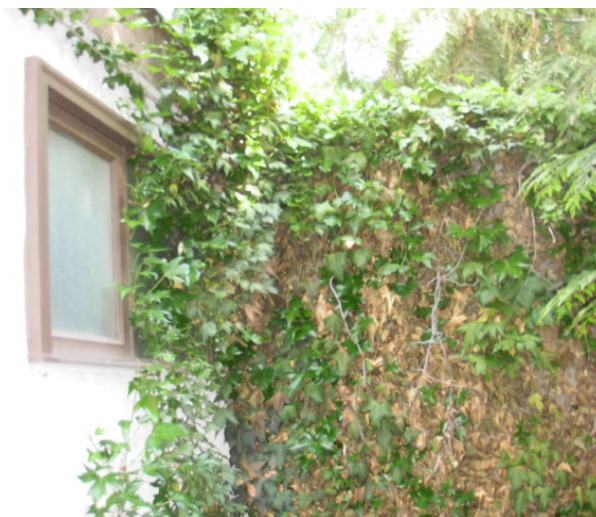
- 101 Driveway: Concrete, exposed aggregate finish.
 102 Walks: Concrete. **Common cracking and settling noted.**
 103 Fences: Wood and chain link construction.
 104 Siding: Wood and stucco siding. **Common cracking noted. We recommend trimming all vegetation away from the siding to prevent deterioration and insect infestation.**

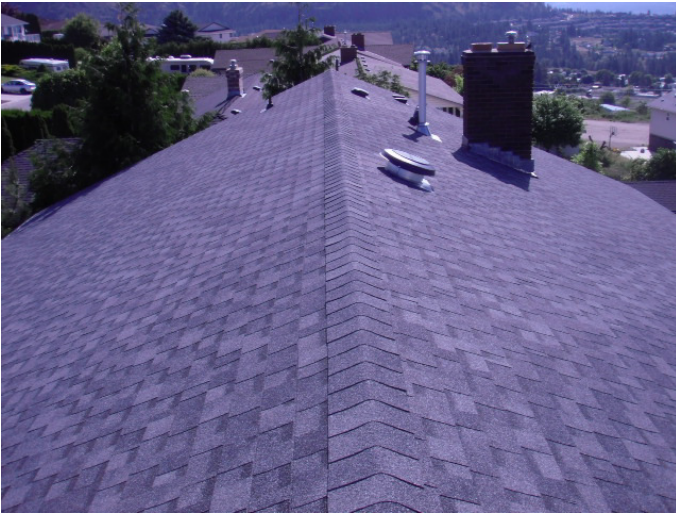
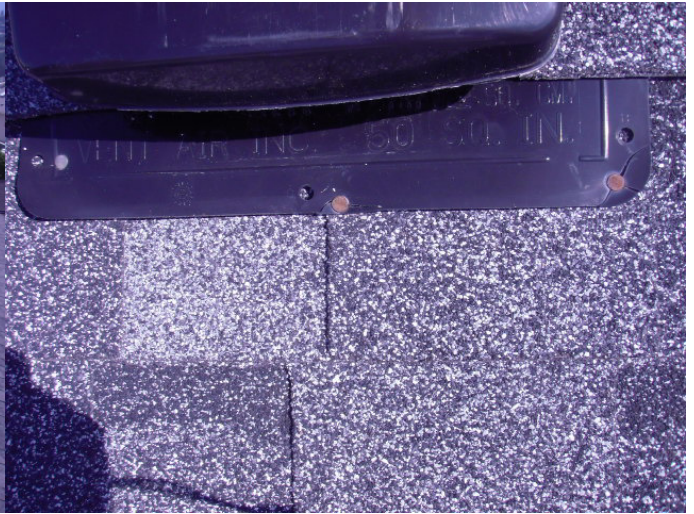
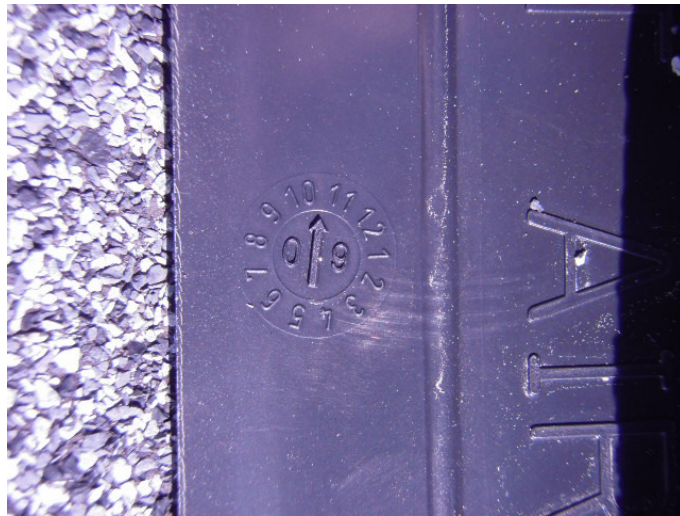
- 126 Type/Material: Sloped gable construction, asphalt shingle covering, observed from the roof.
- 127 Flashing: We suggest re-sealing all through roof vents, projections, joints and seams as part of routine maintenance to prevent possible leaking. **We recommend tarring all exposed nails to prevent possible water leakage and consequent damage to the roof decking and framing.**
- 128 Roof Comments: Roof shows normal wear for its age and type; appears to be in serviceable condition. **It appears that this roof was installed in approximately 2010.**
- 129 Skylights: N
- 130 Chimneys: Pre-fabricated metal and masonry. Our chimney review is limited to the visible and/or accessible components only.

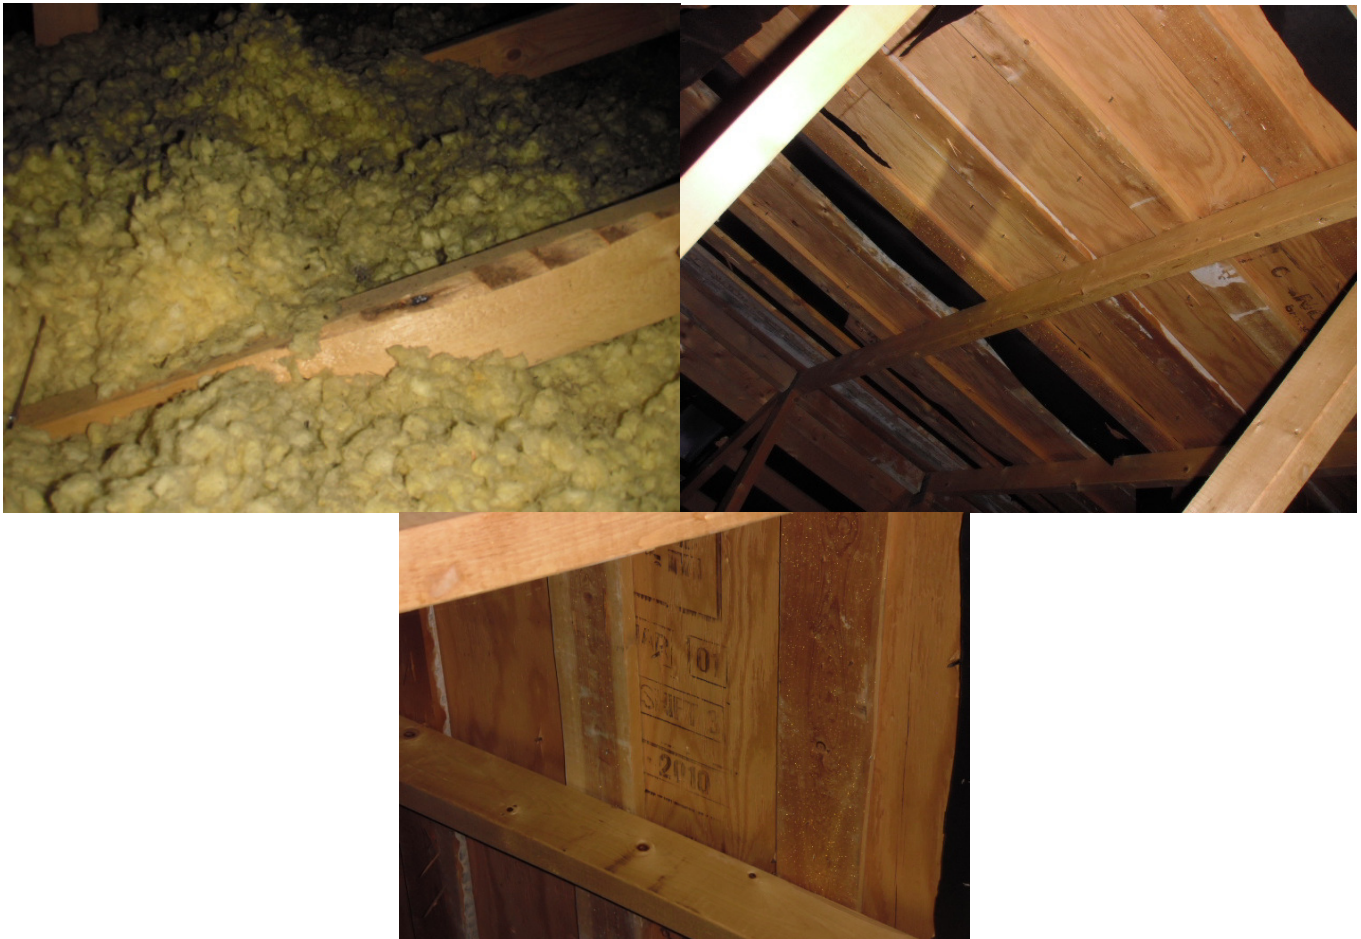
- 136 Access: Hatch located at the main floor hallway.
- 137 Framing: S Trusses.
- 138 Sheathing: S Solid (Plywood over 1" x 4" strapping). This roof was originally wood shake. **The plywood roof sheathing is date-coded 2010.**

- 141 Ventilation: S. Roof, gable end, and soffit vents noted. This home is equipped with a thermostatically controlled power attic exhaust fan. It was not warm enough at the time of our inspection for this fan to operate. Contact the vendor for more information with regard to the operation of this fan.

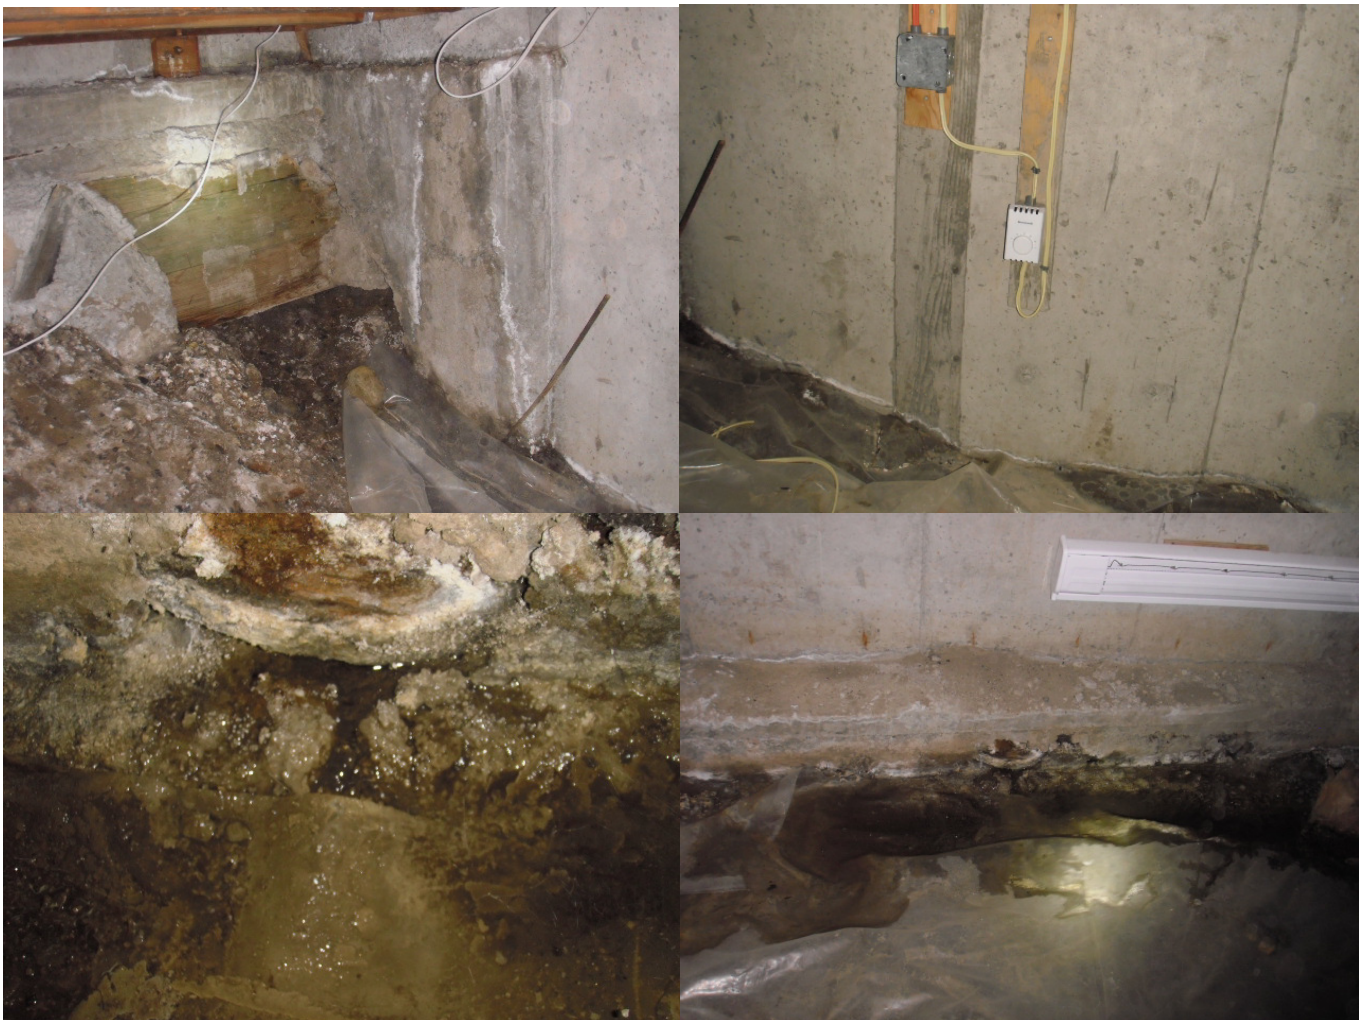
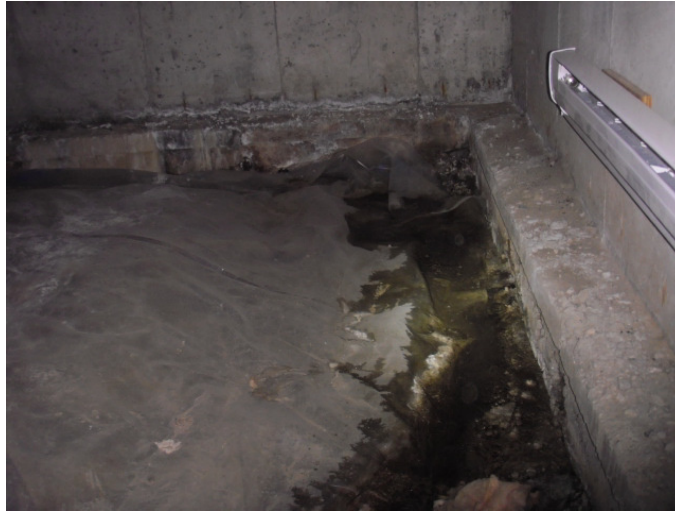
- 151 Access: S At the front-left basement bedroom. **The crawlspace access hatch is very small.**
- 152 Floors: Dirt.
- 153 Walls: Poured concrete and open framing. **Common cracking noted. Evidence of past leaking was observed at the front-left corner area of the crawl space. It appears an underground spring is draining directly into the rear-left area of the crawlspace. We cannot determine from our one-time visual inspection if this water entry is seasonal or a constant on-going issue. Contact the vendor and/or a reputable ground water specialist for further review.**

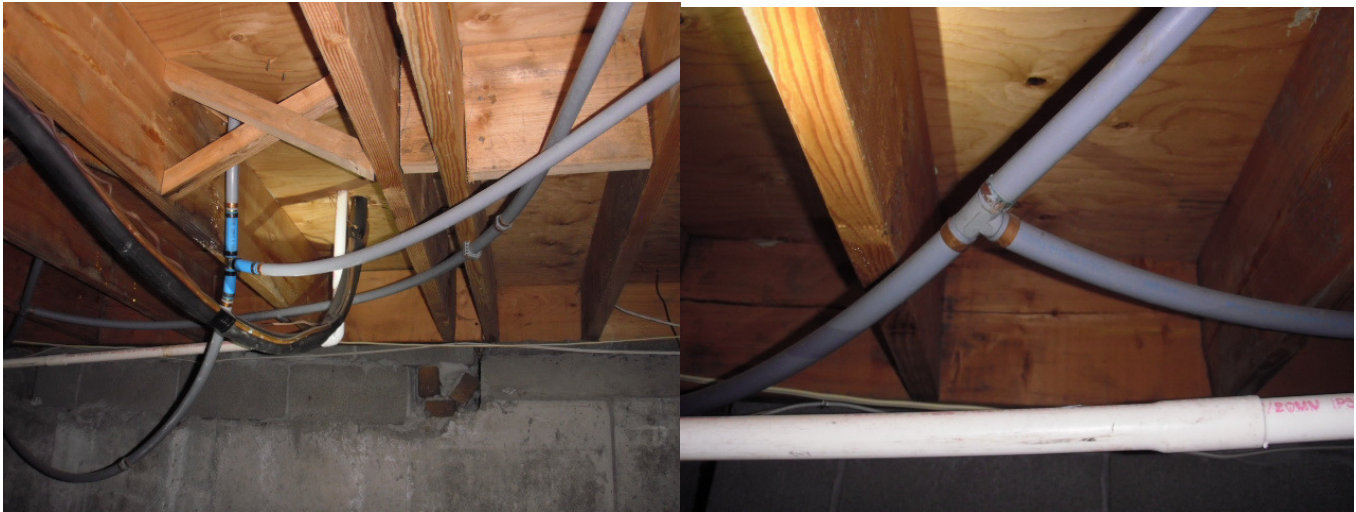
- 158 Ventilation: Screened venting provided.
159 Insulation: Fibreglass batts where visible.
160 Vapour Barrier: S
161 Plumbing: **This home is plumbed in areas with Polybutylene tubing with Acetal fittings. Some production runs of this material are subject to deterioration from exposure to chlorine or ultra-violet light. Instances of tubing or fitting failure and subsequent leaking have been reported in this community. Evidence of past repairs was observed. There have been several class action lawsuits that have been settled with regard to this material. For more information: www.classaction.ca or www.pbsettlement.ca. Contact a reputable plumbing contractor for further review if concerned. Also, some home insurance companies are concerned with Polybutylene water distribution plumbing lines and fittings. Contact your insurance broker for more information with regard to coverage and any required repairs or retrofits.**

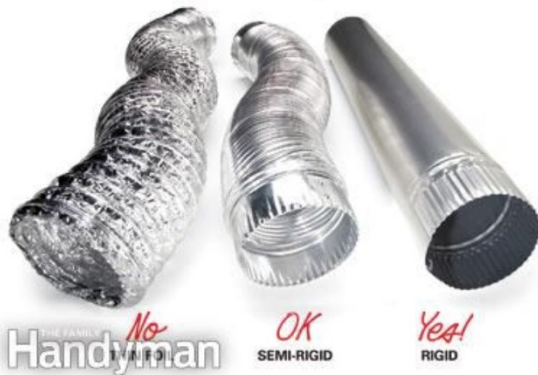
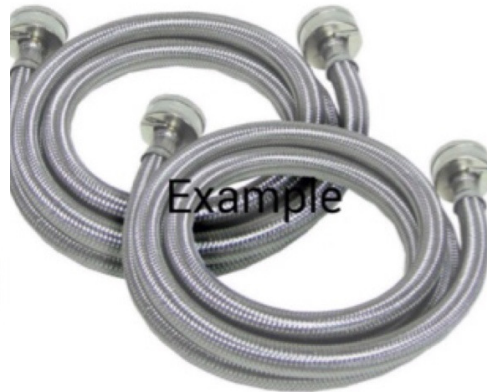
S “Samsung” brand electric/240 volts. Appears to be vented to the exterior. **The exhaust hose for the dryer is the ribbed, flexible plastic or foil type in areas. These types of dryer exhaust hose can cause excessive lint build-up and restrict flow and can be a potential fire hazard. Ideally, dryer exhaust ducts should be rigid metal and as short and straight as possible to reduce lint accumulation. Repair as required.**

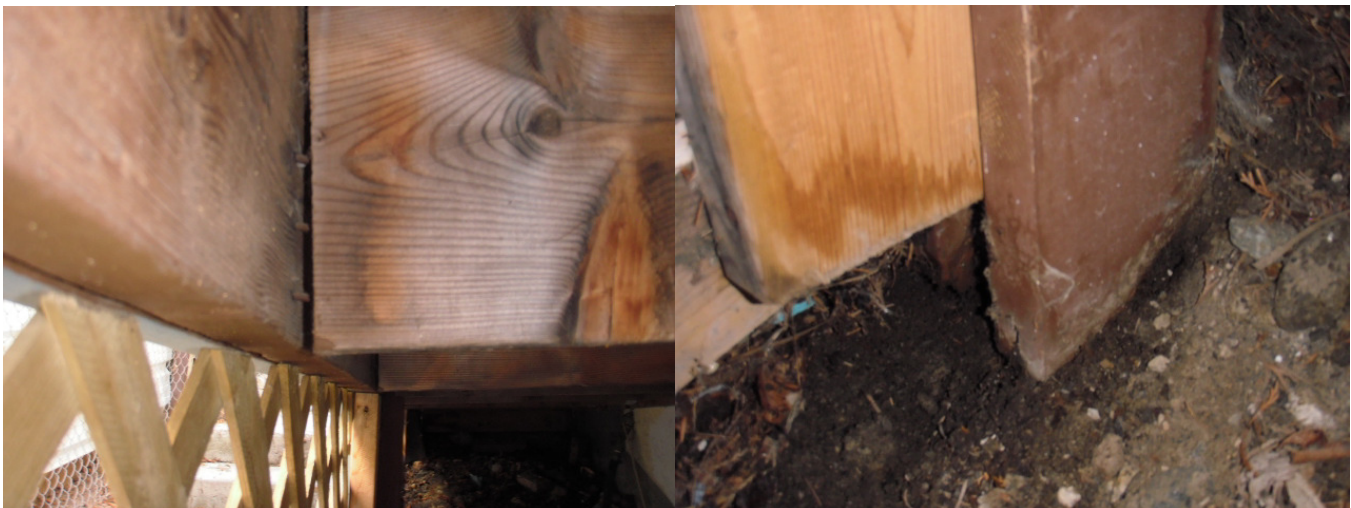
N
S
The wood support posts of the right side deck are extensively damaged and deteriorating in areas. The floor joist assembly is pulling away from the rim joist as this deck sinks. Ideally, proper metal joist hangers should be provided. Contact a reputable building contractor for further review and an accurate quote for necessary repairs.

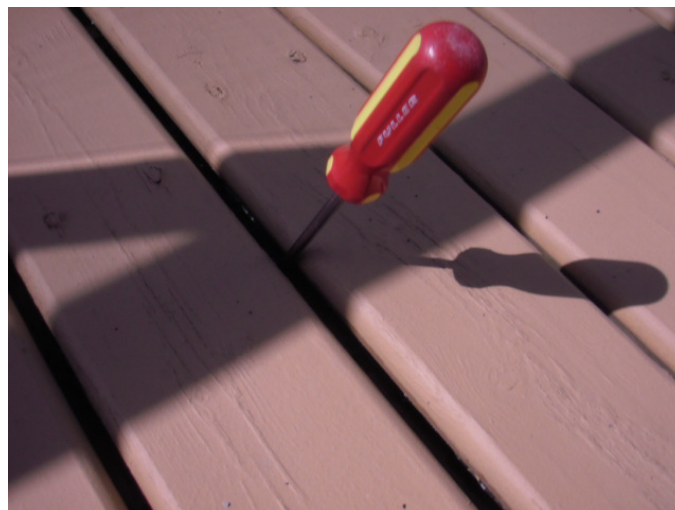
- 221 Cover: N
 222 Electrical: S. **A GFI protected outlet is provided for added safety. See #408.**
 223 Deck/Slab: **The plywood decking that is sandwiched between the layers of slat decking is extensively damaged and deteriorating in areas. Repair or replace as required.**

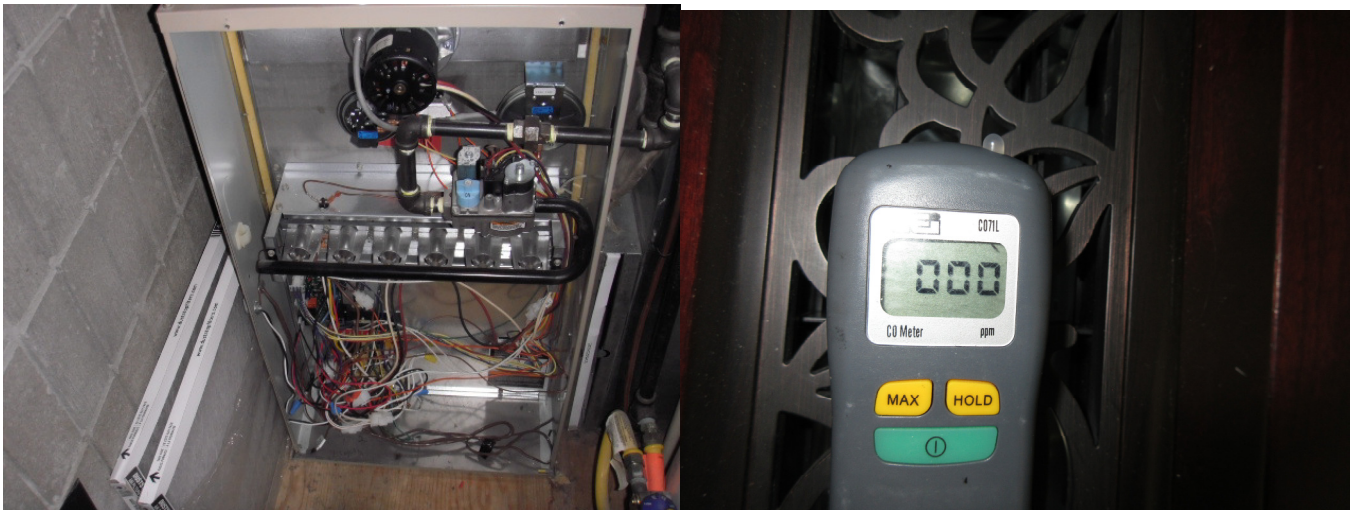
Appears to be a 2001 model year “Lennox” brand, 120,000 BTU, mid-efficiency (80%), gas fired forced air furnace located at the utility area. Unit operated normally when tested. Gas shut off and electrical disconnect provided. It is recommended that heating systems be serviced by a qualified heating contractor on an annual basis to ensure safe and efficient operation. Inspection of the furnace heat exchanger for evidence of cracks and/or holes can normally only be done by dismantling the unit. Therefore, the integrity of the heat exchanger of this furnace is beyond the scope of our inspection. Contact a reputable HVAC contractor for further review if concerned. **No measureable amount of carbon monoxide was detected at the heat distribution ducts when tested on the day of our inspection with a “Universal Enterprises” brand commercial grade detector.**

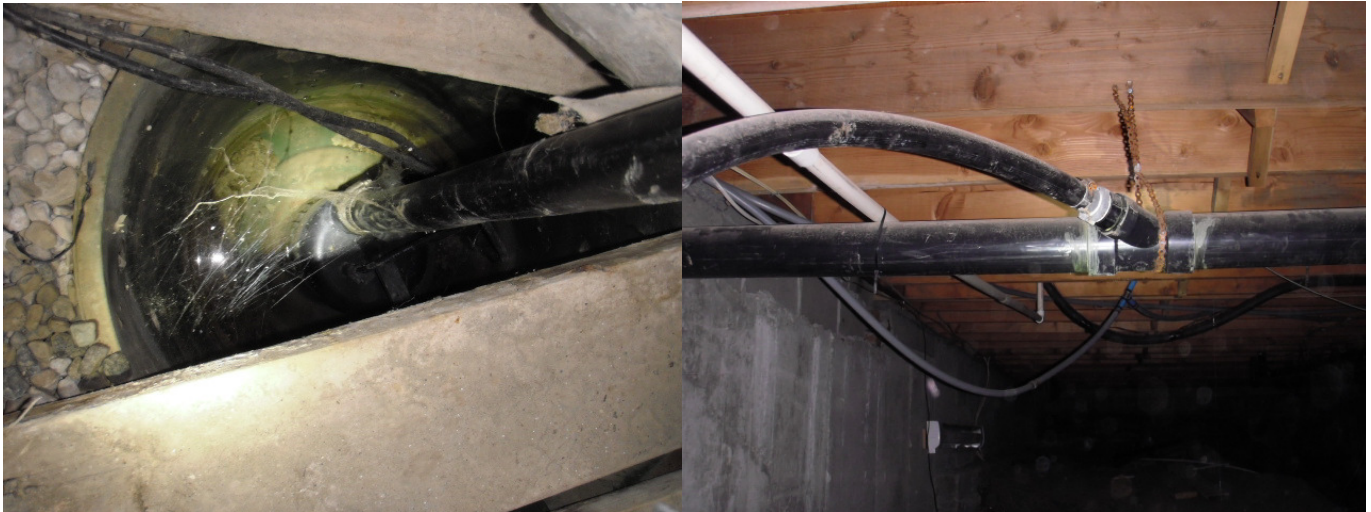
This home is equipped with an electric lift pump to handle the water from the underground spring at the rear-left area of the crawlspace of the home. This pump operated normally when tested. Ideally, sump pumps should be wired on a dedicated circuit to ensure continuous power is supplied to the pump. This sump pump is discharging directly into the municipal sewer system. This is not allowed. Ideally, this pump should be discharging topically on the lot. This arrangement may have to be rectified at any time.

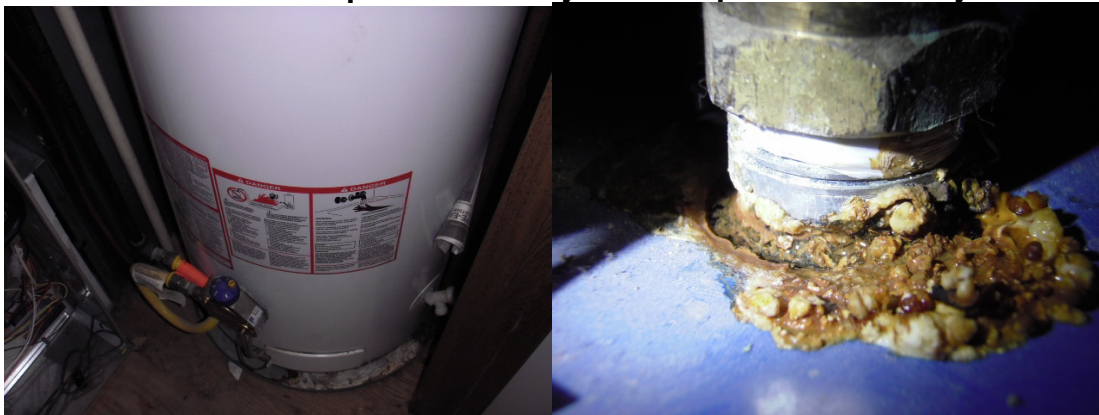
Located at the utility area. Approximate capacity is 189 litres. Unit is gas fired. **Unit appears to be a 2002 model year.** Cold water shut off noted. **The cold water line has been leaking for a long period of time. Significant corrosion was observed at the cold water pipe union and tank cabinet.** A pressure & temperature relief valve is installed as a safety feature. **As most manufacturers claim a life expectancy of 10 – 12 years, replacement may be anticipated in the very near future.**

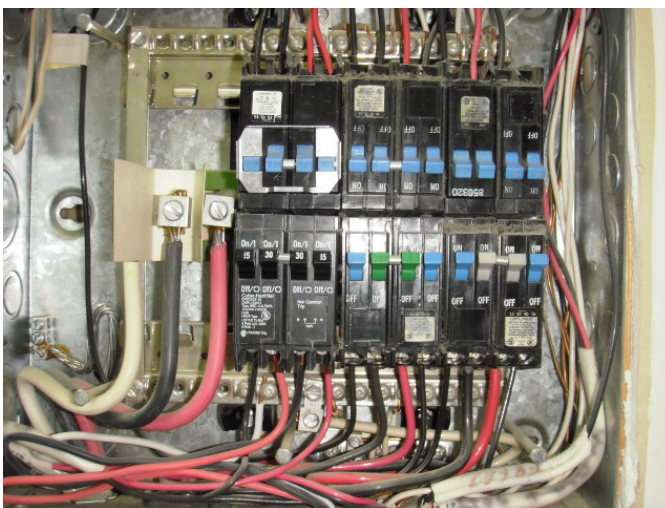
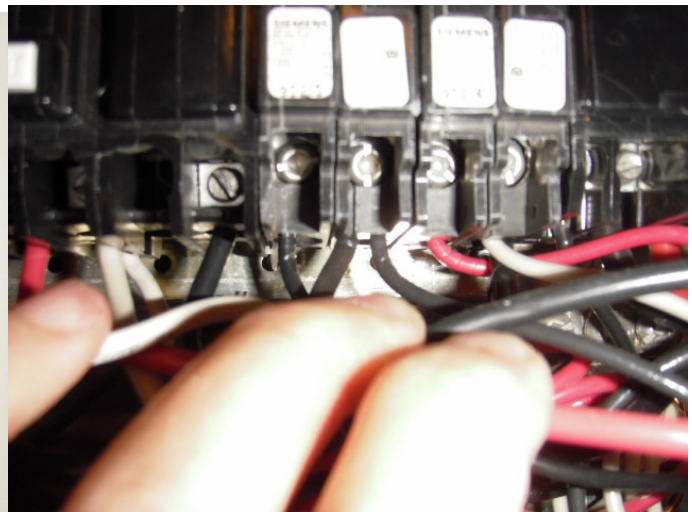
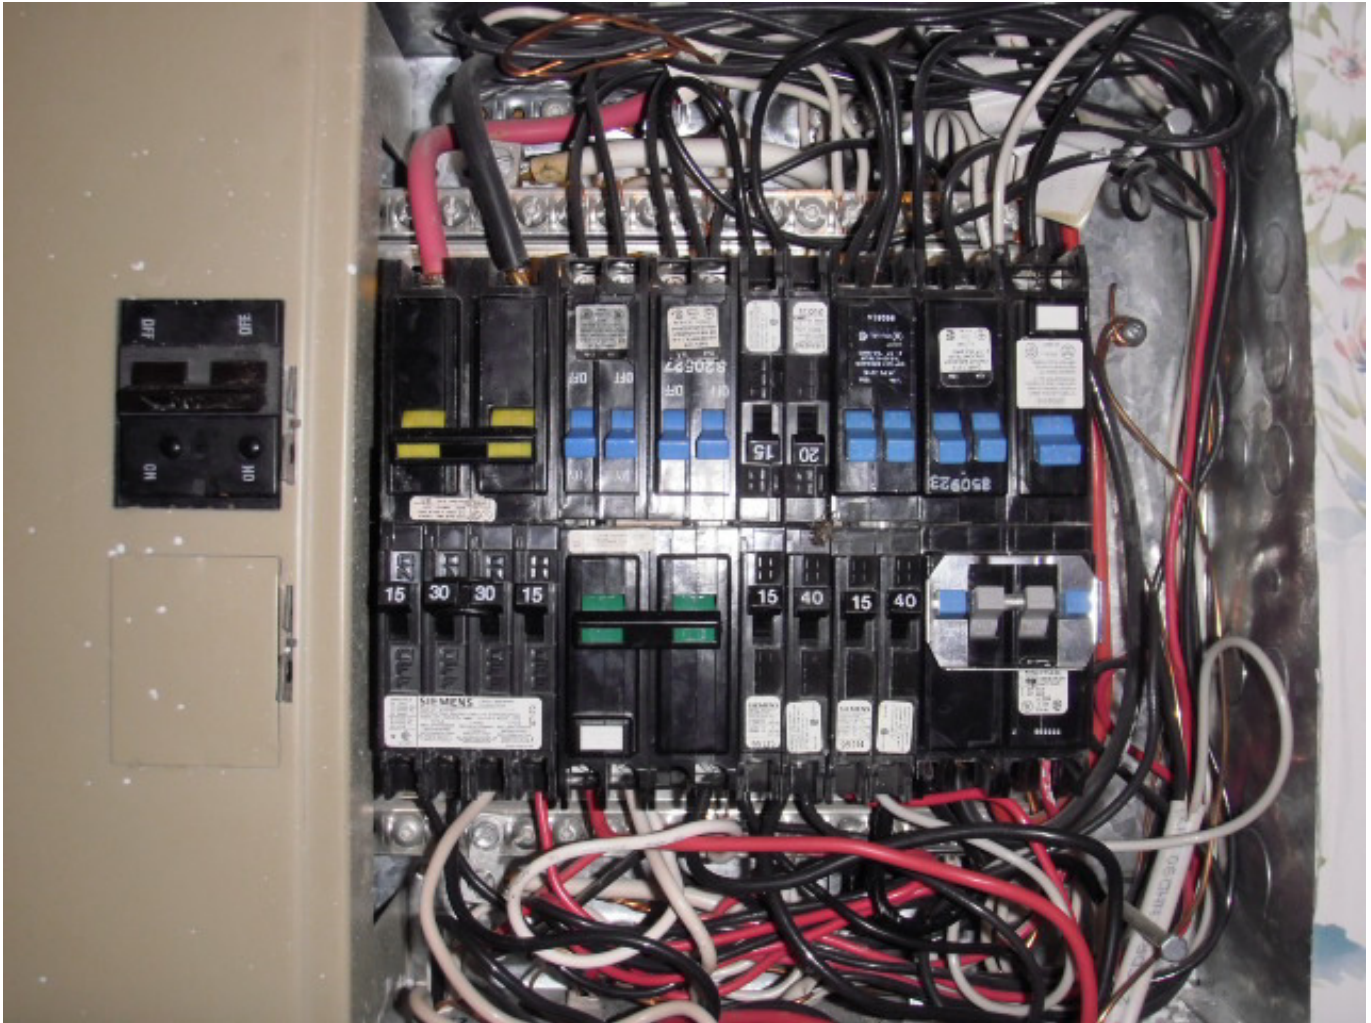
The electrical service is approximately 200 amps, 120/240 volts. Service entrance is underground. Main panel located at the front-left basement bedroom. A 70-amp sub panel is located at the main floor laundry room. Main service conductor is aluminium. Overload protection is provided by breakers. **Wire size does not appear to be compatible with the over-current protection devices at the 20-amp and 40-amp breakers. This can cause over-heating of the conductor and may be a potential fire hazard. Doubled-up circuitry noted. This condition can add to the load of the affected electrical circuits causing a possible overload and tripping the breakers. Ideally, doubled-up circuitry should be independently fused. Contact a reputable electrical contractor for further review and necessary repairs to ensure safety.** Main disconnect noted. Extra breaker spaces are not provided for possible expansion. **This panel is now full. The installation of another sub-panel or larger main service and panel may be required if additions are to be made to this electrical system.** Low amperage branch circuit conductor, where visible in the main panel, is copper, preferred for safety. Grounding system is present.

Ground Fault Circuit Interrupters (GFCI) are an electrical safety feature that have been provided in various areas of the home. **We suggest client consider upgrading with GFI's at all receptacles near water sources, such as the 2pc bathroom, garage, outlets within 1.5 meters of sinks and all exterior outlets to enhance electrical safety.**

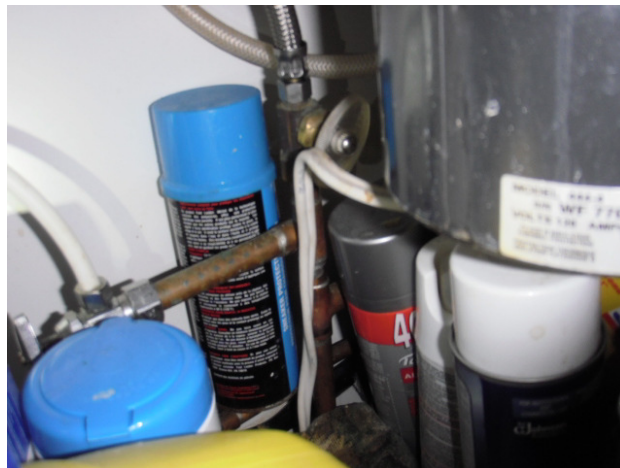
601 Floor: S
602 Walls: S
603 Ceiling: S
604 Doors: N
605 Window/Skylights: S
606 Cabinets: S
607 Counter Tops: S
608 Electrical: S
609 Heating: S
610 Sinks: S
611 Faucets: S **The faucet leaks slightly. Repair or replace as required.**
612 Drain/Supply Pipes: S
613 Disposal: S **Ideally, the power line to the disposal unit should be armoured "BX" cable or enclosed in conduit to protect from physical damage. These units are no longer allowed on municipal sewer systems.**

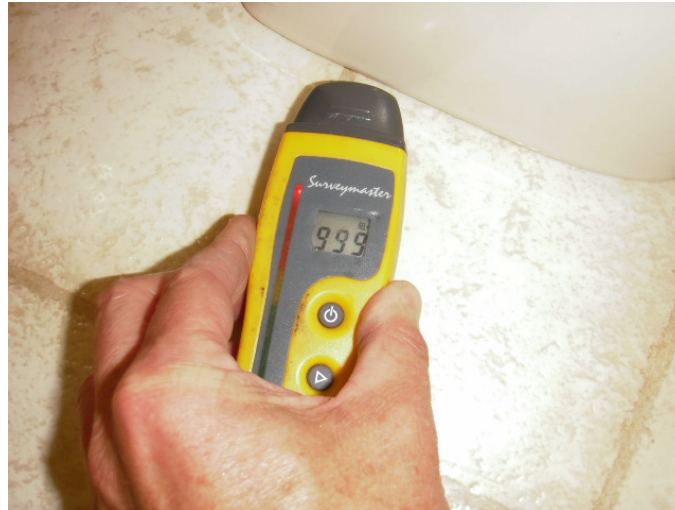
S Elevated readings were observed at the floor around the toilet when tested with a “Protimeter Surveymaster” moisture meter. This may indicate active leaking and consequent damage to the subfloor structure. We cannot determine the extent of possible damage from a non-destructive, visual inspection. Contact a reputable building contractor for further review and an accurate quote for necessary repairs.

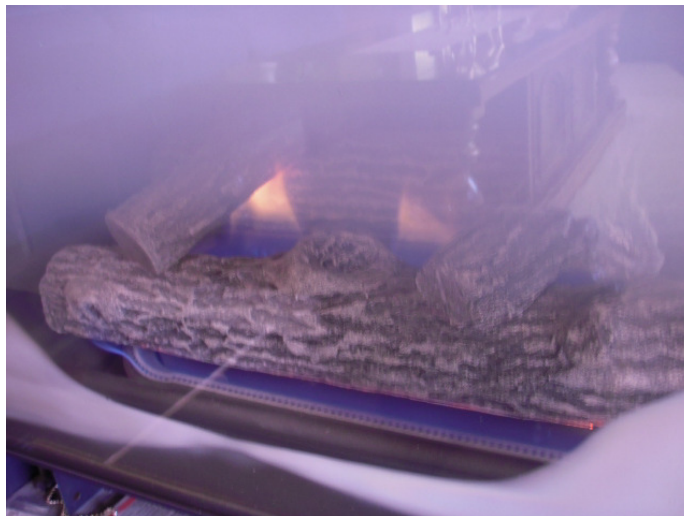
- 907 Heating: S
- 908 Closets: S
- 909 Stairs: S
- 909a Railings: S
- 910 Fireplaces: S **Gas burning model located at the family room. A distribution fan is provided for added efficiency. No measureable amount of carbon monoxide was detected at the fireplace when tested on the day of our inspection with a “Universal Enterprises” brand commercial grade detector.**
