AmeriSpec Inspection Services of Peterborough

Inspection Address:

AmeriSpec General Home Inspection

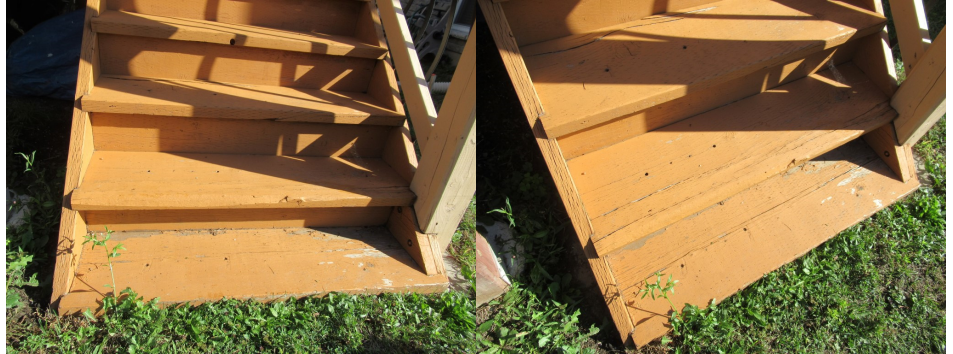
1340. Stairs **Safety. Treads/risers are not uniformly spaced which can cause a possible trip hazard (bottom step could be removed due to contact with soil/earth). We recommend professionally modifying the affected step(s) to ensure safety.**

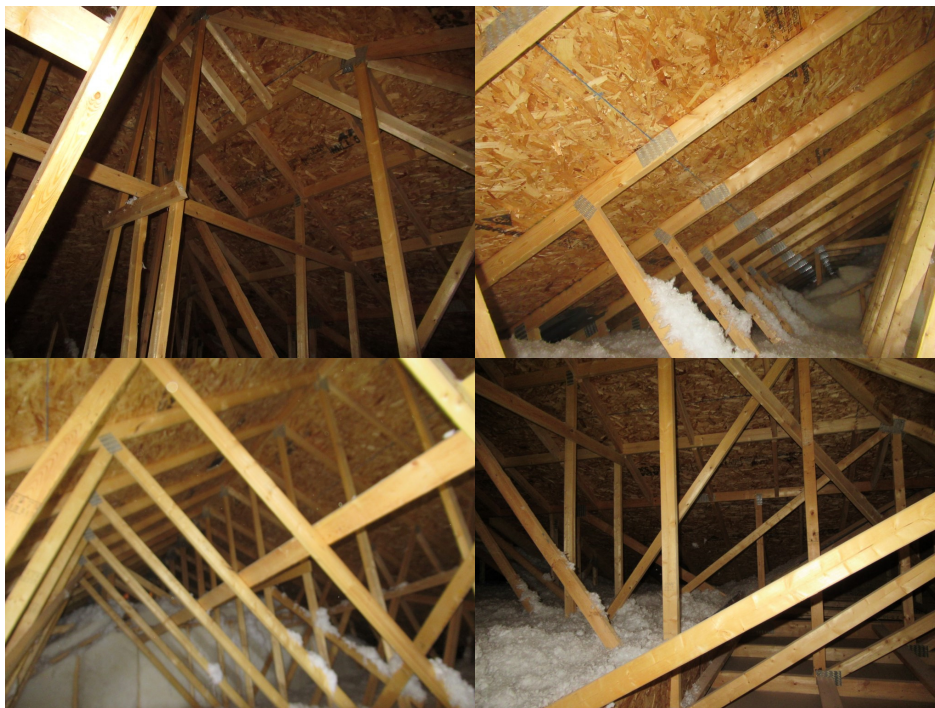
1902. Framing Serviceable. Truss construction.

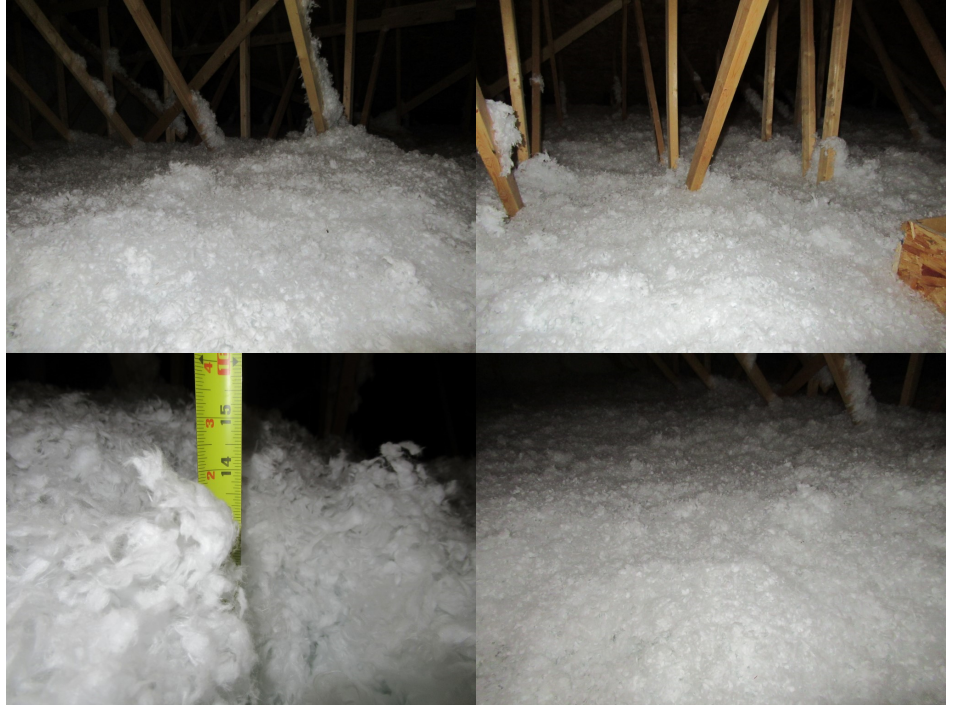
1920. Insulation Serviceable. Blown-In, Fibreglass. Insulation thickness varies from 12 to 14 inches. Approximate thermal resistance value is R-50. Plastic air/vapour barrier noted under the insulation. Due to insulation covered conditions, we were unable to determine the continuity of the barrier.

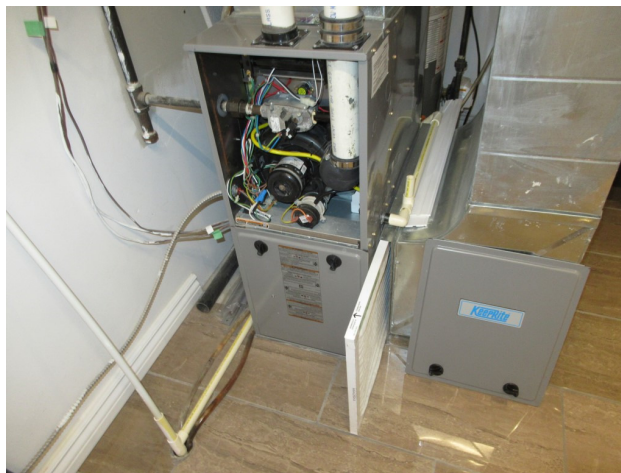
| Step # | Component | Comment |
|---|--|--|
| 2110. | System Location/ Design/Type/ Brand | Furnace. Forced air system. Gas fired unit. Located at the rear right of the basement. Manufacturer: KEEP-RITE. Serial #: A1245 44315. Model #: N9MSE0601410A. Gas shutoff valve and electrical disconnect(s) provided for safety. The furnace is approximately 7 years old. |

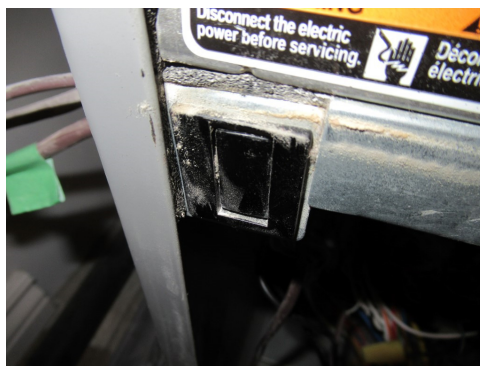
2125. General Conditions **Review.** At the time of the inspection the furnace tested operable under normal operating controls. No evidence of any obvious or significant corrosion or deterioration was observed at the time of the inspection. The average life expectancy of a furnace of this type when properly serviced and maintained is typically 15 - 20 years. **Safety switch at the lower furnace cabinet not functioning (furnace should shut off when the cover is removed). Recommend review for repairs, as required, by a qualified HVAC contractor.**

2125. General Conditions **Review. Safety switch at the lower furnace cabinet not functioning (furnace should shut off when the cover is removed). Recommend review for repairs, as required, by a qualified HVAC contractor.**

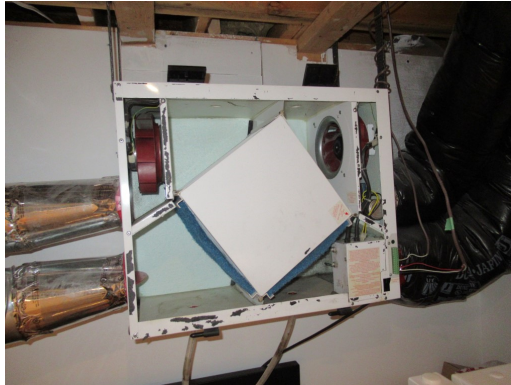
| 2170. | Heating Comments | The thermostat was activated at the time of the inspection. Based on our observations, the heating system appeared to be functional. Home is equipped with a Heat Recovery Ventilation (HRV) system. These are mechanical ventilation systems that provide controlled ventilation to homes. This type of system delivers a continuous supply of fresh air into the home, while venting stale, humid indoor, along with household pollutants, to the exterior of the home. While in operation, HRV systems extract heat from the outgoing stale air (cool air in the summer) and use it to preheat (or cool) the incoming fresh air. The stale air then gets exhausted to the exterior of the home. As a result of this process, significantly less energy is required to heat (or cool) the incoming air. Unit tested operable at the time of the inspection. |

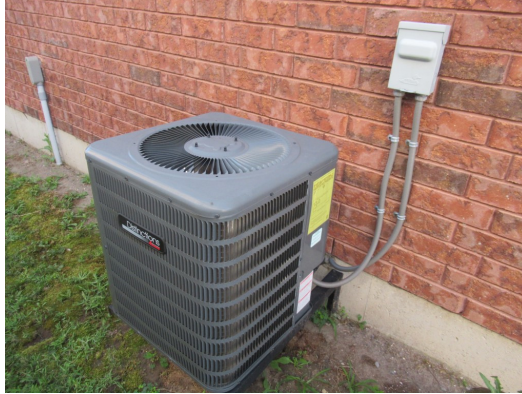
2315. Test Status The air conditioner was tested under normal operating controls at the time of the inspection to check for functionality of the system. At the time of the inspection the air conditioner appeared to be operable under normal operating controls.

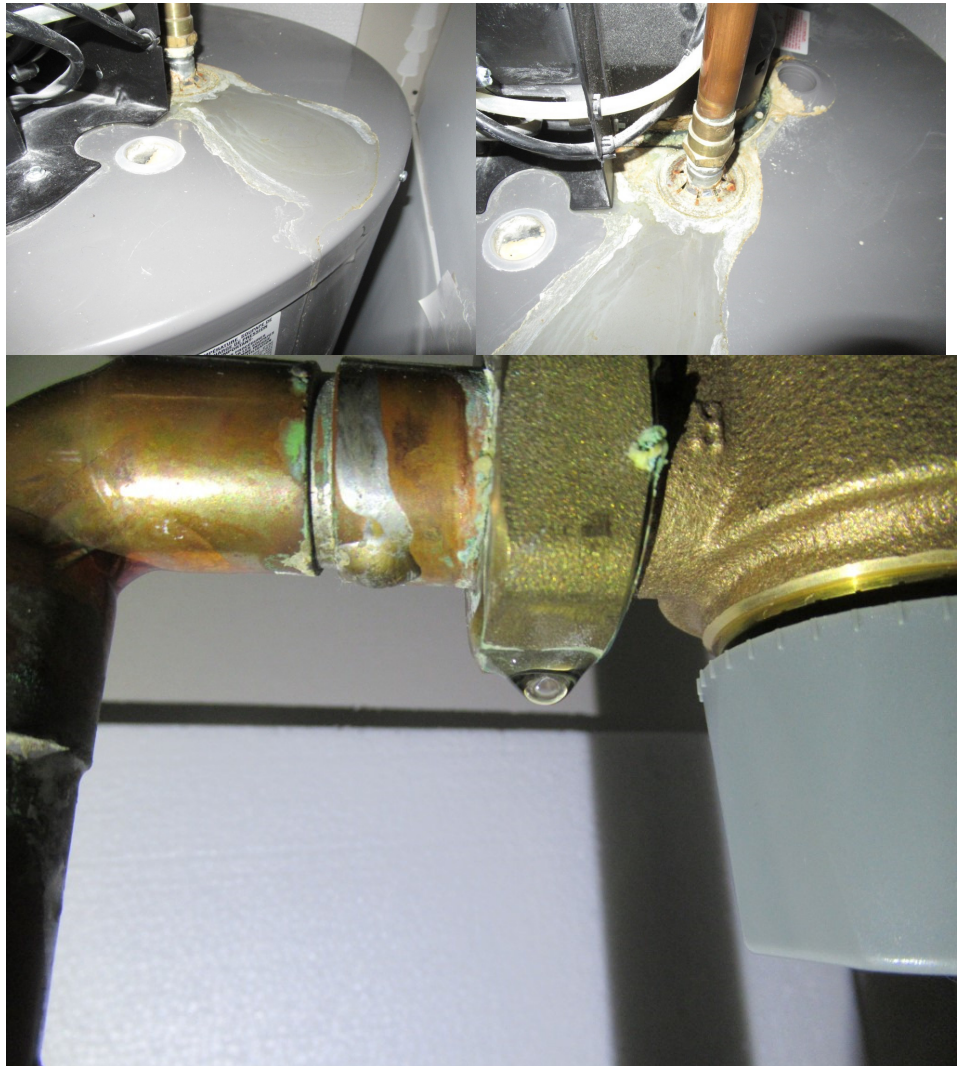
Review. Gas fired unit. Located at the rear right of the basement. Unit has a 189-litre/50-gallon capacity. The unit has a cold water shut off valve. Gas shut off valve provided. Temperature/Pressure relief valve installed as a safety feature. Unit appears to be on the order of 7 years old. Unit appears to be on the order of 7 years old. The average life expectancy of a unit of this type in this geographic area is typically 14 - 16 years. The water heater appears to be rented. **Evidence of active leaking noted at the time of the inspection (this appears to be associated with the mixing valve). We recommend immediate review by a qualified plumber and/or the rental company responsible for the water heater for repairs, as required.**

2420. Domestic Water Heater **Review. Evidence of active leaking noted at the time of the inspection (this appears to be associated with the mixing valve). We recommend immediate review by a qualified plumber and/or the rental company responsible for the water heater for repairs, as required.**

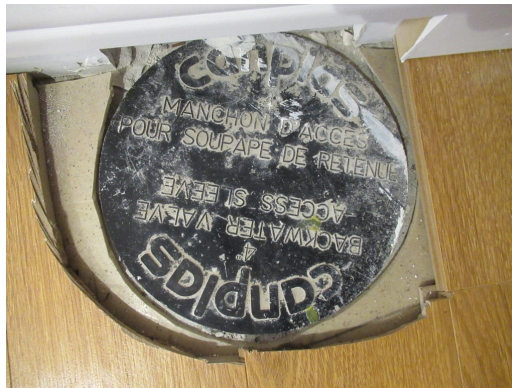
| 2460. | Plumbing Comments | Serviceable. Backwater valve noted at the front of the basement (under the front entry/landing). A backwater valve is a device that stops raw sewage from re-entering the home. These are mechanical devices that require periodic inspection and cleaning by a qualified plumber. |

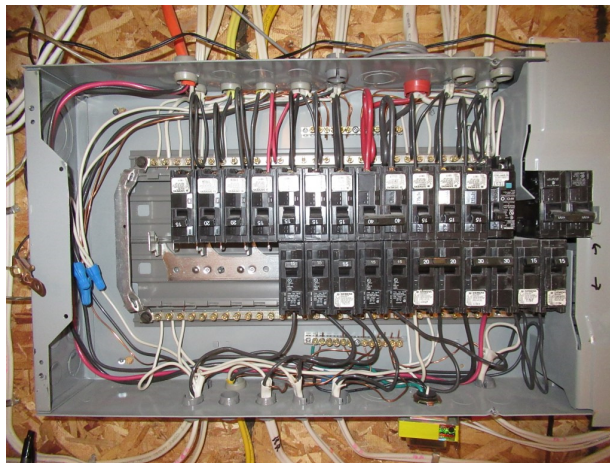
| 2510. | Main Electrical Panel | Serviceable. Located at the rear right of the basement. Manufacturer: SIEMANS. Main disconnect noted. Overload protection of the main electrical service wires is provided by breakers. The main conductor is copper. The system appears to be properly grounded. Circuit(s) available for future expansion/additional circuitry requirements. |
