Inspection Report

AmeriSpec Inspection Services (A Division of CanaSpec Services Inc.)

Sample Townhouse Report
Vancouver BC V5Z
2024-03-27

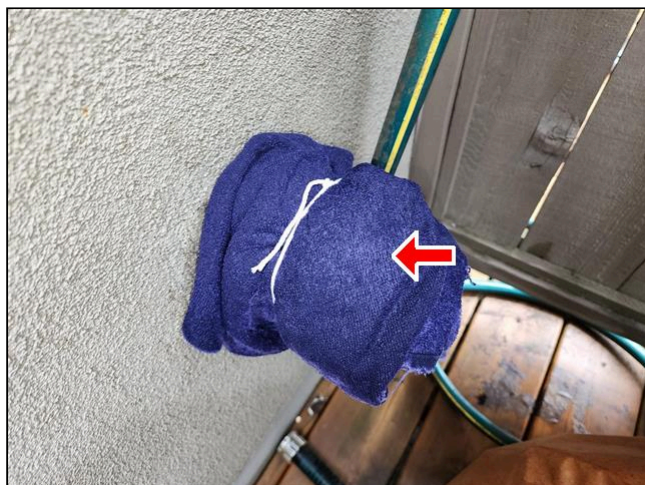
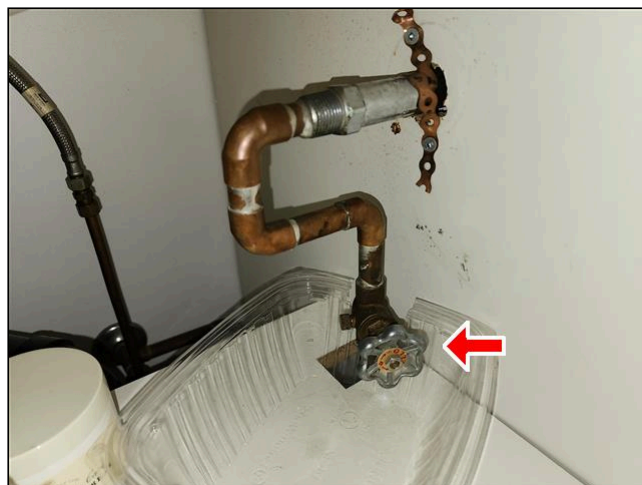
(1) Not tested. Wrapped with rag and foam. Winterization shut off present under upper level bathroom sink.

(2) Generally it is recommended that outside valves and water pipes are shut off and drained during the time of the winter that freezing weather could occur. This could prevent freezing and cracking the exterior piping. If some faucets are inoperable, they may be winterized (turned off inside the home). Inspector did not inspect condition of faucets, fixtures, plumbing, pressure or volume. Client is advised to consult sellers as to operation and location of shut offs.

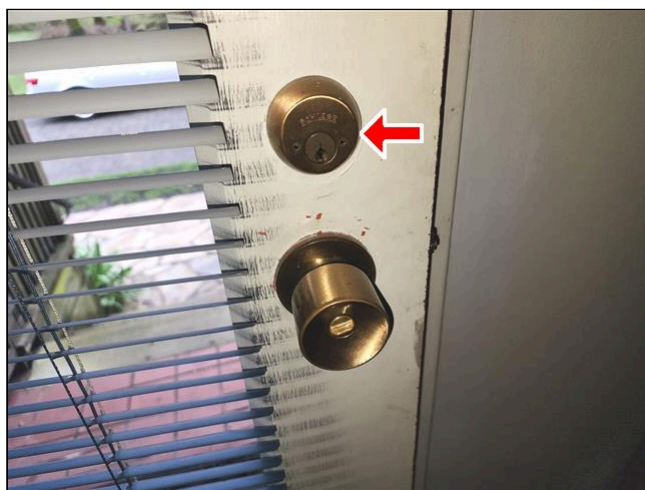
1.8 Item 1(Picture)

This door is equipped with a dead bolt keyed on the outside but also on the inside. Inside keying of a dead bolt is a possible safety hazard in the event emergency egress is required, such as during a fire.

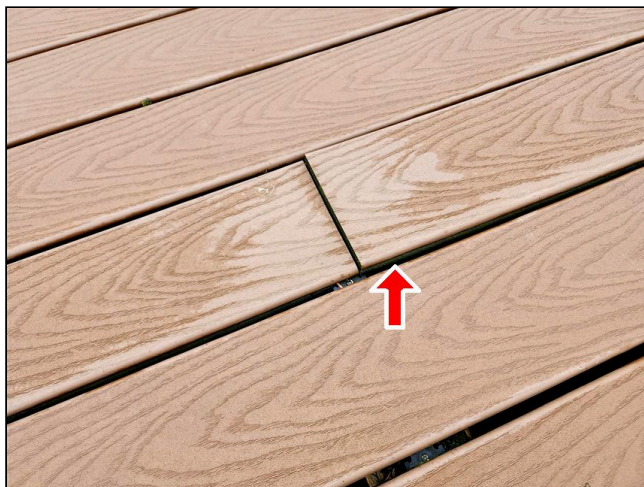
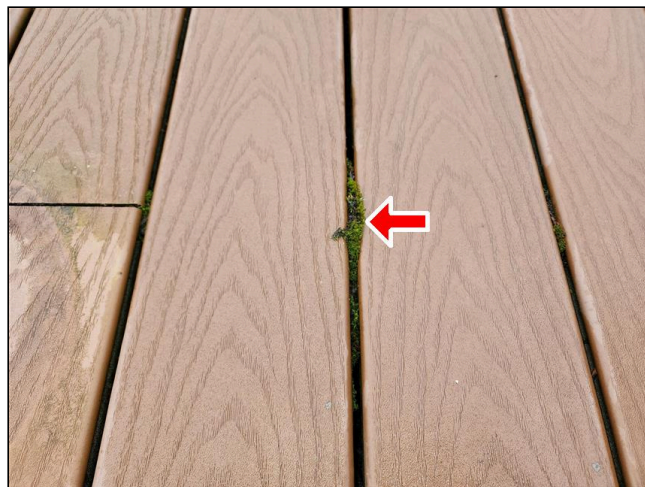
(1) Some lifting plastic deck boards. Moss build up in areas. Repair/clean as required.

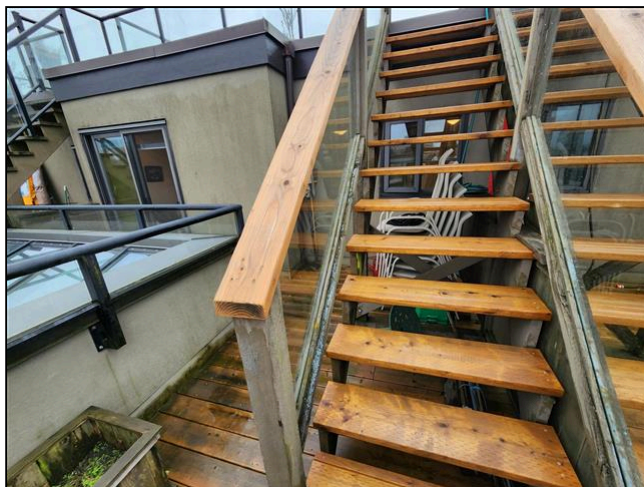
2.3 Item 1(Picture)

(1) Suggest non-slip treads or finish for safety.

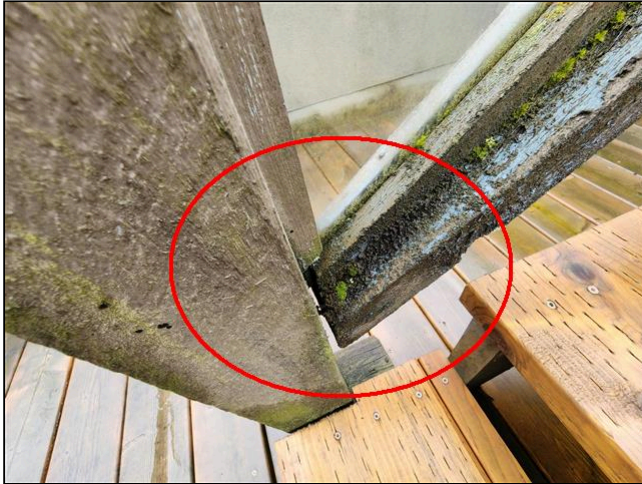
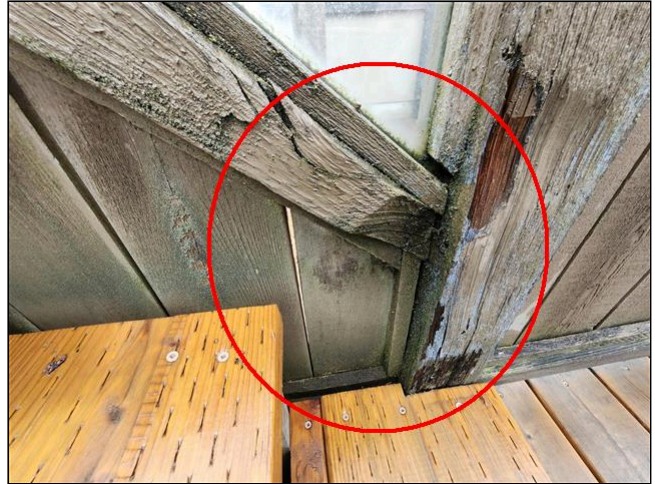
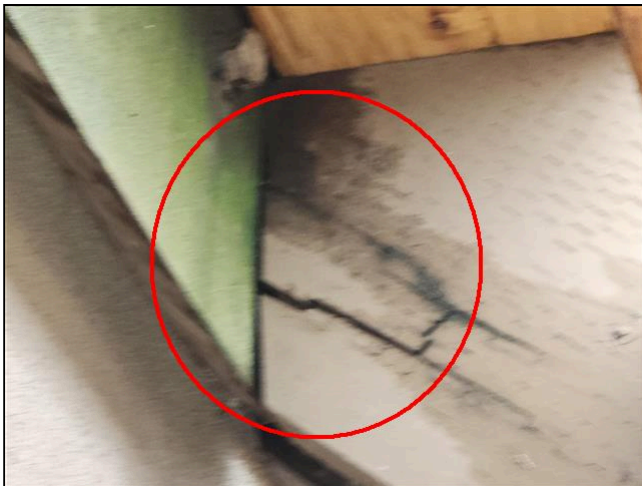
(2) Treads have been replaced relatively recently. Deterioration noted at stair stringers and railings. Monitor and repair or replace as required.

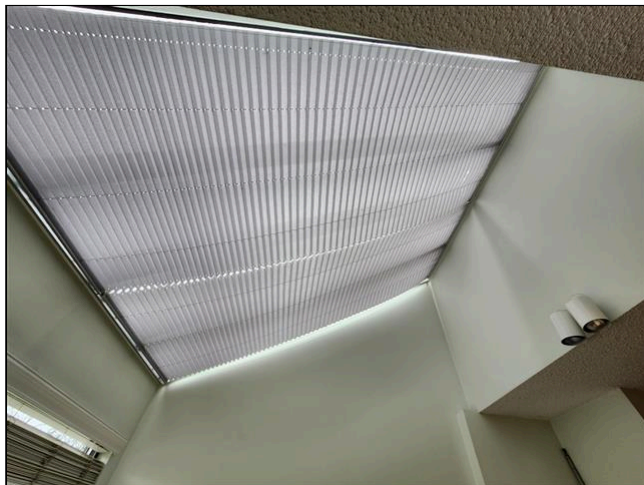
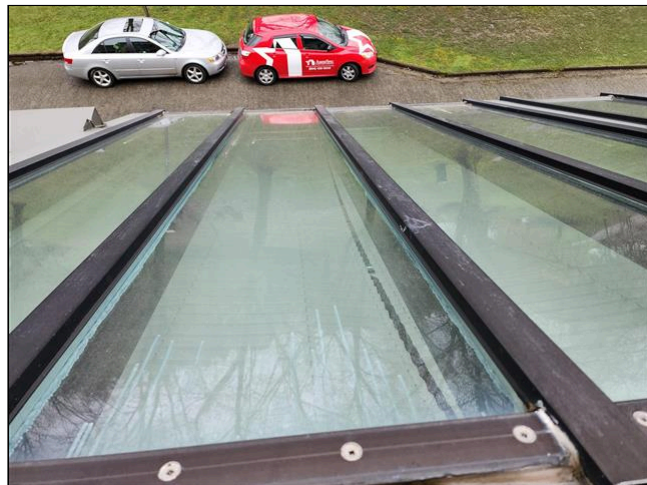
Limited review due blinds covering.

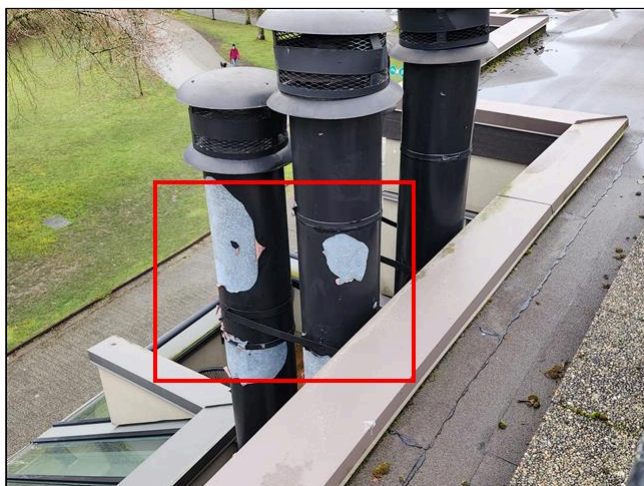
3.4 Item 1(Picture)

(2) Cracking and chipping paint noted. Suggest refinishing to prevent deterioration.

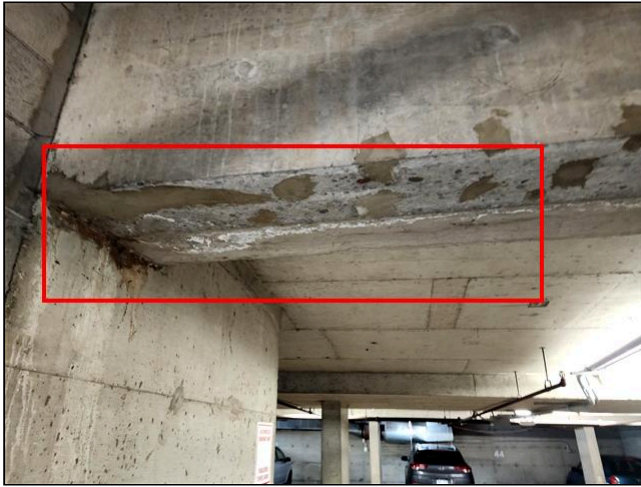
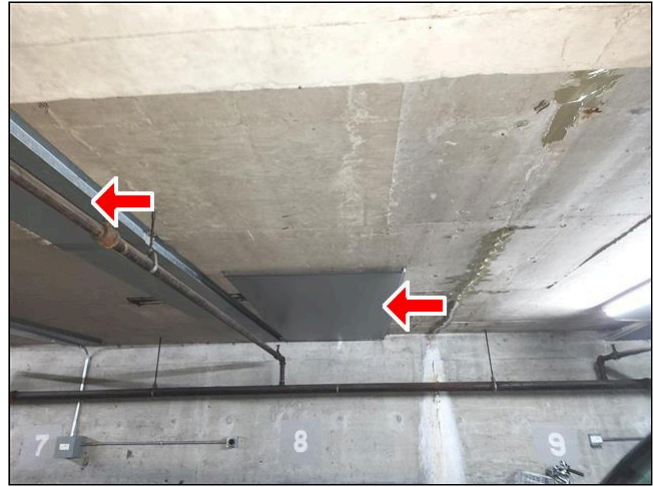
Common cracking noted. Moisture stains and drip pans in areas. It is common to see signs of leakage in underground parking garages as some of the areas are usually located under landscaping, walkways and outdoor patios. Sometimes leaks are addressed by installing drip pans and having sealant injections performed from inside the underground. In extreme cases, repairs or replacement of the waterproof

membrane must be done from the outside. This can be an expensive undertaking because landscaping, walkways, patios and other features must be removed to access the waterproof membrane. Suggest reviewing strata engineering or depreciation reports and reviewing with strata representatives and/or strata management company.

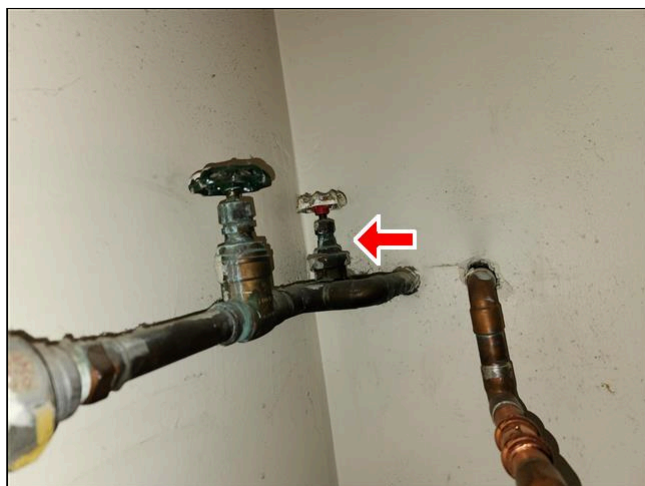
6.0 Item 1(Picture)

(1) Main water shut-off for the home.

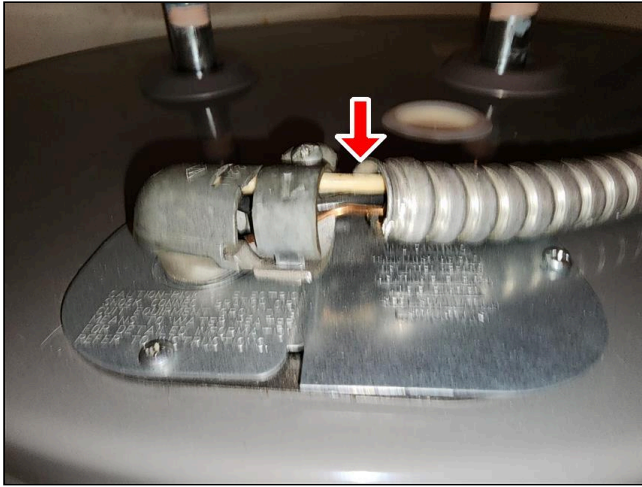
7.2 Item 1(Picture)

Exposed electrical wiring. Recommend protecting from possible damage.

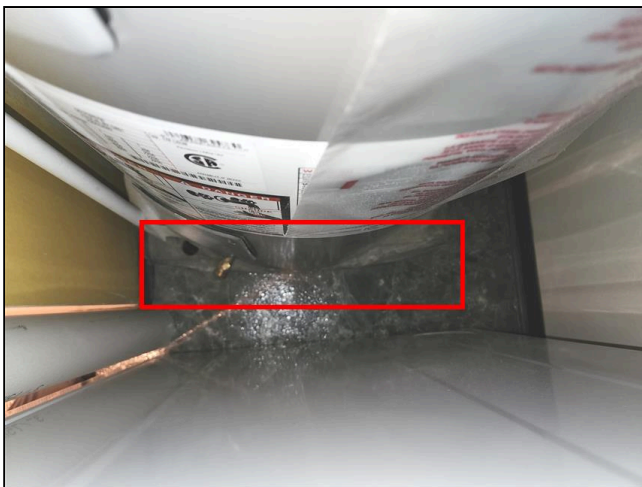
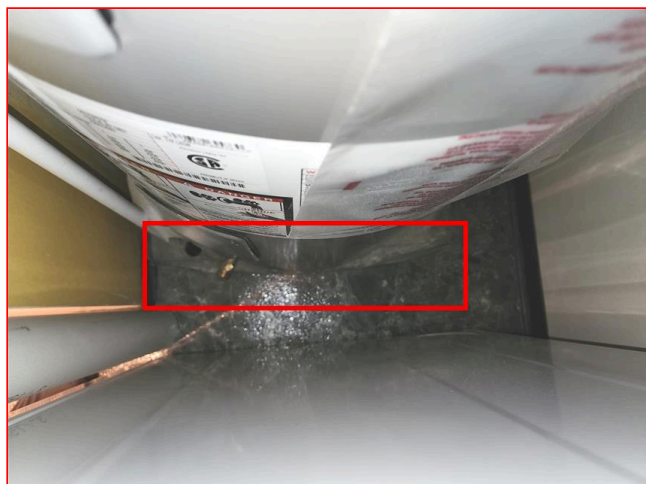
7.4 Item 1(Picture)

Tank is too large for the drip pan. One side has been flattened and therefore will not hold water. Repair or replace as required.

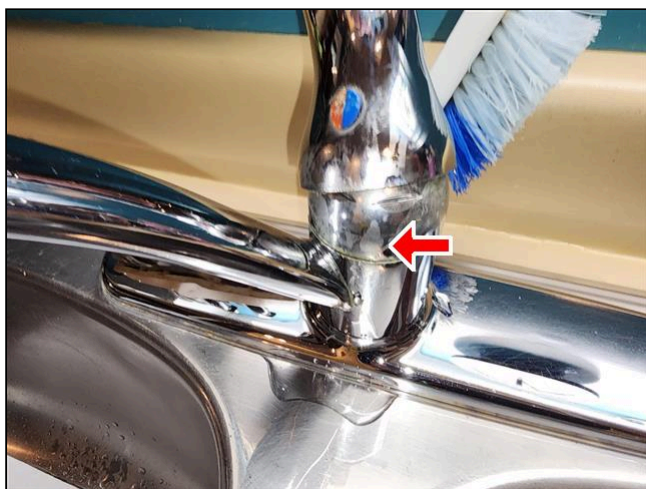
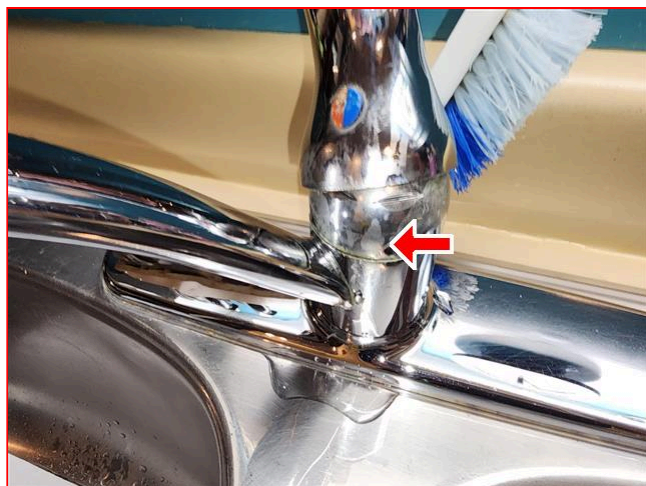
9.6 Item 1(Picture)

Leaks. Repair or replace as required.

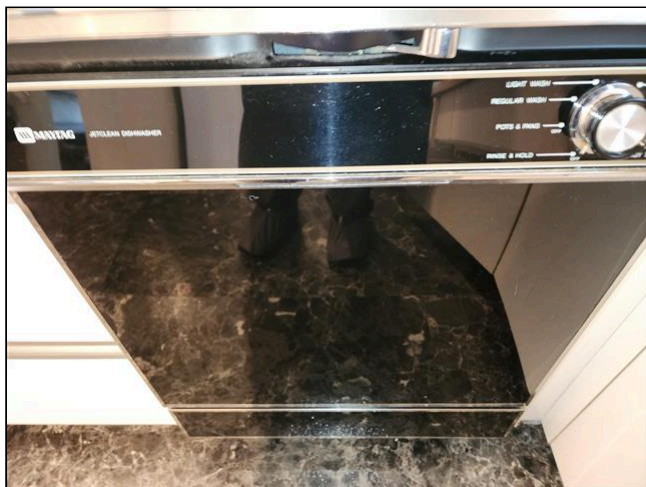
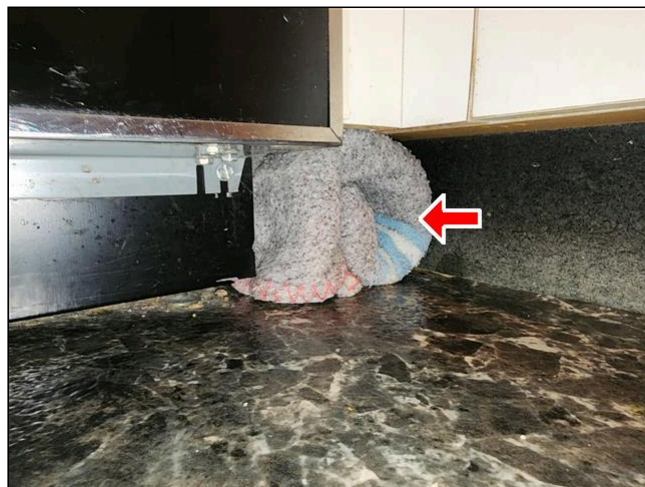
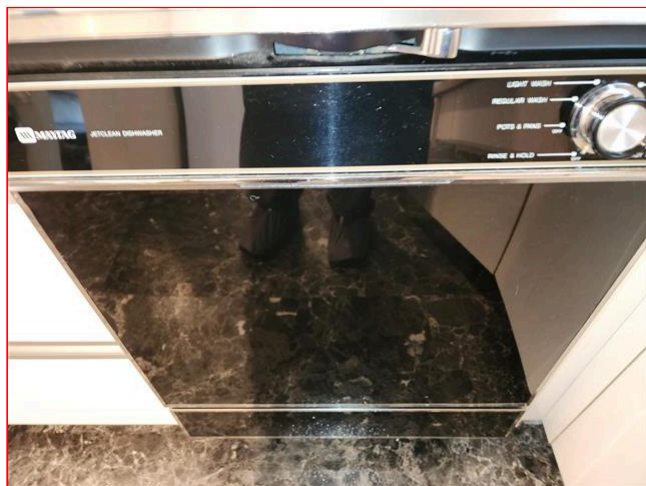
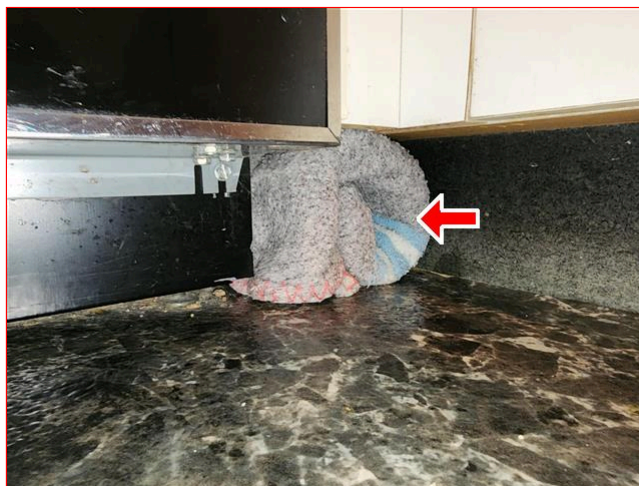
Not tested. Seller stated not used in a long time. Old model. Blanket is positioned along side of dishwasher. Suggest contacting vendor for further information. Repair or replace as required.

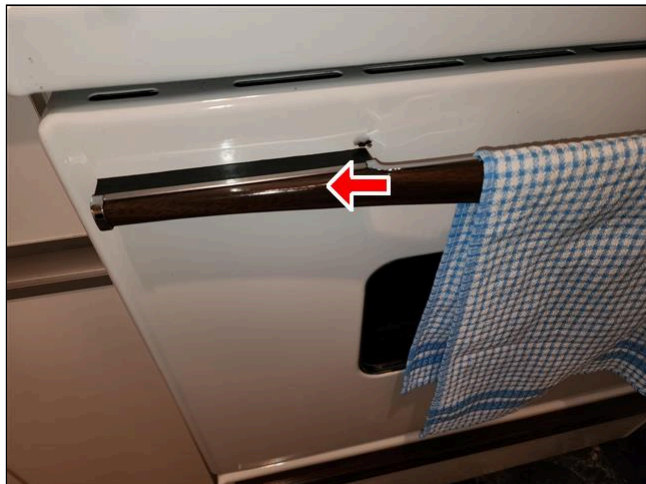
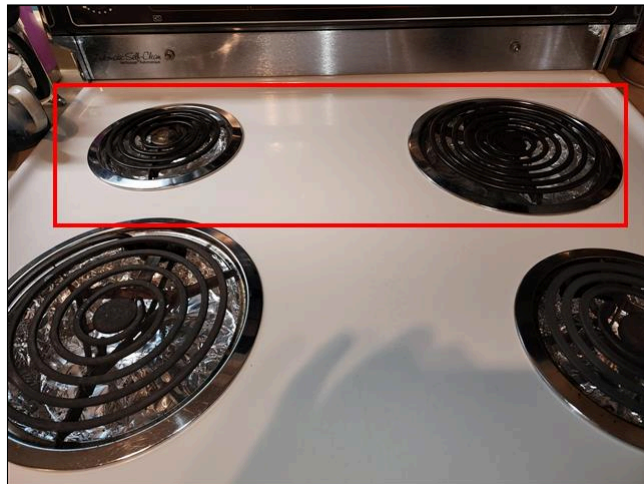
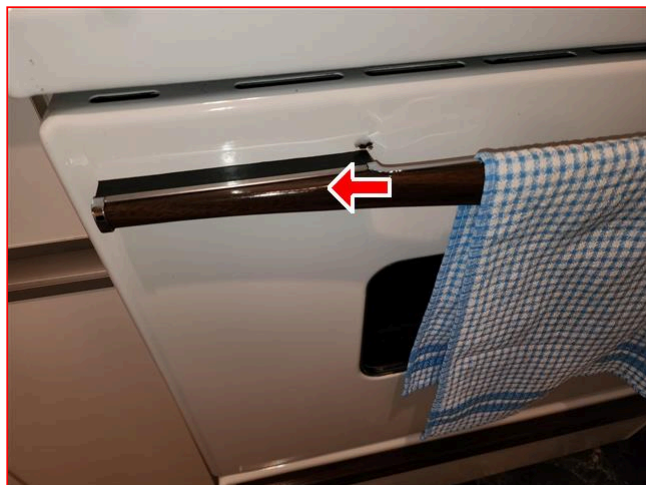
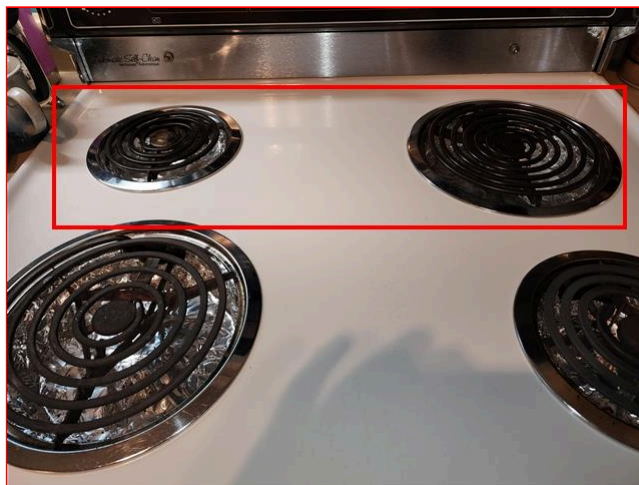
Oven door is stiff to open/close. Rear two burners not operable. Older worn model. Repair or replace as required.

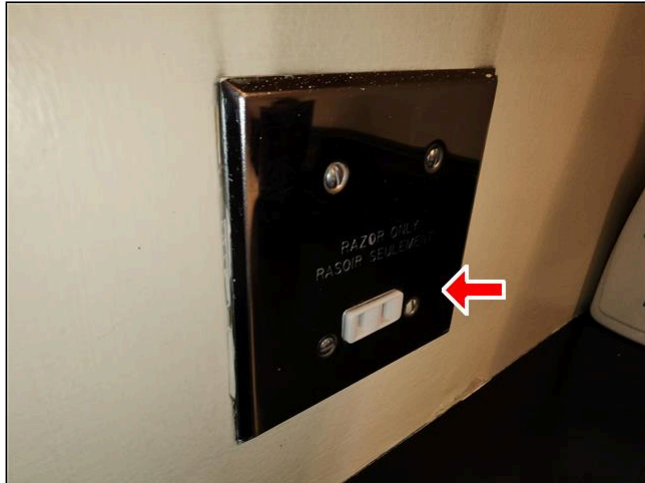
10.4.A Item 1(Picture)

Razor outlet noted which is intended for low voltage appliances only, specifically razors. Overheating may occur with use of other appliances. Recommend upgrading to Ground Fault Interrupter outlet for enhanced safety.

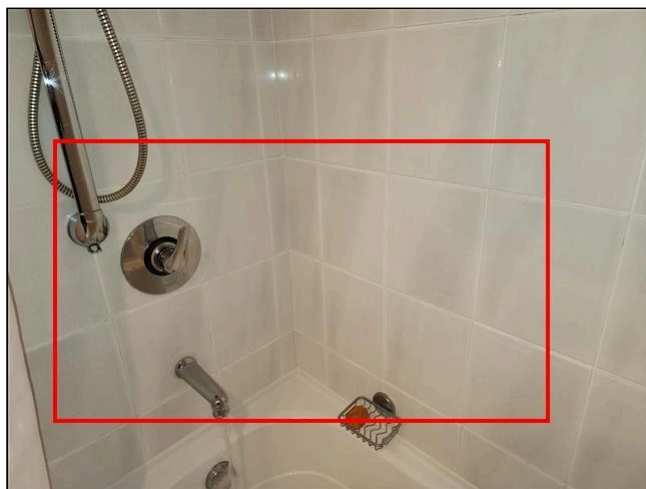
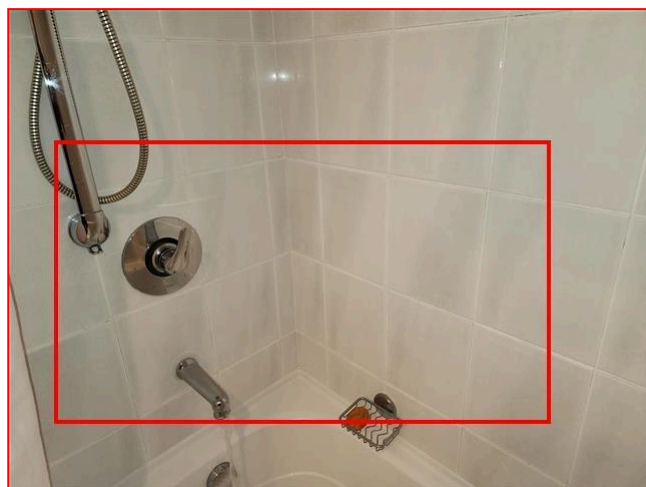
10.7.B Item 1(Picture)

(1) Cracked grout noted. This condition may have allowed moisture behind the coverings. The preceding conditions should be reviewed by a qualified contractor and repaired or replaced as required.

Recommend cleaning and water sealing grout with a liquid grout sealer. This can help prevent moisture penetration through the grout and behind the tile. Recommended that this be done every 3-4 years.

The tile edges of the tub/shower walls should be caulked to prevent moisture penetration. Failure to keep walls sealed can cause deterioration and moisture damage to the interior walls, which is not always visible to the inspector at the time of inspection.

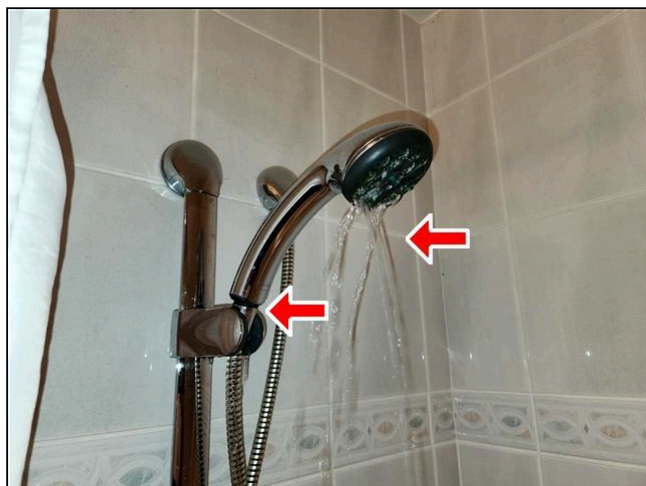
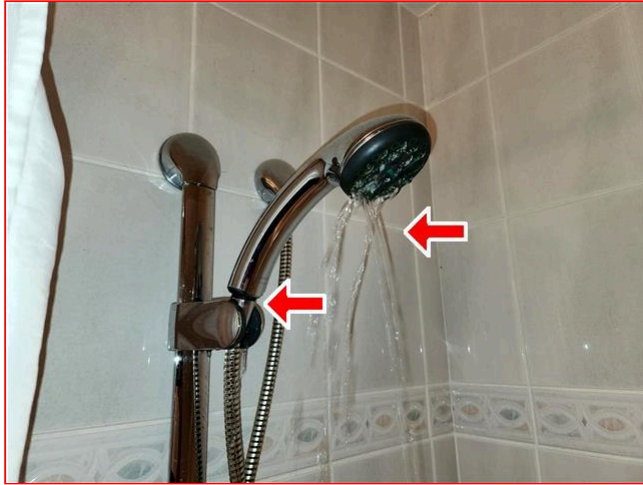
10.7.B Item 2(Picture)

(2) Drip leak at shower head attachment. Low water flow. Suggest contacting vendor for further information. The preceding conditions should be reviewed by a qualified contractor and repaired or replaced as required.

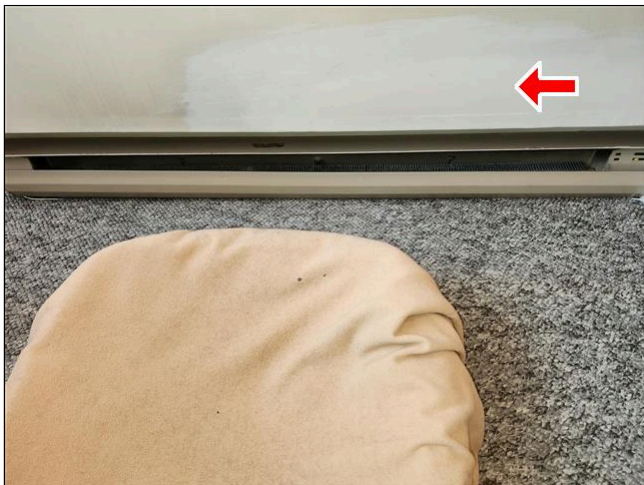
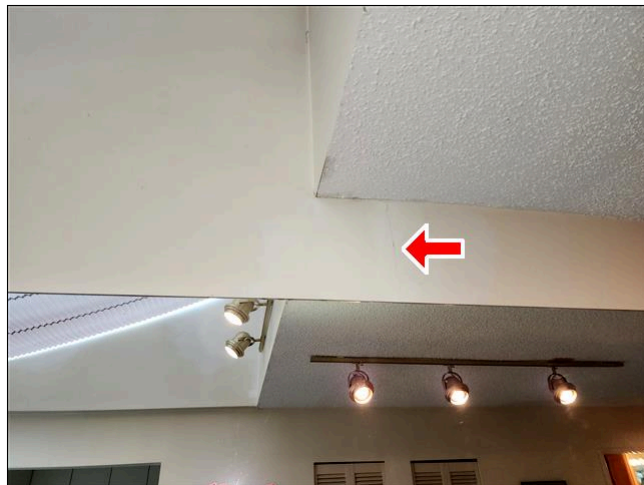
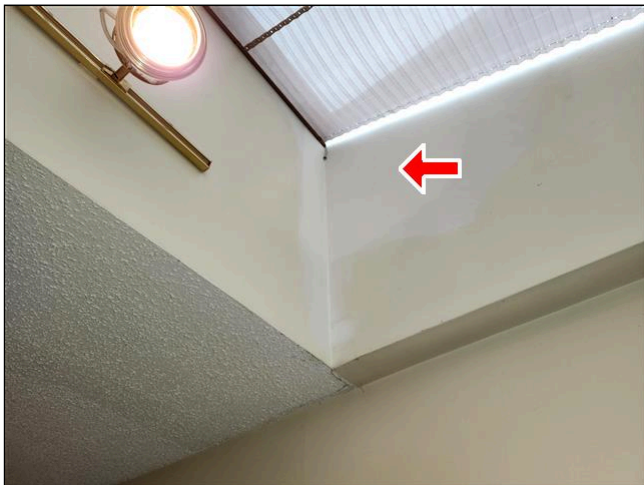
Comments: Serviceable
Common cracking noted. Patching in dining room. Suggest contacting vendor for further information.
Refinish as required. Monitor.

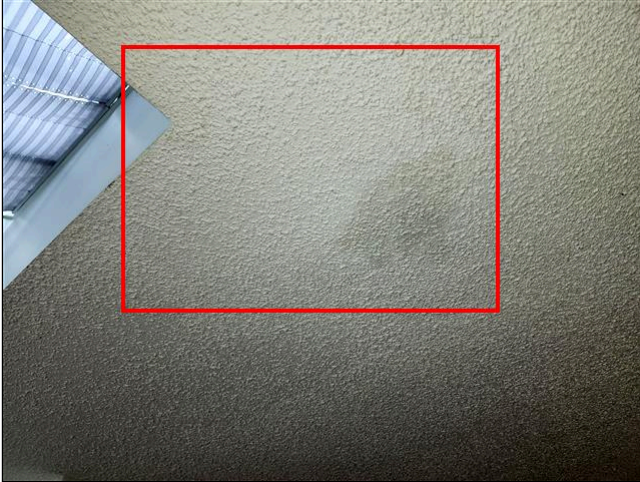
11.2 Item 1(Picture)

(1) No water noted but evidence of previous leaks. Staining and patching near skylight. No elevated moisture detected with non-invasive moisture meter.

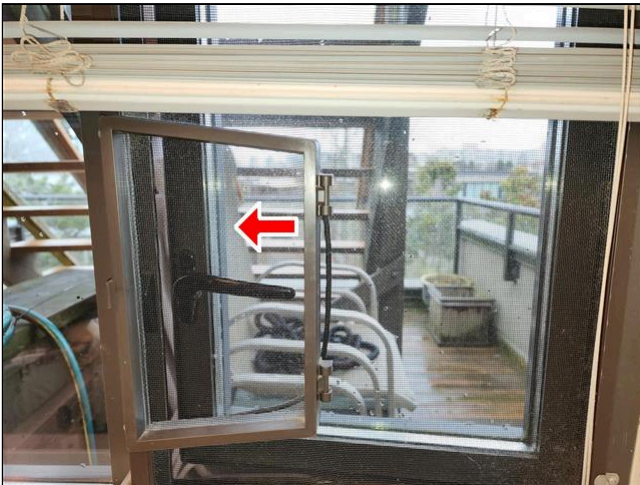
11.4 Item 1(Picture)

(1) Some windows do not open or close without restriction. Lubricant/repair as required.

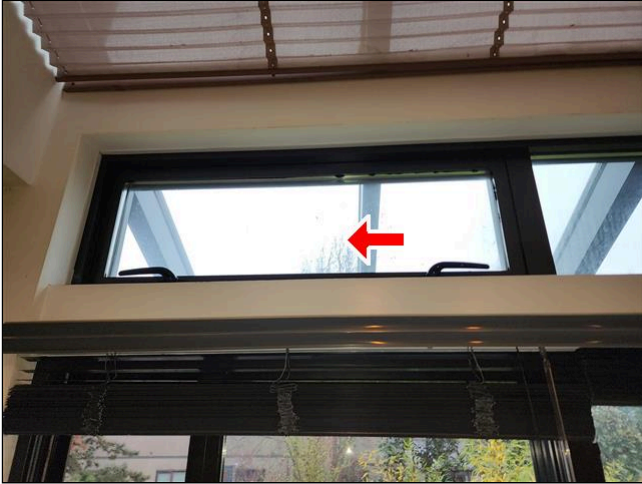
11.4 Item 2(Picture)

(2) Possible fog and condensation was noted in one or more double glazed insulated window panes. This indicates a broken seal which will reduce visibility and the insulating capability of this window. To restore visibility and regain the insulating capability, replacement of this window pane is required.

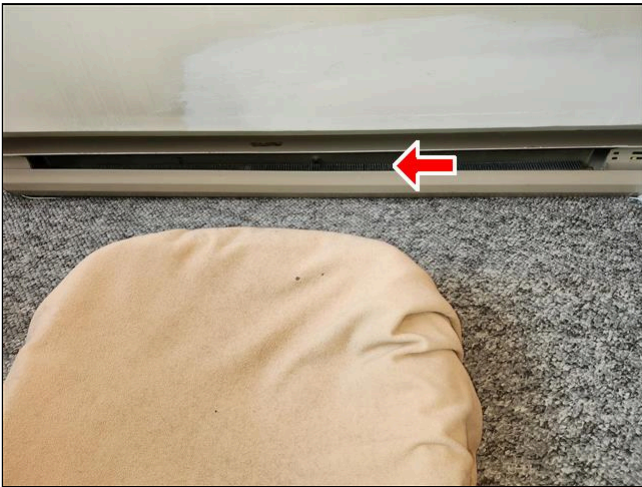
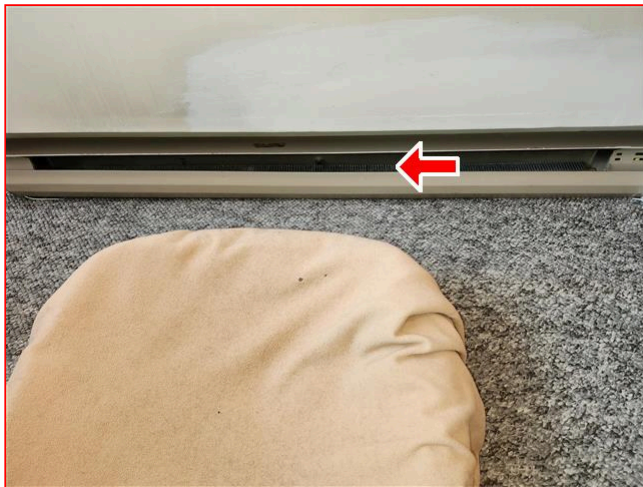
11.6 Item 1(Picture)

(1) One of the baseboards in the dining room did not activate. Repair or replace as required.

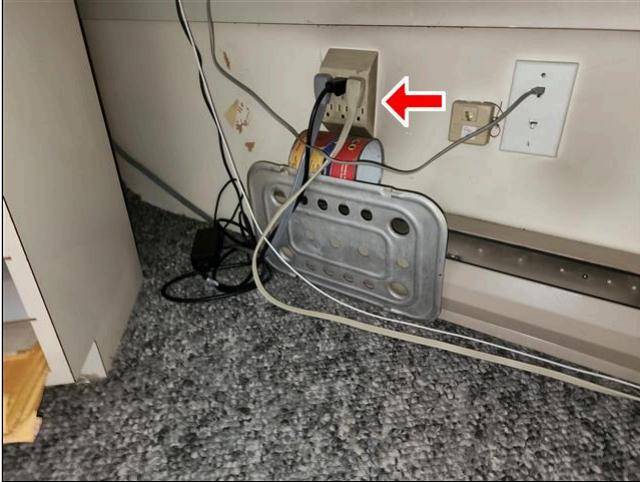
11.6 Item 2(Picture)

(2) Electrical outlet located over top of baseboard. Recommend keeping wiring safely away from baseboard.
