AmeriSpec Home Inspections

Doc #: 2019-07-1853 Inspector: Chris Hill

Date: 7/11/2019

Dwelling Address: 40 Groomsport Cres.
Toronto, On

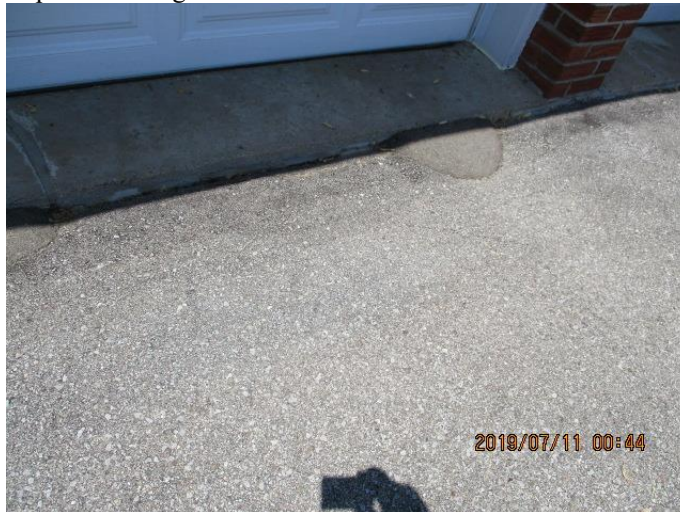
Step #	Component	Comment
1105.	Driveway	Asphalt. Settling noted.

We recommend proper sealing and leveling across settled area at front of garage or consulting with a qualified paving contractor to determine appropriate repair options and associated costs.

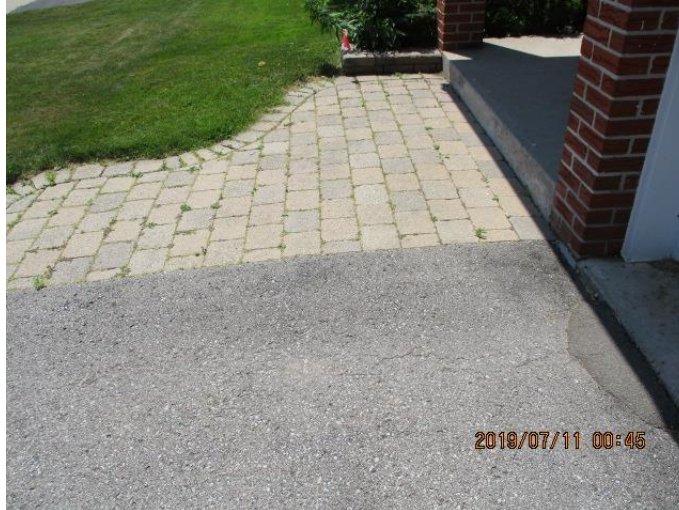
Interlocking brick. Walkway(s) appear to be sloped toward the homes foundation at the front walkway.

In order to prevent possible water infiltration into the home, we suggest regrading underlying fill material with a positive slope away from the foundation walls and re-leveling the walkway materials with a positive slope away from the foundation.

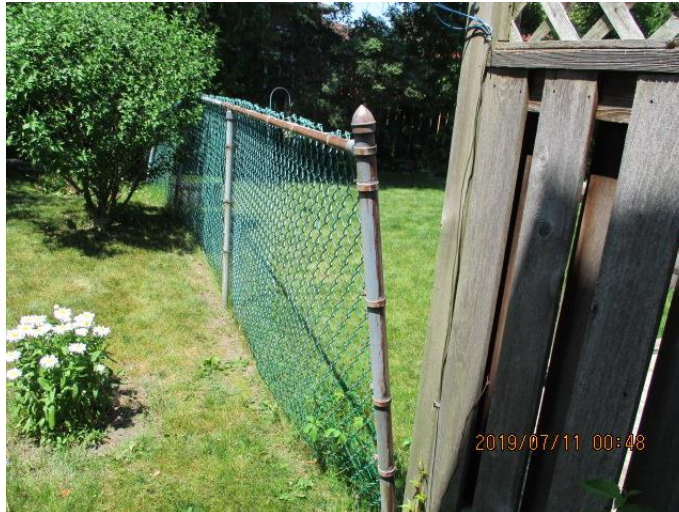
Leaning fence noted at rear right side. We recommend repairs/adjustment be completed in these areas to ensure proper functionality. We recommend repainting/restaining the fence as part of routine maintenance to prolong the functional life of the fence.

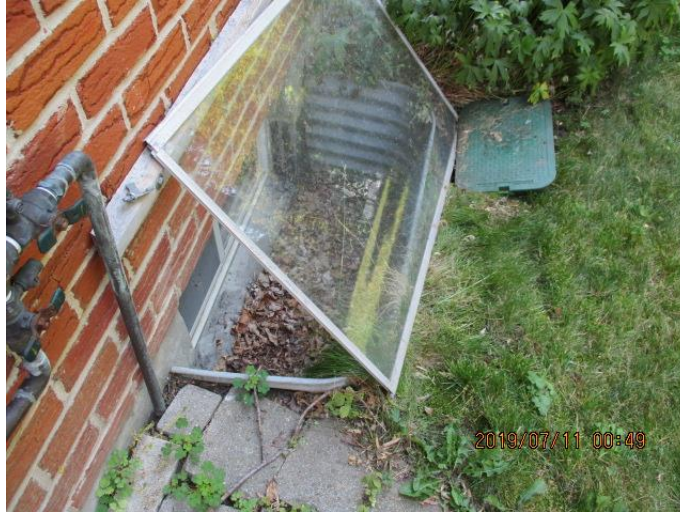
1140. Window & Frames Vinyl. We recommend that the client considers adding/installing window well(s) at the basement area, with adequate/proper drainage to eliminate conditions of poor drainage noted at lower level windows. At the time of the inspection, a build up of debris was noted in several of the window wells around the exterior of the home.

In order to ensure proper drainage of water and reduce the potential for water infiltration into the home during sudden heavy rain falls and snow melts, we recommend removing all debris and ensuring that at least a 3-4 inch separation is maintained between the lower window sill and the gravel window well base. We recommend caulking and sealing around all windows as part of routine maintenance to reduce the potential for water infiltration into the home and minimize air leakage from the home. We recommend ensuring that window wells installed at lower level basement windows are maintained in a clean condition with gravel levels maintained at approximately 3-4 inches below the lower window sills to reduce the potential for water infiltration into the home through the lower level windows. Proper plastic covers installed on hinges for easy access can be installed if needed.

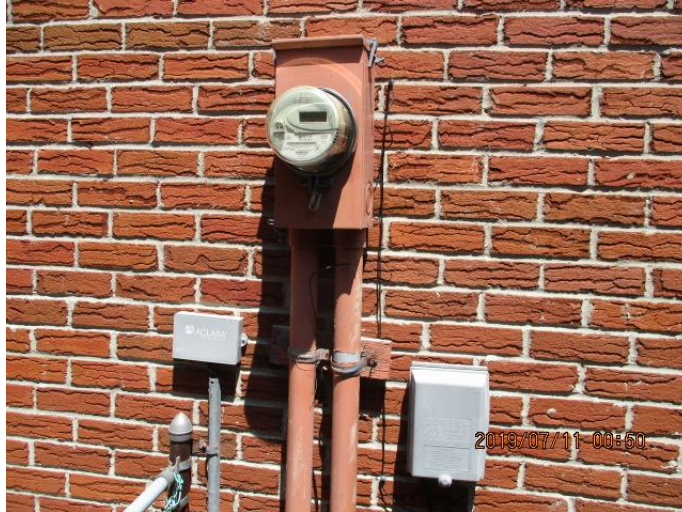
The electric meter/main conduit is loose and/or disconnected. We recommend consulting Ontario Hydro or a licensed electrician to evaluate/correct this situation. Loose or missing support clamp noted at electrical conduit to meter base.

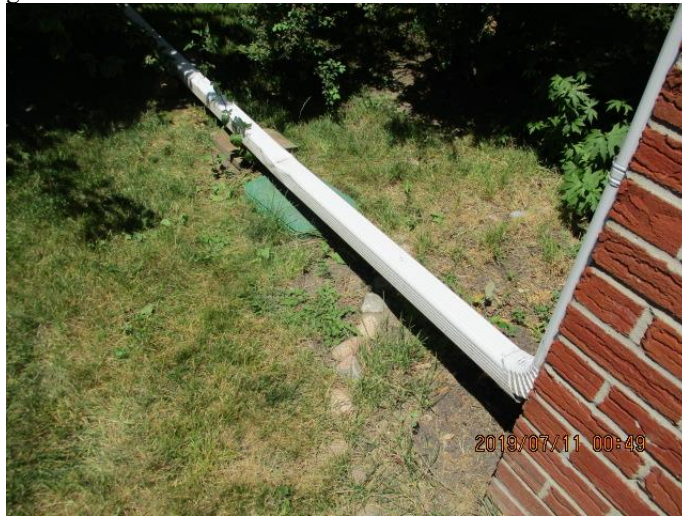
Aluminum. We suggest extending/redirecting downspouts to further channel water away from the foundation (ideally the end of the downspout should terminate with proper support, 6-8 inches above the ground).

(This will prevent premature freezing and allow downspout to drain longer before freezing) in order to reduce the potential for water infiltration into the home.

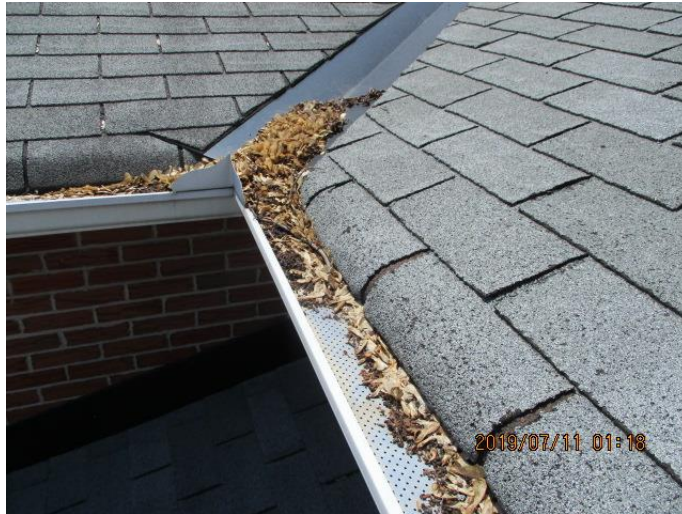
Even though gutter guards are installed a build-up of debris was noted in the gutters. We recommend ensuring that gutters and downspouts are cleaned and flushed as part of routine maintenance to ensure proper drainage of water away from the home and to reduce the potential for water backup and resultant damage to roofing materials and concealed components of the home. Gutters and downspouts are an integral part of a home's storm water management system and should be monitored on a regular basis for proper operation. It is recommended that gutters and downspouts be cleaned and flushed as part of routine maintenance to reduce the potential for water backup and resultant damage to roofing materials and concealed portions of the home.

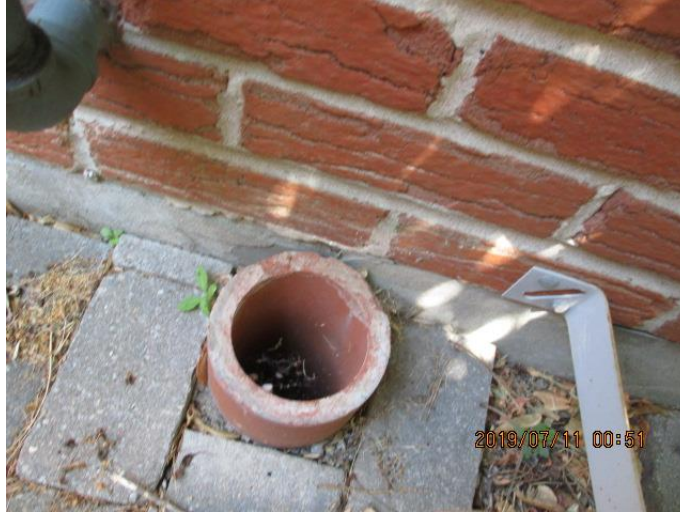
1160. Lot/Grade Drainage
- The building is constructed on a flat lot. We suggest maintaining a positive grade away from the foundation walls around the entire house wherever possible to further channel water away from the foundation walls and reduce the potential for possible water infiltration into the home. The lot slopes toward the home at window well areas. This is a sensitive area in terms of potential water infiltration into the basement. We recommend adjusting the grade here to ensure positive grade away from the foundation. We also recommend properly capping all old clay tiles that were used to drain downpipes.

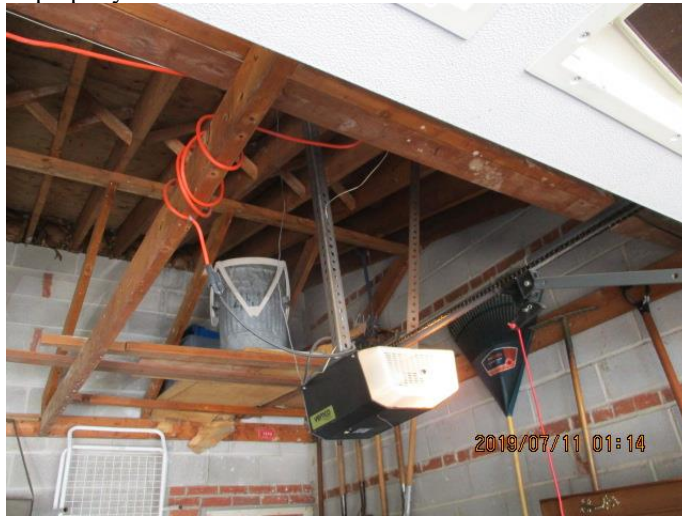
1340. Garage Door Opener
Opener
- The garage door-opener is equipped with a safety reverse device which operated when tested at the time of our inspection. It is recommended that these devices be checked regularly. Garage door opener is improperly wired with extension cord.

Ideally the wiring should be dedicated with its own supply cord to an electrical outlet at the ceiling area.

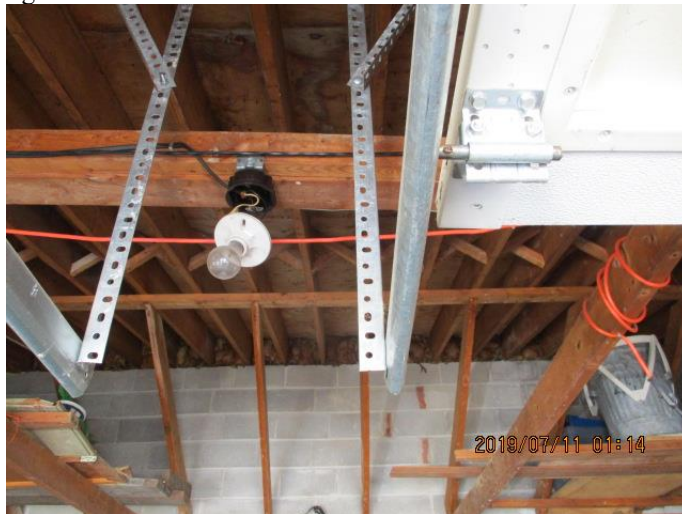
1345. Window
1350. Service Door
1360. Fire Wall
1365. Walls
1370. Ceiling
1375. Electrical
- Fixed plastic in overhead doors.
Wood. Unable to access rear wood door.
No obvious significant breeches were noted where visible.
Block and brick common cracking above rear door seal.
Unfinished.
Improperly used extension cord(s) for general wiring, loose hanging light fixture.

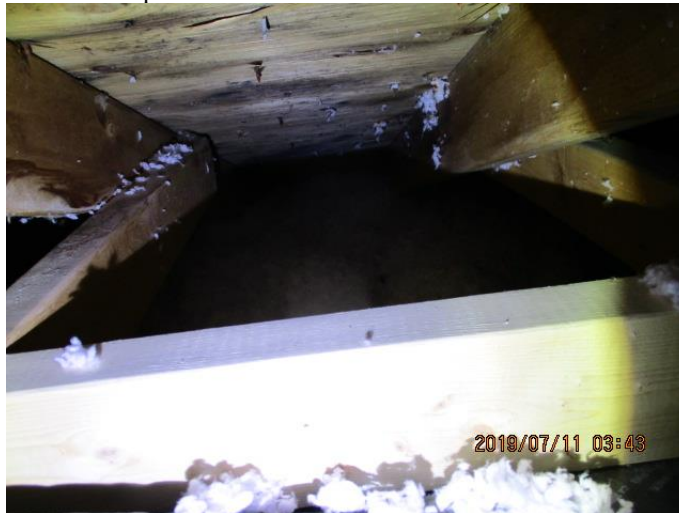
1515. Sheathing/Leaks Plywood. Minor black discolouration due to poor venting suggest review as required.

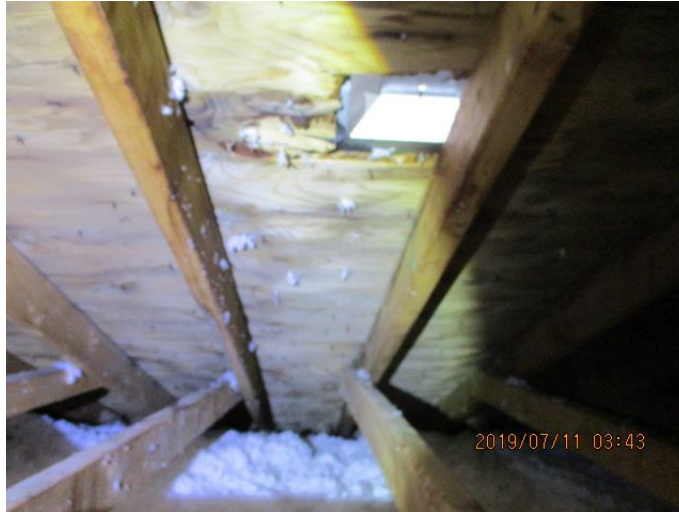
The amount of ventilation observed in the attic may be inadequate for the size of the roof. Although no evidence of any obvious adverse ventilation effects were observed at the time of the inspection, Client may consider installing additional ventilation including proper soffit vents and roof vents to enhance ventilation in the attic and reduce the potential for moisture related damage originating from the interior of the home.

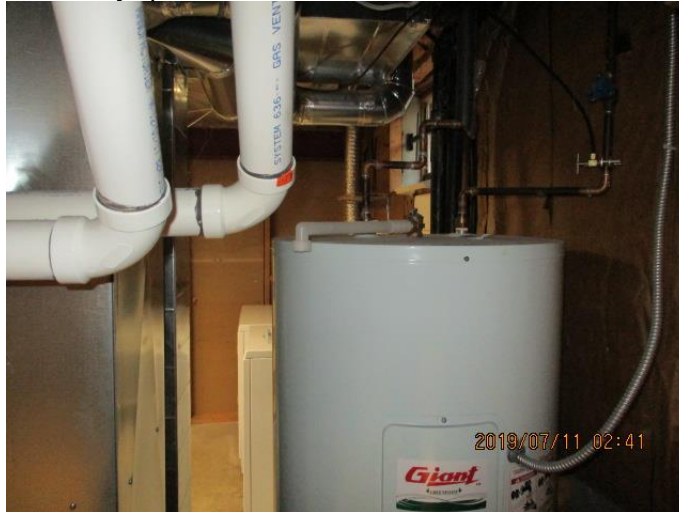
The unit has a cold water shut off valve. A Temperature/Pressure relief valve is installed as a safety feature. Temperature/pressure relief valve does not have a proper extension pipe. The pipe allows the steam to escape near the floor reducing the risk of scalding. We recommend that one be installed for additional safety. Unit has a 189 litre capacity.

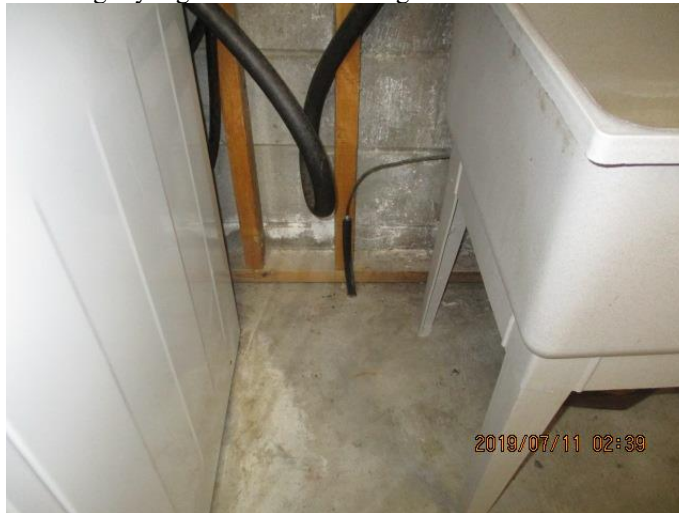
Concrete block. Evidence of efflorescence was noted at several minor areas slightly higher moisture reading.

Efflorescence is a white mineral deposit often seen on the interior of foundation walls. The presence of efflorescence indicates that moisture penetration has occurred, however does not tell a great deal about the severity of a potential water infiltration problem or whether the problem is active. As water passes through the wall, it collects and dissolves mineral salts from the masonry, concrete or mortar, so that when the water arrives at the interior wall surface, it contains high levels of minerals salts in solution. The crystalline salt deposit, known as efflorescence, is left behind when the water evaporates off the wall surface. This may be a result of water originating from the outside of the home passing through the wall, or water rising up through the wall by capillary action. See Exterior - Lot/Grade Drainage section and Exterior - Exposed Foundation section for additional information. Evidence of active seepage noted at the front of house under basement stair area.

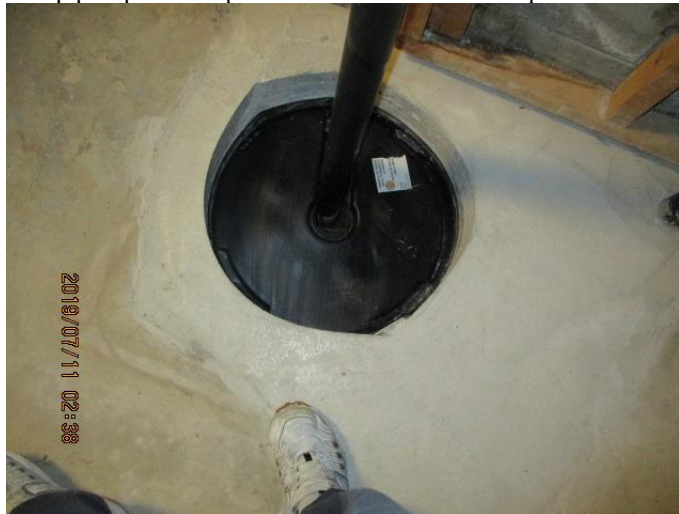
The sump pump appears to be discharging into the home's sanitary sewer system. In accordance with current standards, we recommend redirecting the discharge piping to the exterior of the home to reduce the potential for overloading of the municipal waste water treatment system. A qualified plumber should be consulted to determine modification options and associated costs. Given the active nature of some sump pumps, Client may consider installing a battery backup system and backup pump to ensure that the sump pump is operable during power outages. Sump pits/pumps are designed to collect and properly manage/discharge storm water from rain and snow melt that accumulates around the building. Sump pits/pumps are usually provided in basements where there is a higher risk of subsurface flooding. If installed, exterior perimeter foundation drainage tile may drain into the sump pit. We are unable to confirm however, if a proper connection between the weeping tiles, if existing, and the sump pit was made. We recommend consulting with the current owner or builder. Sump pits /pumps are typically necessary in areas where the water table may become excessively high during certain times of the year. In addition, some municipal building departments require the installation of a sump pit/pump if storm sewers located at the street are higher than the lowest floor level.
