SUMMARY REPORT

AmeriSpec Inspection Services of Hamilton, Brantford and Stratford
32 Livingstone Cres
Cambridge ON N3H 5S7
226-341-9569

URGENT REVIEW SUMMARY

Doc #: 010621SH2

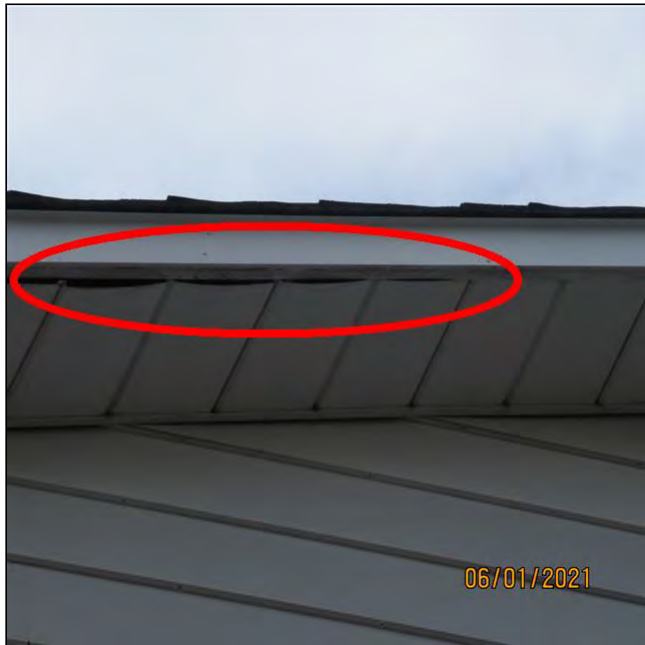
1.3 Item 2(Picture)

(2) Loose trim observed at left side gable soffit. We suggest securing as necessary.

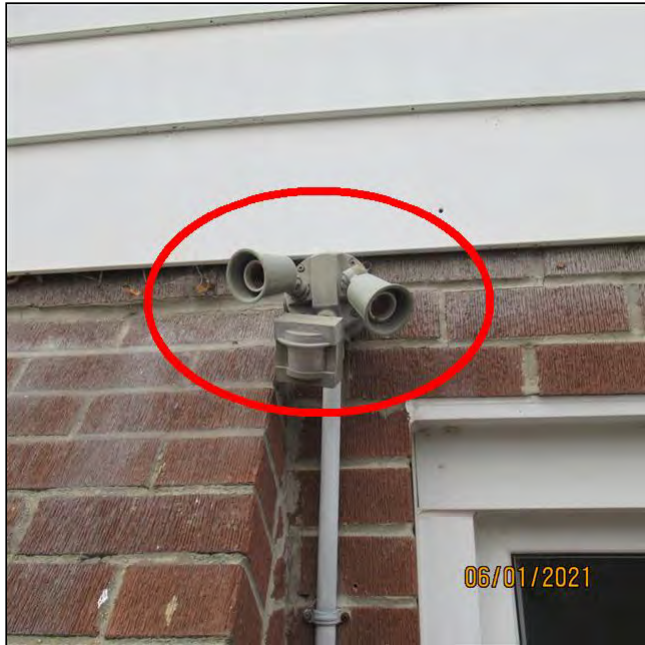
1.8 Item 1(Picture)

(1) Light fixture at rear was inoperative at time of inspection; missing bulbs. We suggest the client verify fixture for proper operation prior to closing.

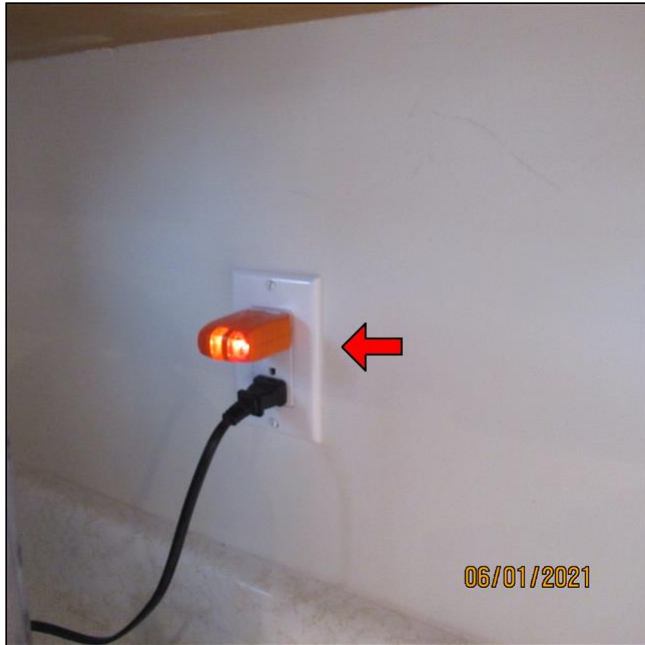
7.6 Item 1(Picture)

Reversed polarity wiring conditions was observed at the receptacle to the right of the kitchen sink. A reversed polarity condition occurs when the hot and neutral wires are connected to the opposite terminal connections of the outlet (i.e. hot wire connected to neutral terminal and neutral wire connected to hot terminal). This can be a safety hazard. This condition is usually easily corrected by minor wiring adjustments at the specific outlet(s).

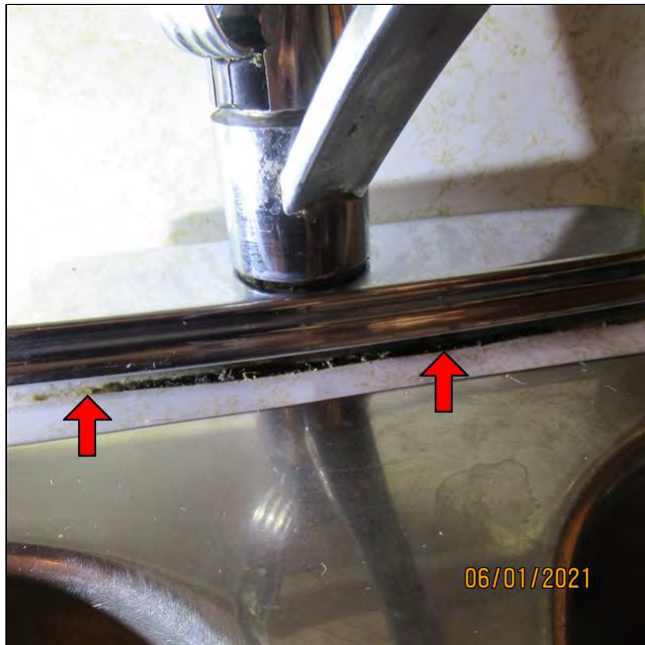
7.10 Item 1(Picture)

Faucet loose, allowing water to leak into the counter top. Recommend review by qualified professional for repair or replacement as necessary.

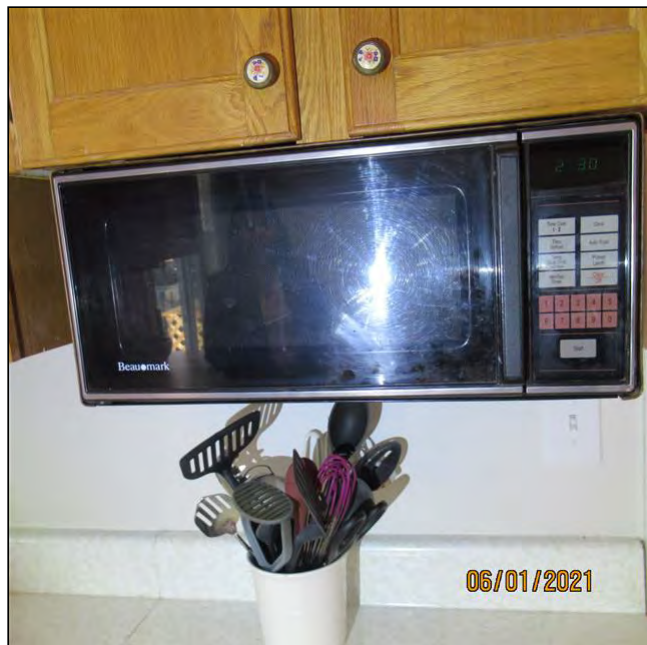
7.17 Item 1(Picture)

Inoperable at the time of inspection. Recommend review by a qualified appliance technician for repair or replacement as necessary.

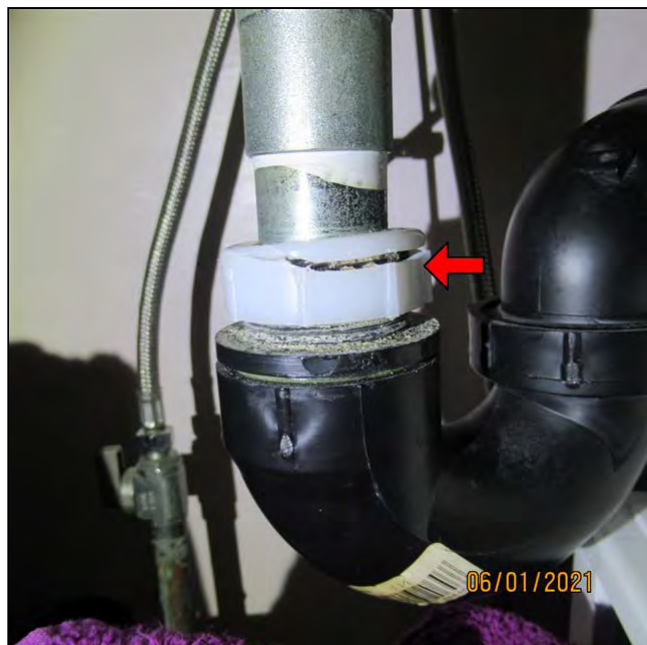
8.16.B Item 1(Picture)

Left sink drain assembly has a cracked/loose connection; no leaks observed. We recommend review by a qualified professional for repair or replacement, as necessary.

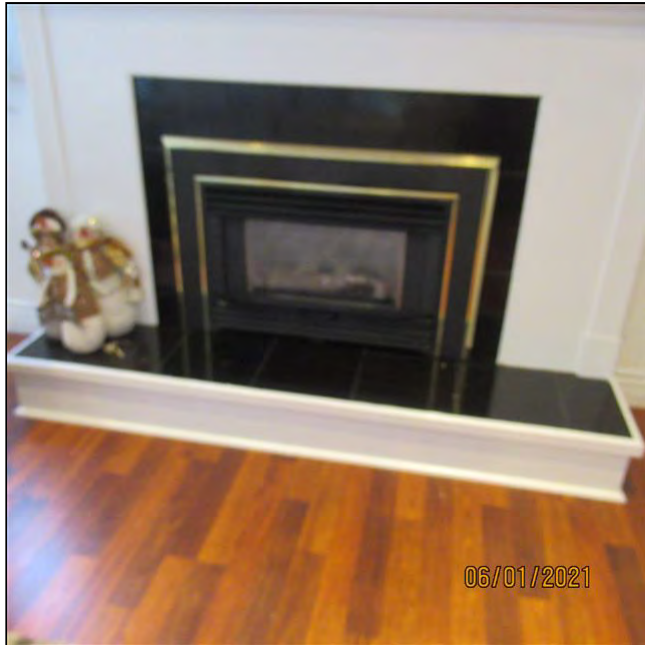
11.7 Item 1(Picture)

Inspector was not able to operate the fireplace. No pilot light operating to ignite the fireplace.

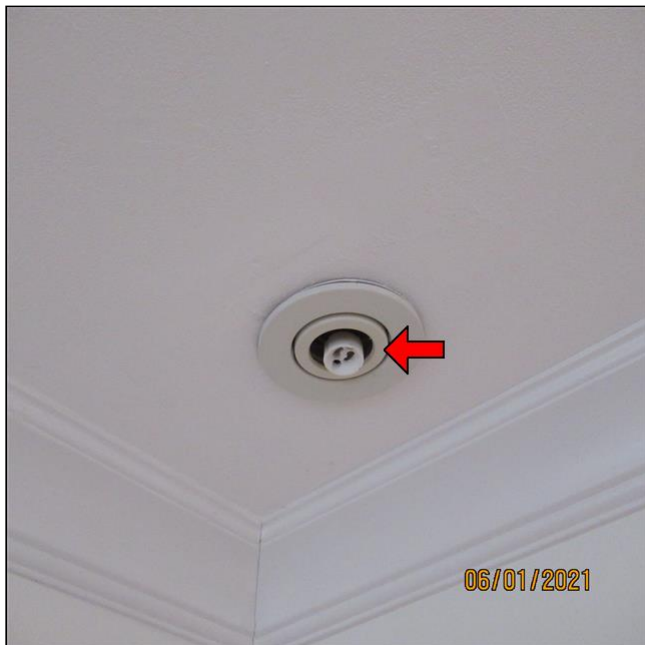
11.8 Item 1(Picture)

(1) Light fixture in the family room was inoperative at time of inspection. Missing bulb observed. We suggest the client verify fixture for proper operation prior to closing.

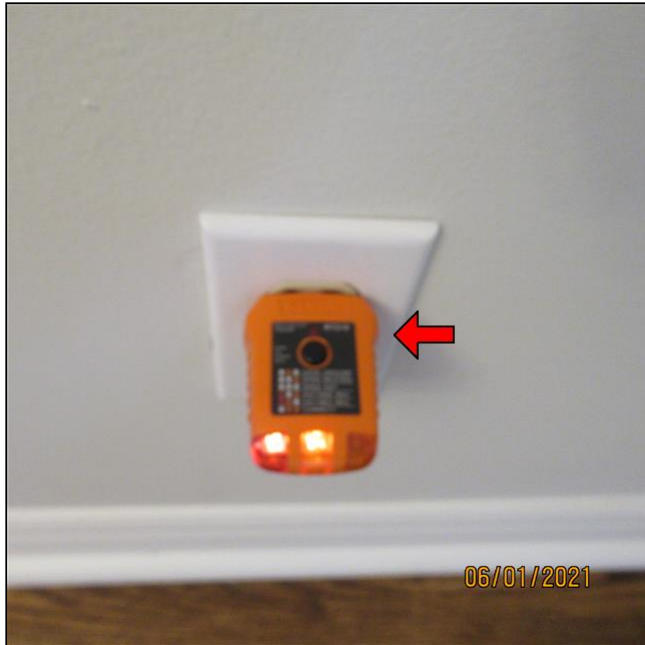
11.8 Item 2(Picture)

(2) Reversed polarity wiring conditions was observed at the receptacle in the dining room. A reversed polarity condition occurs when the hot and neutral wires are connected to the opposite terminal connections of the outlet (i.e. hot wire connected to neutral terminal and neutral wire connected to hot terminal). This can be a safety hazard. This condition is usually easily corrected by minor wiring adjustments at the specific outlet(s).

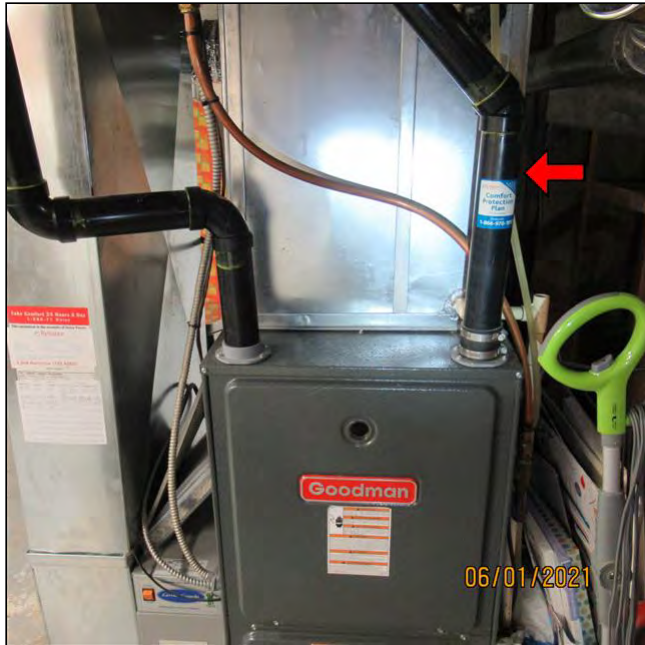
12.2 Item 1(Picture)

ABS vent material is no longer permitted on new installations since it was prone to cracking. The client may wish to upgrade to System 636 PVC or other approved material. It is recommended that the pipes be inspected by a qualified HVAC contractor.

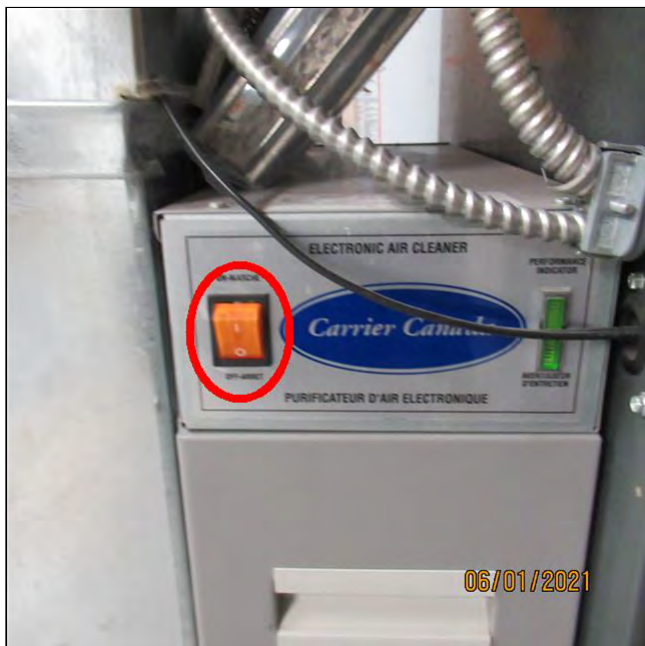
An electronic air filter was observed at this unit. This type of filter systems is not within the scope of this inspection. The unit was turned off and the filter elements were stored behind the furnace. A improperly fitted disposable filter was placed in the filter cabinet. The client is advised to consult seller's to ensure proper operation.

12.5 Item 1(Picture) Turned off

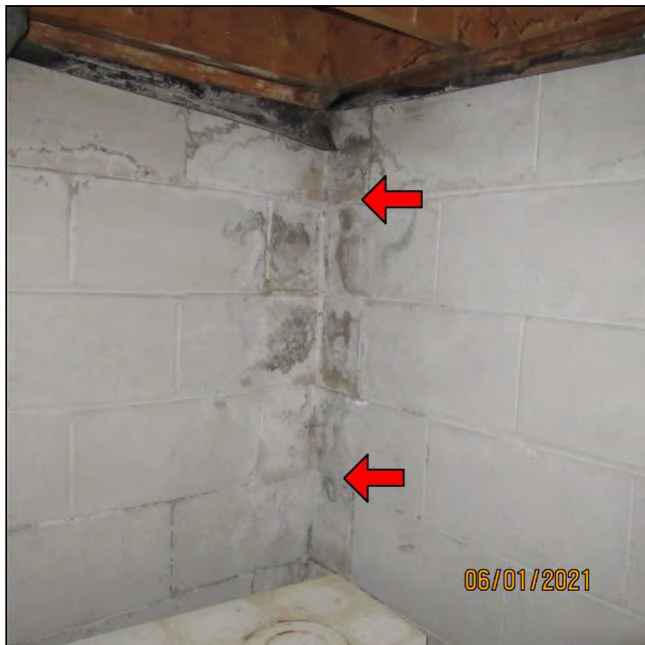
13.2 Item 1(Picture) Crawlspace

(1) Water staining and efflorescence observed at crawlspace (corners); this is a mineral deposit left behind from exterior water infiltration. We recommend consulting sellers as to moisture problems in these areas, and correct the exterior grading around the foundation in these areas to ensure effective drainage away from the foundation.

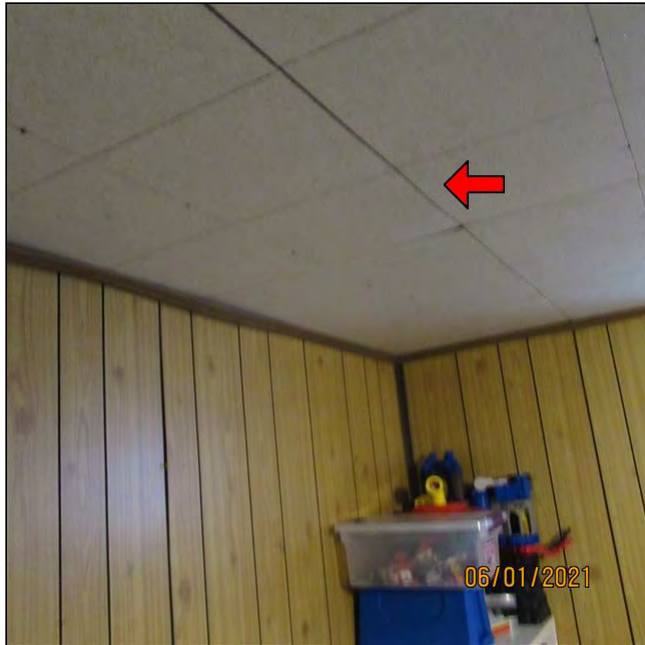
13.3 Item 1(Picture)

Drop tiles noted. Some older ceiling tiles can contain asbestos. This is not an issue if the tile is in good condition and not disturbed. If concerned about this or if you are planning renovations that might involve removal of the tiles, you should contact a laboratory to test for the presence of asbestos.

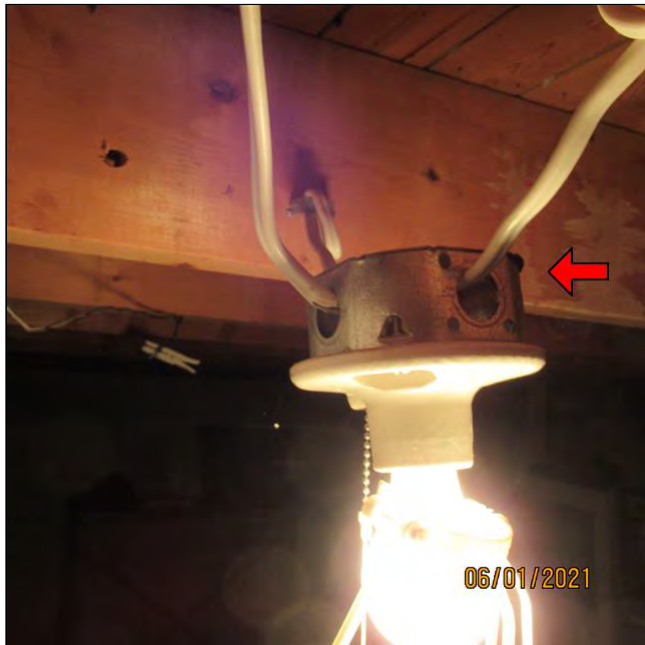
13.13 Item 1(Picture)

Light fixture in the crawlspace is not properly secured. This arrangement places strain on the electrical cables and connections. We recommend review and correction by a qualified contractor.

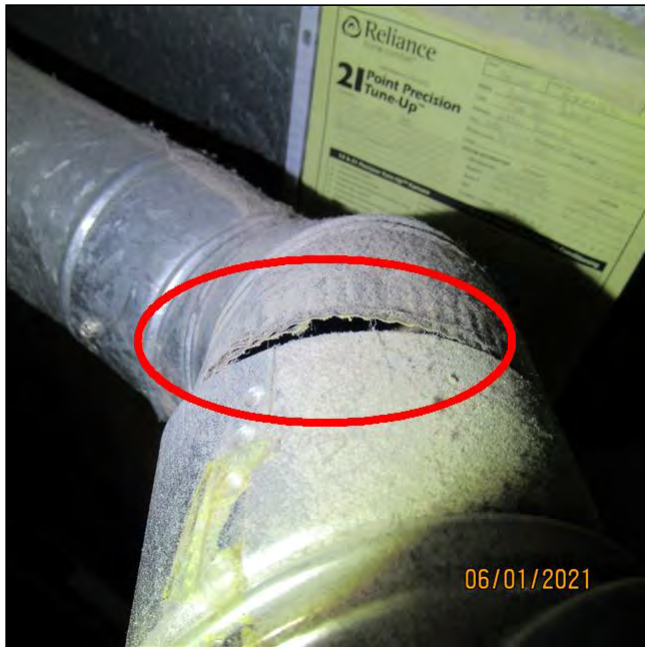
16.2 Item 1(Picture)

Vent pipe is disconnected or poorly fitted, which is a safety concern. We recommend review for repair or replacement, as necessary, prior to close.

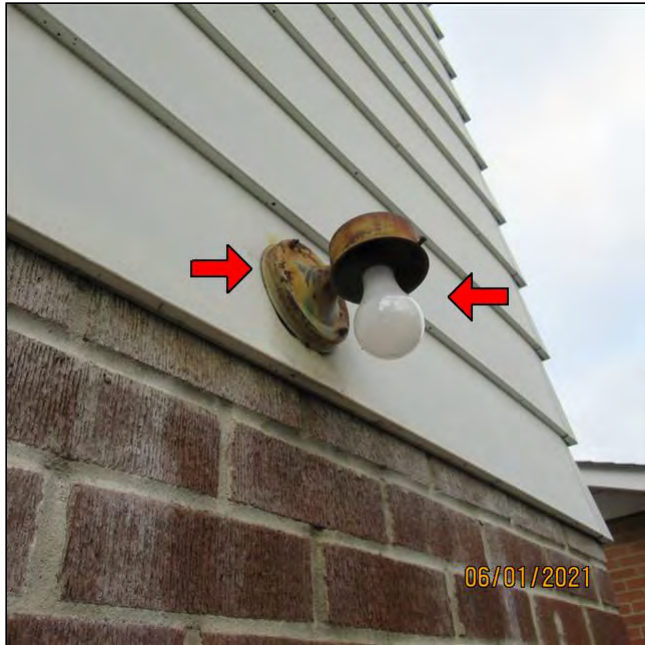
1.8 Item 2(Picture)

(2) The light fixture at the rear entry door is not properly sealed and is missing its globe. Correct as necessary.

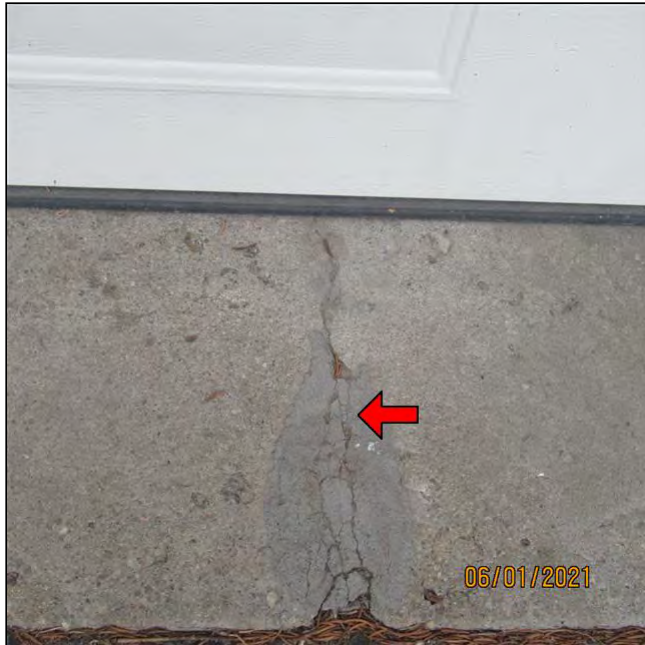
3.0 Item 1(Picture)

Common cracks observed. Generally, concrete floor slabs are not structural. Concrete floors naturally crack during the curing process due to shrinkage. Since the concrete slab does not usually carry the load of the structure, shrinkage cracks are generally considered cosmetic. However we do recommend sealing all cracks in concrete/ asphalt/brick surfaces to prevent water penetration as a routine maintenance effort.

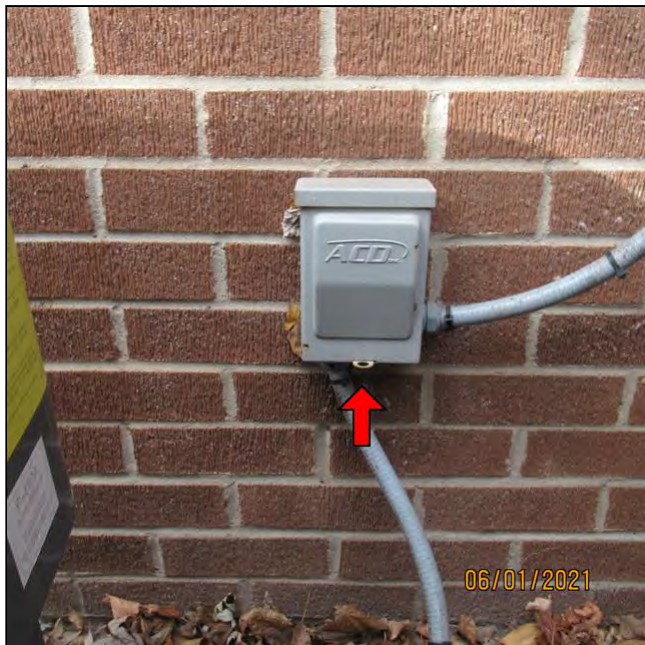
5.1 Item 1(Picture)

Electrical disconnect observed. It is recommended that the disconnect be kept locked at all times to prevent access by children.

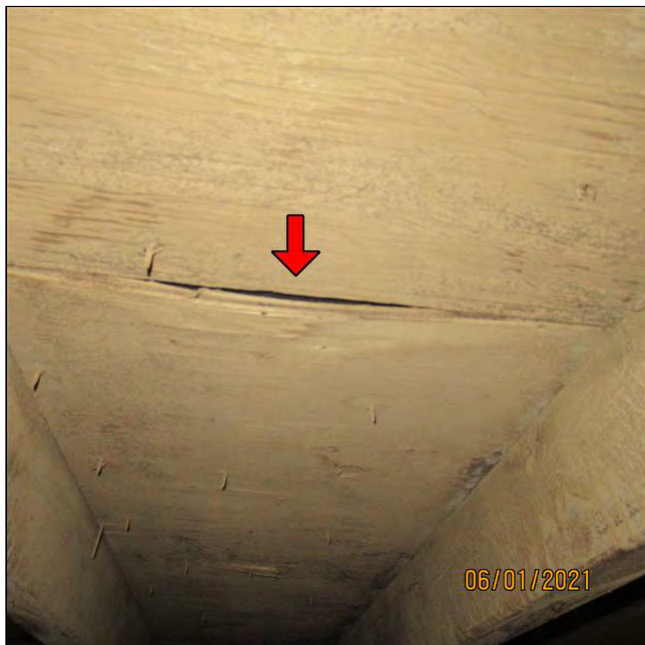
6.1.A Item 1(Picture)

(1) Cracked, warped plywood decking observed. Recommend review by qualified professional for repair or replacement as necessary.

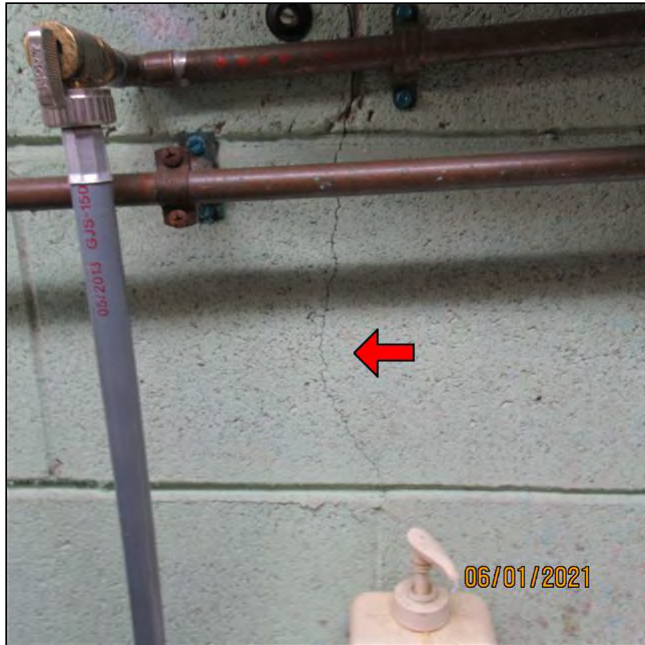
(2) The home's foundation appears to have experienced a common degree of cracks. In our opinion the cracks do not currently affect the serviceability of the structure, however even minor cracks can sometimes permit water entry into the home. In that regard, the client should ensure that positive drainage exists around the perimeter of the home and that no downspouts discharge water near the foundation walls. In addition, the client may wish to seal or repair these cracks to reduce the potential for water infiltration into the home.

13.2 Item 6(Picture) Laundry wall

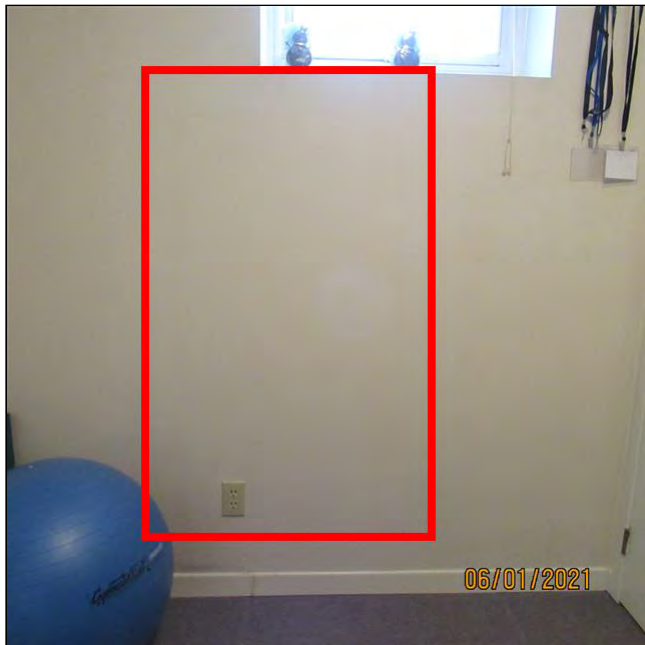
13.2 Item 7(Picture)

(3) Air entering the basement wall assembly from gaps at the rim plate, around windows and penetration through the wall, exit into the basement through electrical outlets, at breaks in the wall covering and along the trim. Reducing air infiltration requires sealing gaps and cracks in the building envelope.

The vertical green areas are the result of thermal bridging through the wall studs (heat travels from the warm interior to cold exterior resulting in the cooling of the wall covering in contact with the studs). Thermal bridging is reduced by installing insulation between the studs and the exterior walls.

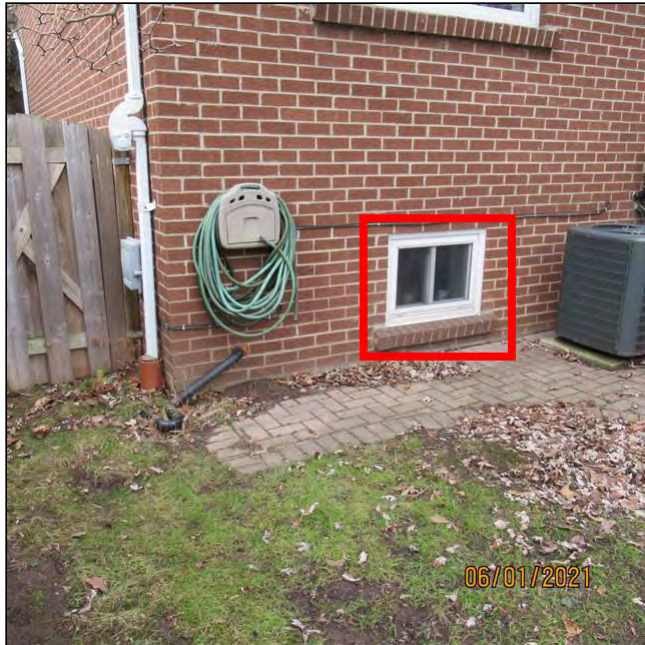
13.11 Item 1(Picture)

Heat loss observed around window frames. Improved sealing between the window frame and the rough opening will reduce some of the loss. Other loss is related to the window design and wear.

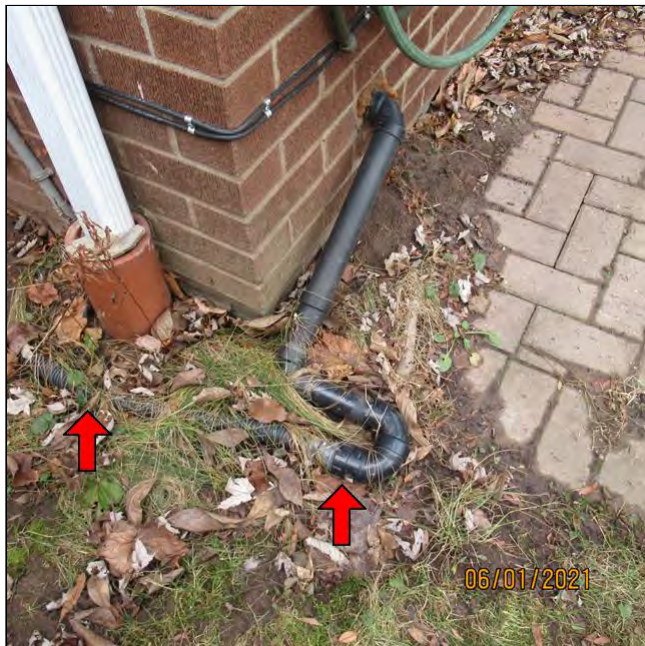
14.4 Item 1(Picture)

(1) Sump pump drains to the rear right side exterior. The drain pipe is located at the ground surface and is subject to mechanical damage. We recommend review by a qualified contractor for correction to protect the drain and ensure it drains appropriately away from the foundation.

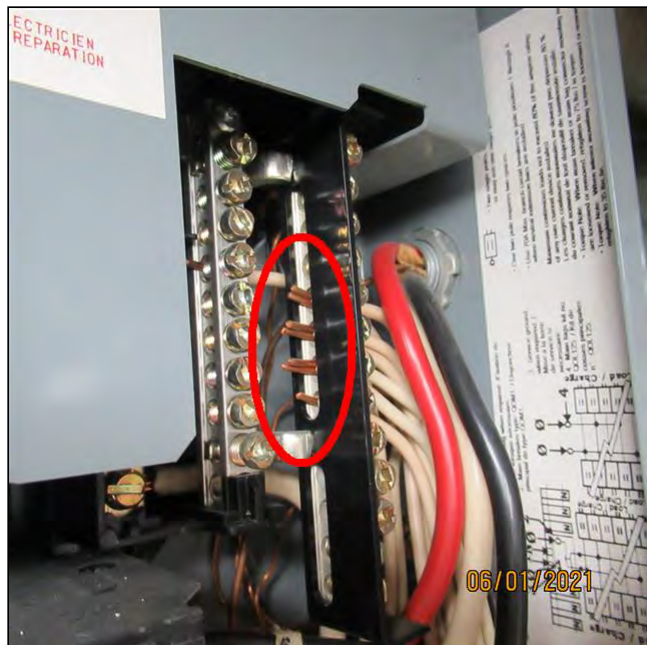
15.5 Item 1(Picture)

Double tapping observed in main electrical panel at the neutral bar. Double tapped neutrals at the breaker panel (i.e. 2 wires on a single pole breaker) prevent circuits from being properly isolated when working on them and are prone to working loose over time resulting in overheating and an increased fire hazard. We recommend review by a qualified electrician for repair or replacement as necessary.

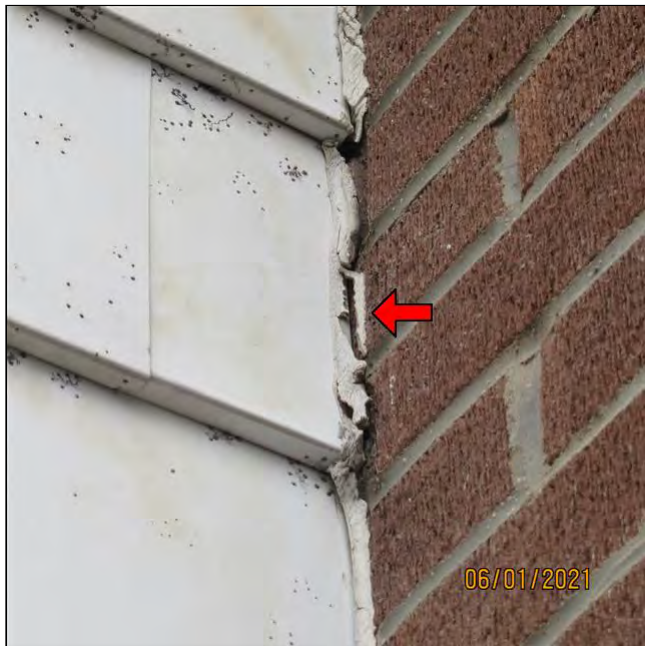
(2) Siding on this home is covered with metal. The inspector is unable to view the condition of covered areas. It is important to keep siding well caulked and sealed to prevent moisture penetration.

1.2 Item 1(Picture) Siding joint with chimney

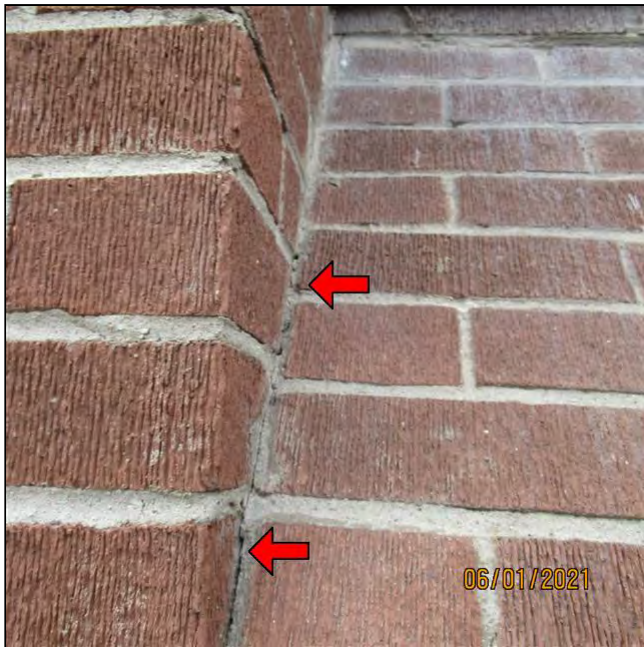
(6) Damaged/deteriorated mortar joints observed (left side of sliding door, front left side of garage, lower chimney, left side window). We suggest tuck pointing mortar repair as necessary to prevent further damage.

1.2 Item 6(Picture) Lower chimney

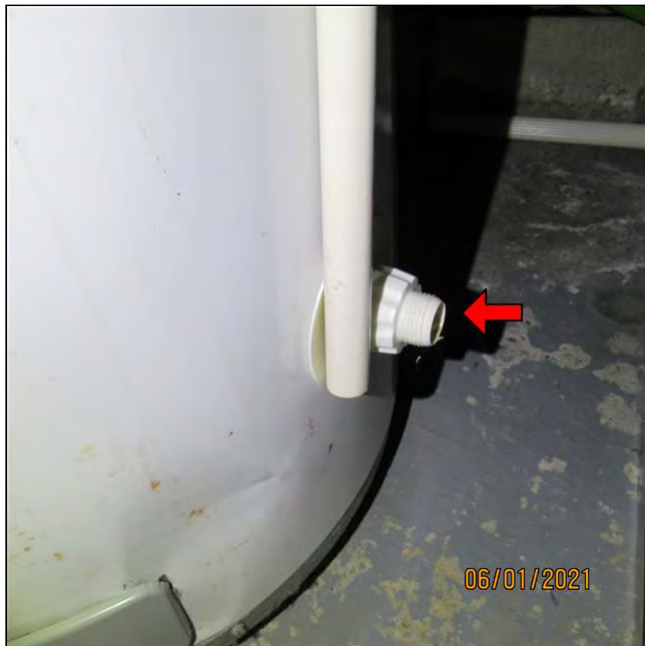
Since a temperature pressure relief (TPR) valve is operated infrequently, it is not unusual for them to leak or break when operated after a period of inactivity. For this reason, the TPR valve is not tested during a home inspection. We suggest caution when operating TPR valves that have not been tested for a long period of time. When installed new the TPR valve should be tested regularly to ensure free movement in case of emergency. The client should consult with a licenced plumber for testing and operation of the TPR valve on older water heaters.

16.5 Item 1(Picture) Drain plug

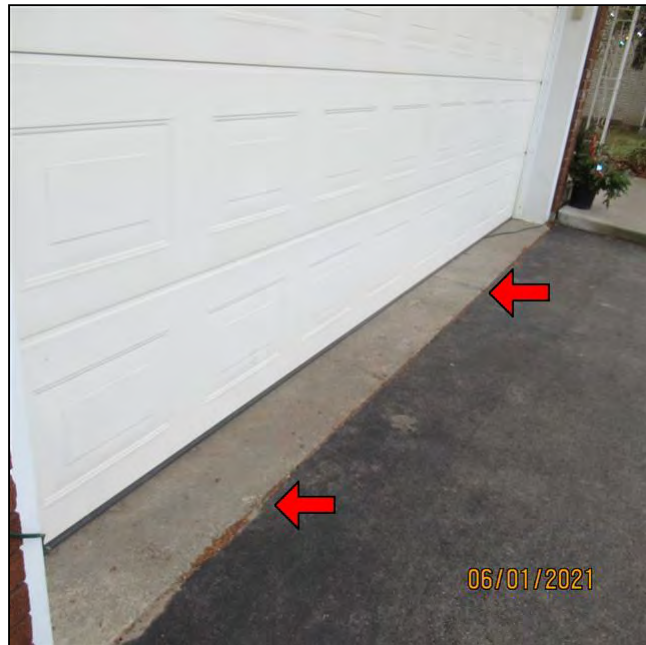
1.0 Item 3(Picture)

(2) We recommend that the client seals/caulks the opening between the foundation and the driveway with an elastic sealant and seal the driveway in accordance to manufacturer's directions for further protection.

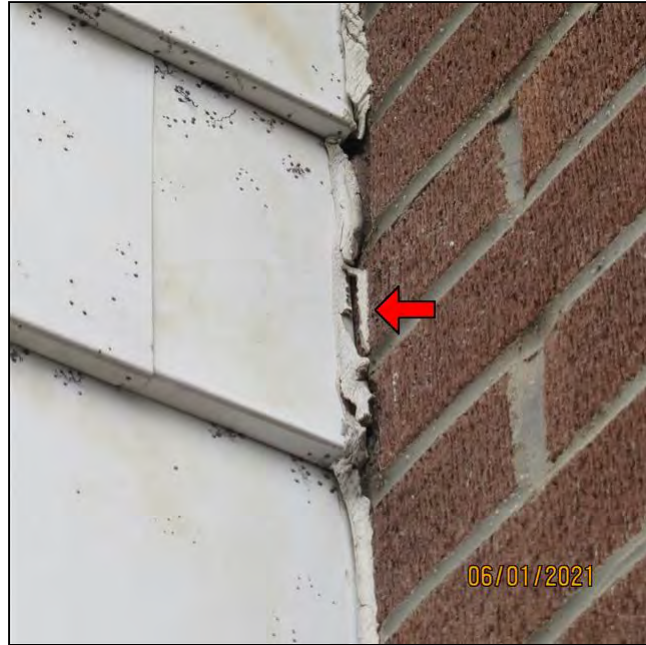
(2) Siding on this home is covered with metal. The inspector is unable to view the condition of covered areas. It is important to keep siding well caulked and sealed to prevent moisture penetration.

1.2 Item 1(Picture) Siding joint with chimney

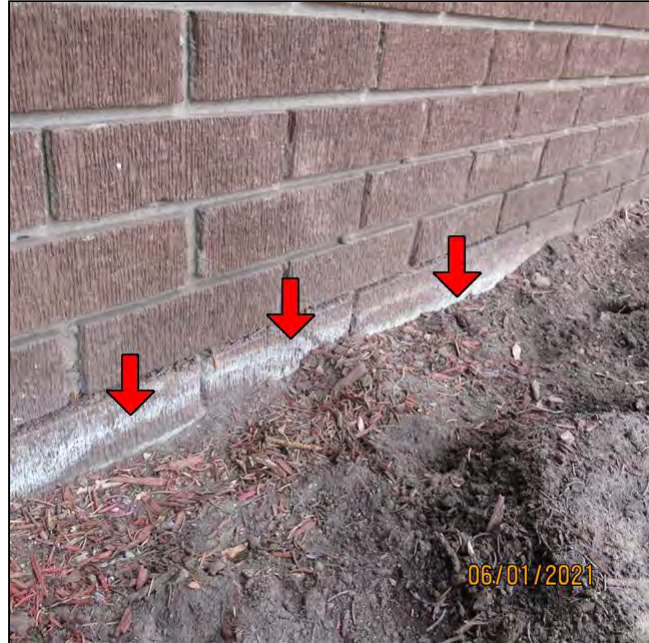
1.2 Item 4(Picture)

(4) Efflorescence observed at front brick above the garden; this is a mineral deposit left behind from exterior water movement through the brick. We recommend lowering the garden to maintain a 6 inch gap between the ground and the brick.

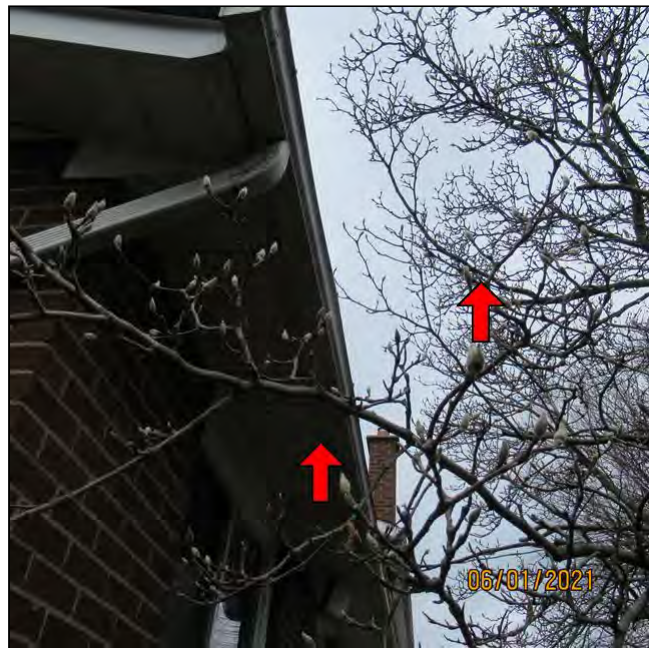
1.2 Item 5(Picture)

(5) We suggest trimming vegetation away from structure to enhance air flow, reduce moisture build-up and help prevent accelerated deterioration.

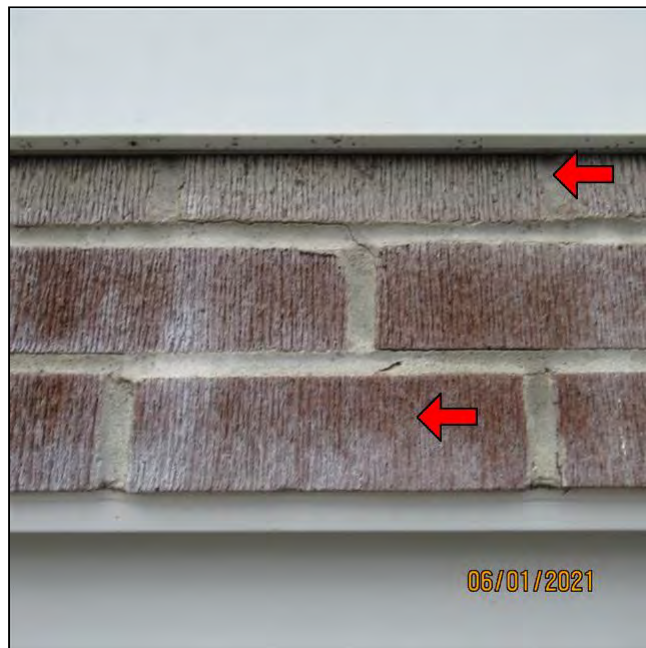
1.2 Item 11(Picture)

(7) Staining observed on the bricks below the metal siding. It appears the paint is leaching pigment that is attaching to the brick as it runs down the wall. This appears to be a cosmetic concern only.

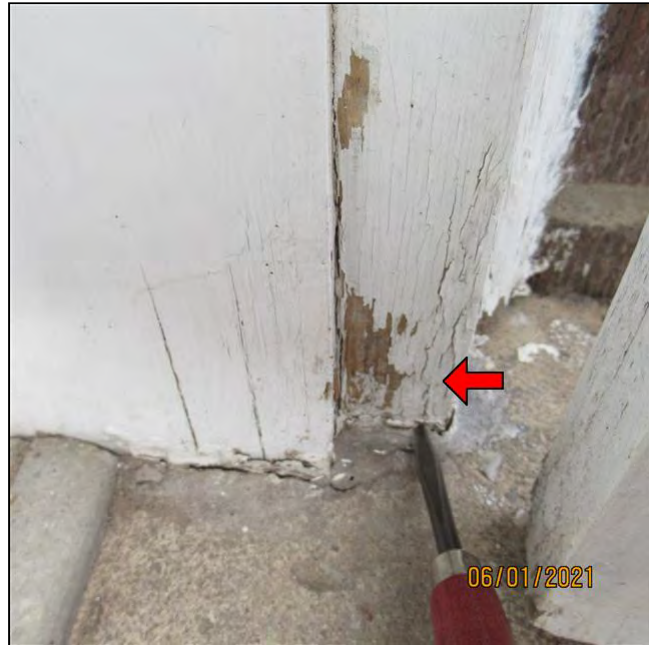
1.3 Item 1(Picture)

(1) Wood trim will require ongoing maintenance such as painting or staining to prolong its life. The client is advised to consider cladding wood surfaces in aluminum to reduce the level of exterior maintenance of the home.

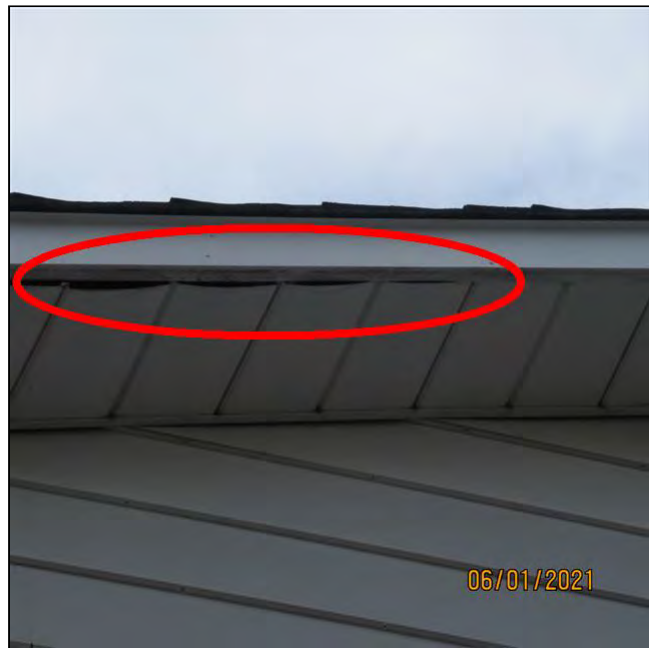
1.3 Item 2(Picture)

(2) Loose trim observed at left side gable soffit. We suggest securing as necessary.

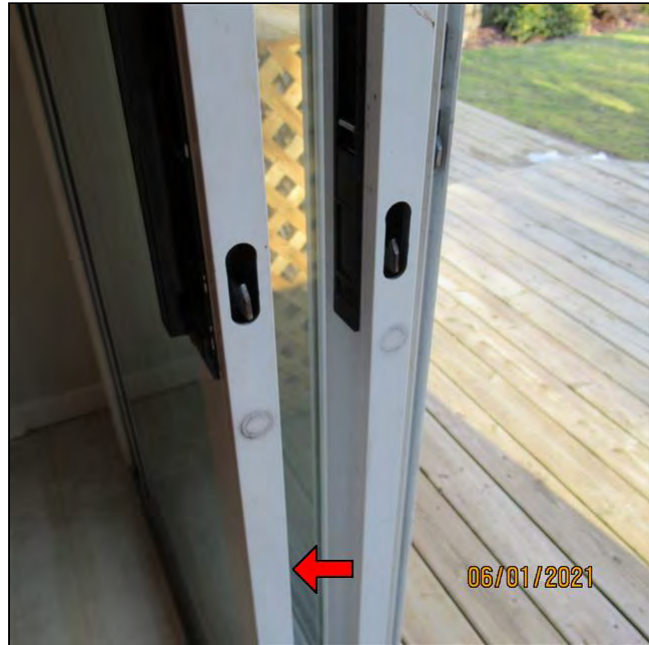
1.5 Item 7(Picture)

(4) Rear sliding glass doors do not slide easily. We recommend review and correction to restore proper operation.

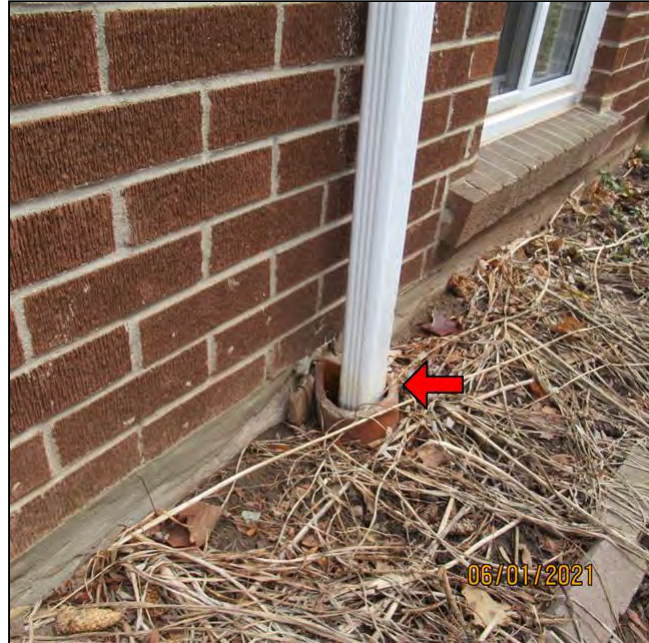
1.6 Item 1(Picture)

(2) Downspouts exit into an underground drainage system. Underground drainage systems are not within the scope of this inspection and a functional water flow test is not performed. In order to verify that this system is working properly, we recommend that downspout locations be monitored during several rainfall/snowmelt events on a regular basis. If water appears to be surcharging (backing up) we recommend contacting a qualified contractor to clear any obstructions that may be blocking the downspouts and/or subsurface components or retrofitting the downspouts so that they discharge directly to the surface soils away from the foundation. In some cases, the subsurface drainage system will be directed to a "dry well" on the property. This system may be unreliable and may result in excess water around the foundation in turn leading to basement leaks. We recommend consulting with the current owner or builder in this regard. As a general statement, we generally prefer to have the downspouts discharge to the lawn or other permeable area, if local by-laws permit.

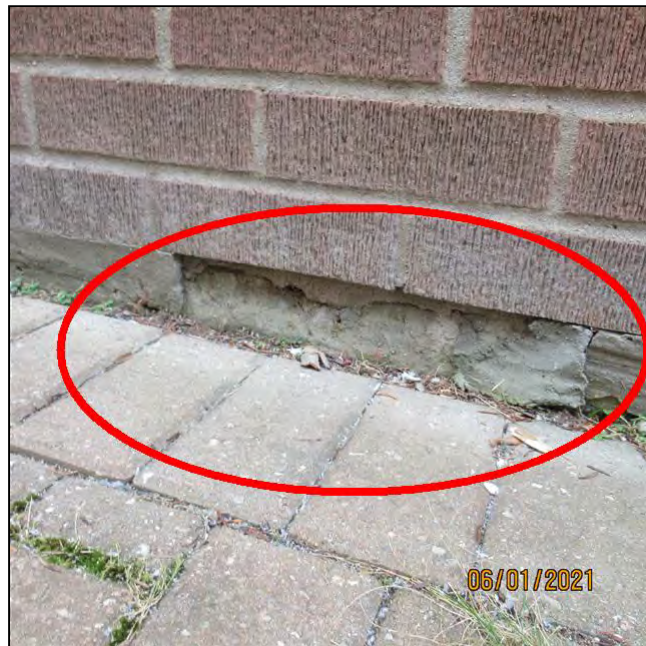
1.15 Item 1(Picture)

(2) Parged exterior noted. Parging is generally a cosmetic feature and may, over time, crack or fall off the foundation walls. At that time, the homeowner may decide to repair or replace the parging, remove it, or leave it in its condition at the time.

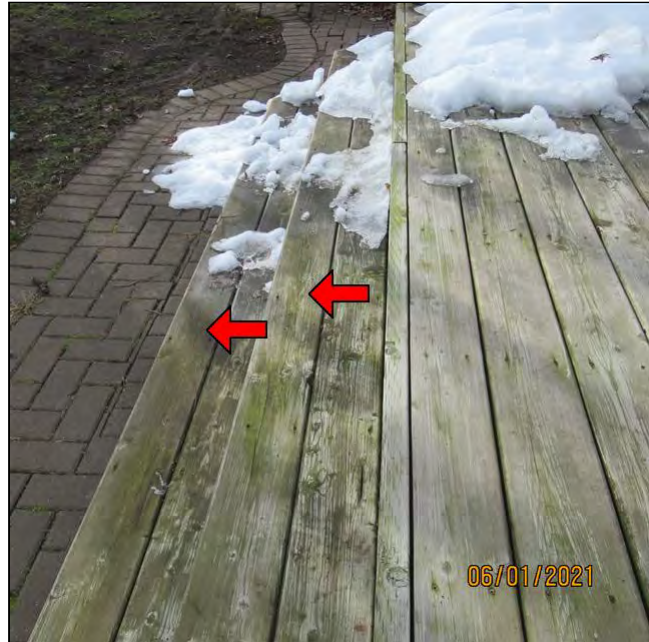
1.18 Item 1(Picture)

(1) Weathered conditions observed (algae observed). Suggest scraping and painting/staining/sealing as necessary as part of normal maintenance.

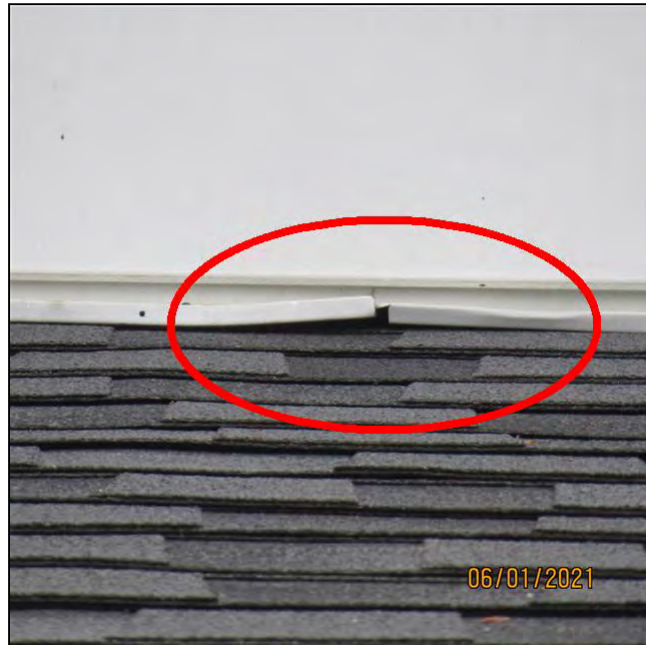
2.1 Item 1(Picture)

Flashings are damaged/deteriorated at front second level wall to roof joint. We suggest review by a licensed roofer for repairs/replacement as needed.

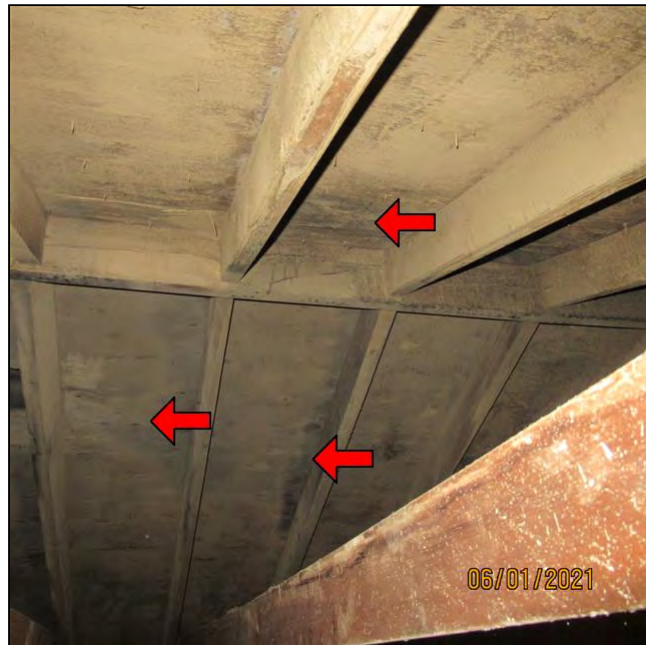
6.1.A Item 3(Picture)

(2) Black discolouration was noted on the under side of the sheathing material (under side of the roof) at the attic sheathing. This is evidence that warm moist air from the conditioned (heated) portion of the home could be leaking into the attic and unable to escape quick enough through roof vents to prevent damage to the attic materials. Black discolouration may be mould and mildew or simply aging of the sheathing material. At the time of the inspection we were unable to determine the existence, nature or extent of mould and mildew, if any. Based on the conditions observed, we recommend consulting with a qualified home air leakage control contractor to determine air leakage control measures to reduce the potential for warm moist air to enter the attic, and increase ventilation in the attic space.

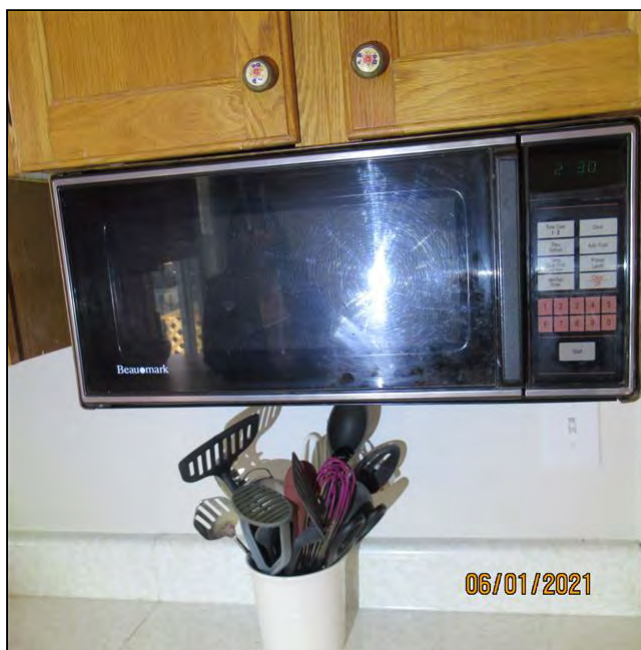
7.17 Item 1(Picture)

Inoperable at the time of inspection. Recommend review by a qualified appliance technician for repair or replacement as necessary.

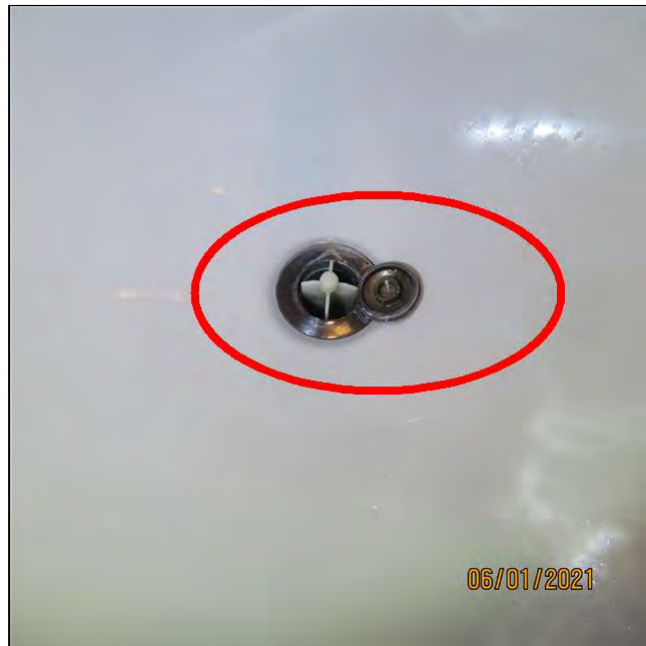
8.14.A Item 1(Picture)

Stopper is damaged; corrections are needed for proper operation.

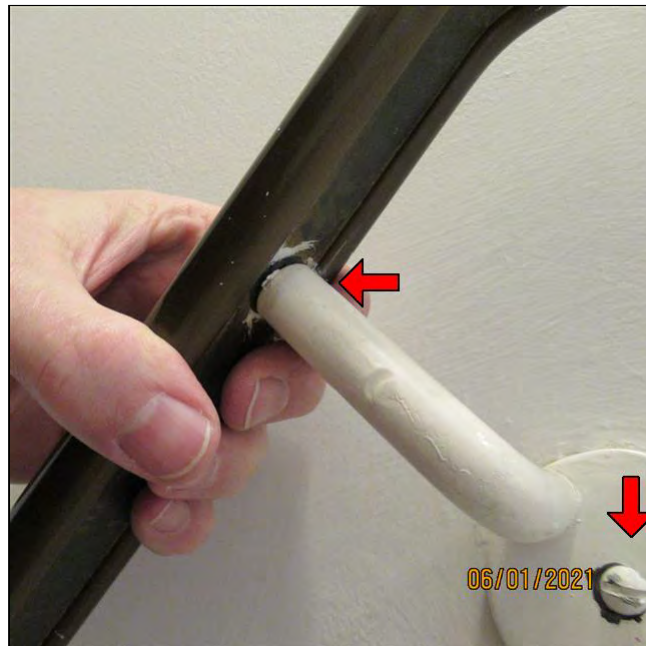
10.8 Item 1(Picture)

Handrail is loose at the top of the stairs to the upper level. We recommend review for repair as necessary for safety.

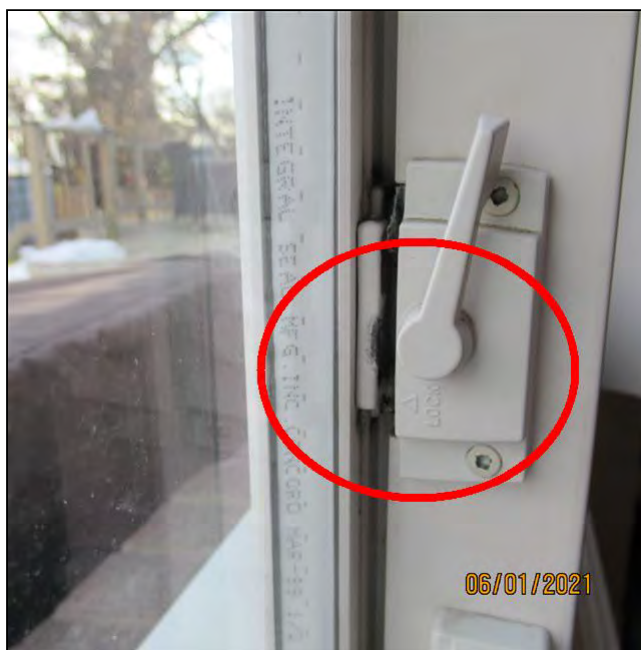
11.4 Item 1(Picture)

(1) The sliding window latching hardware is inoperable in the family room. We recommend corrections as needed for proper operation.

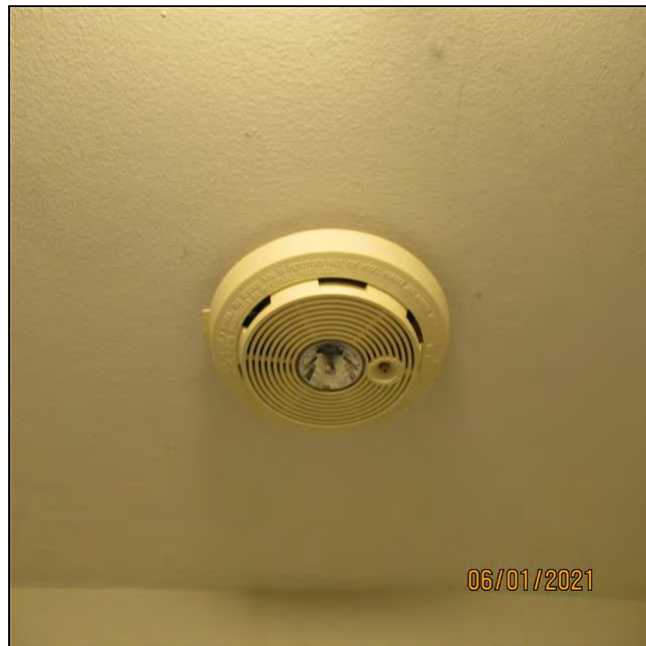
11.5 Item 1(Picture)

In the inspectors opinion the smoke detector(s) are near the end of their useful life due to age. Smoke detectors are required on all levels of the home and carbon monoxide detectors are required in the proximity of all bedroom areas. We recommend replacement for safety and for regulatory compliance.

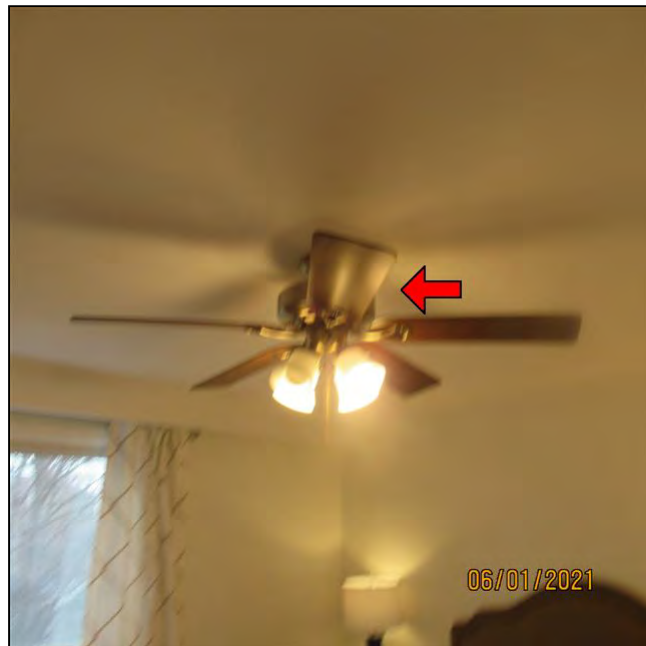
11.9 Item 1(Picture)

Ceiling fan(s) noted at master bedroom. We recommend that the Client ensures that a safety strap is properly installed for each fan.
