SUMMARY REPORT

AmeriSpec Inspection Services of Hamilton, Brantford and Stratford
32 Livingstone Cres
Cambridge ON N3H 5S7
226-341-9569

URGENT REVIEW SUMMARY

Doc #: 010621SH2

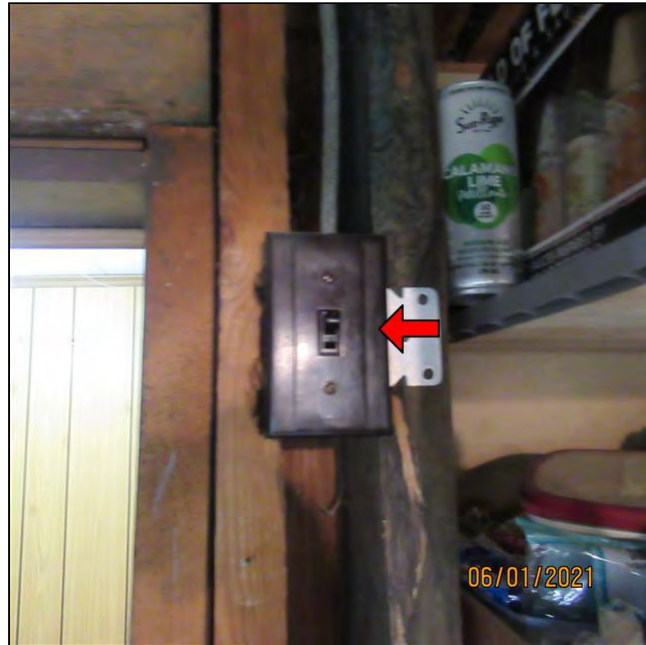
12.1 Item 5(Picture)

(4) Electrical disconnect noted at wall next to utility room entry door.

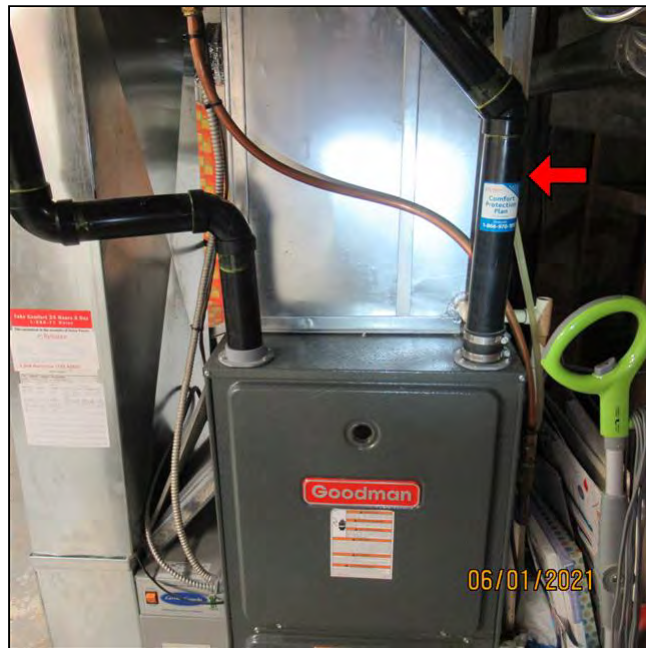
12.2 Item 1(Picture)

ABS vent material is no longer permitted on new installations since it was prone to cracking. The client may wish to upgrade to System 636 PVC or other approved material. It is recommended that the pipes be inspected by a qualified HVAC contractor.

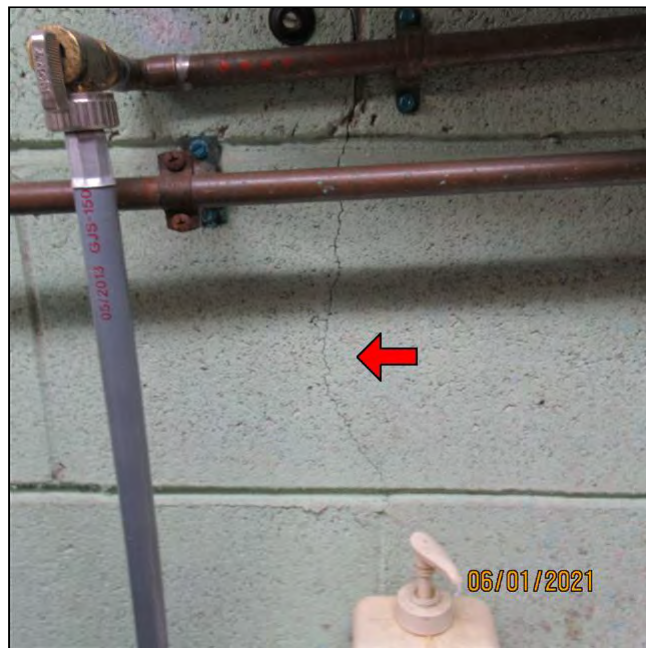
(2) The home's foundation appears to have experienced a common degree of cracks. In our opinion the cracks do not currently affect the serviceability of the structure, however even minor cracks can sometimes permit water entry into the home. In that regard, the client should ensure that positive drainage exists around the perimeter of the home and that no downspouts discharge water near the foundation walls. In addition, the client may wish to seal or repair these cracks to reduce the potential for water infiltration into the home.

13.2 Item 6(Picture) Laundry wall
