SUMMARY REPORT

AmeriSpec Inspection Service
Tecumseh, Ontario
Ph#: (519) 739-1010 Fax#: (519) 739-1016

Doc #: 05162 [REDACTED]
Dwelling Address: [REDACTED]
Windsor, Ontario

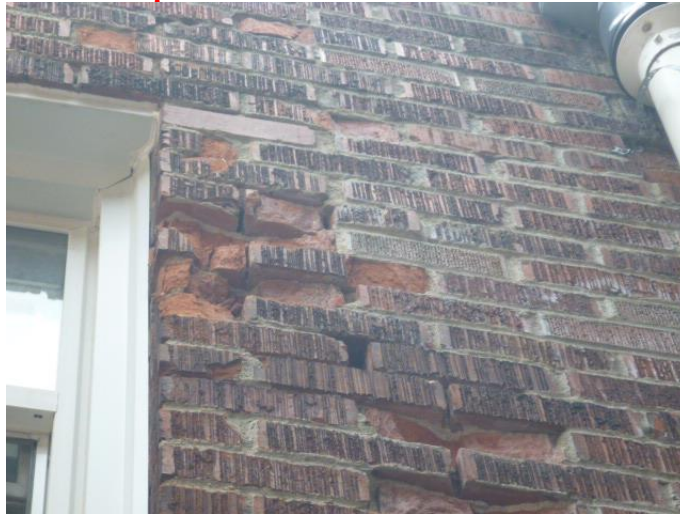
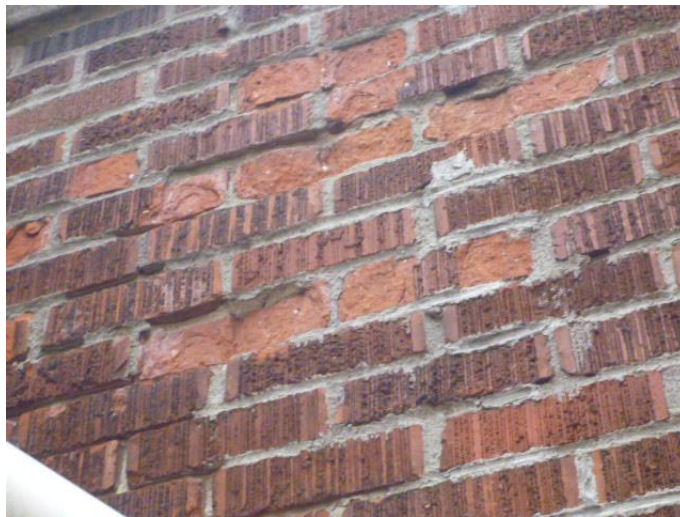
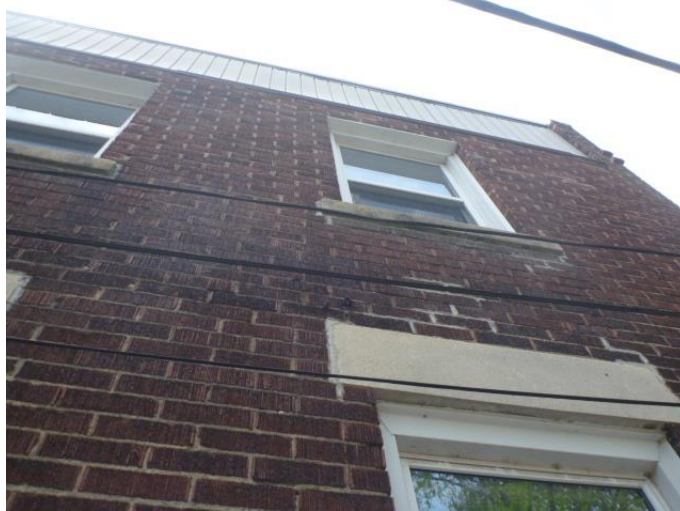
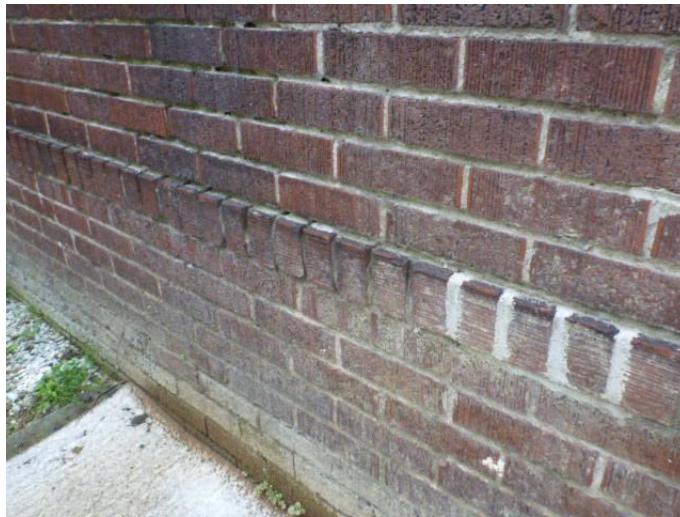
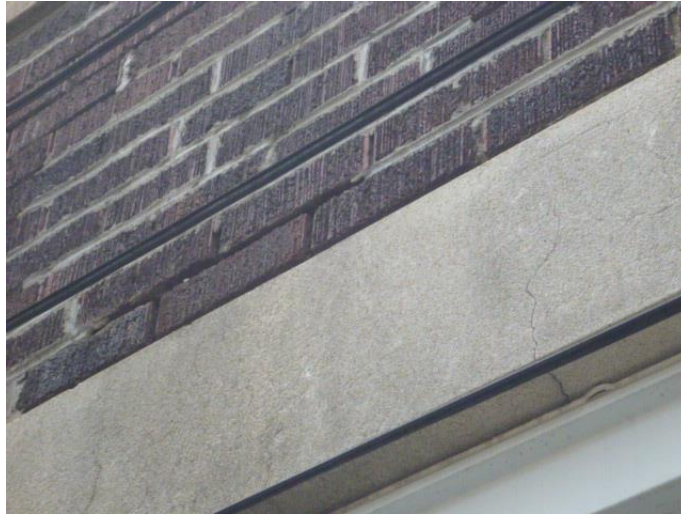
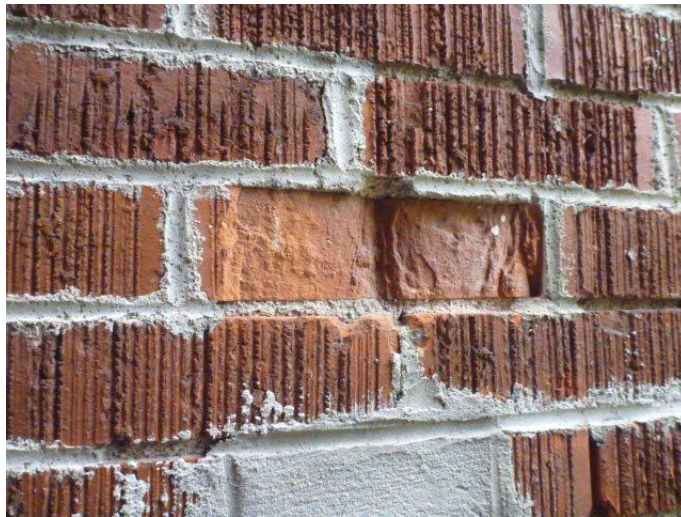
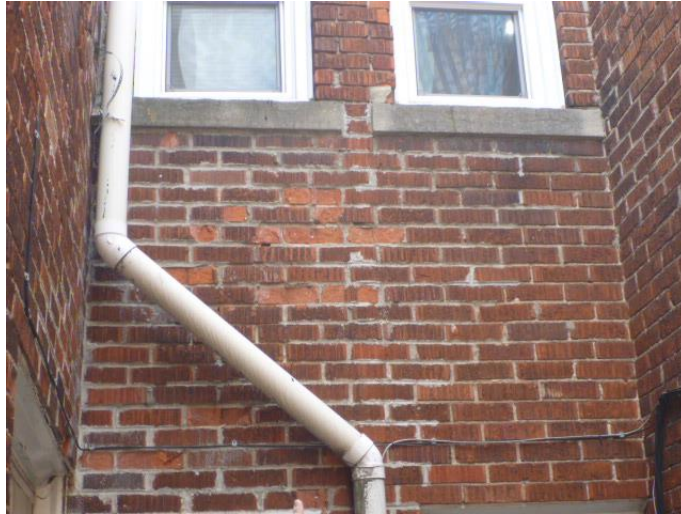
1103. Exterior
Wall
Cladding

Review. Cracked/deteriorated brick and/or missing mortar joints observed at multiple locations area of the building. We recommend professionally repairing the affected area to reduce the potential for water infiltration into the home and further displacement.

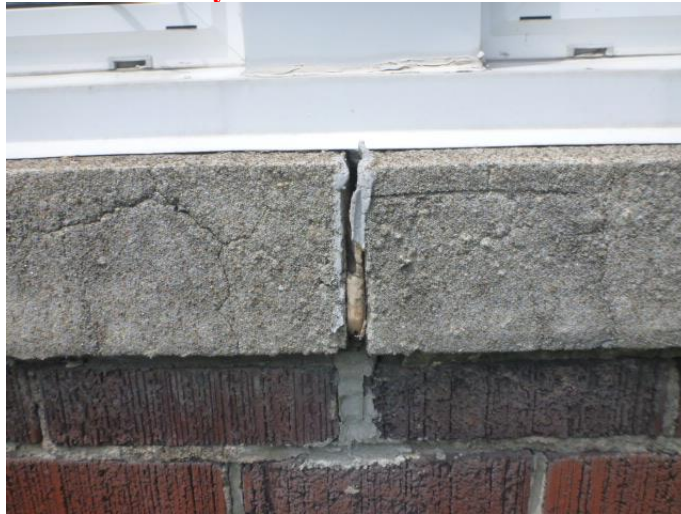
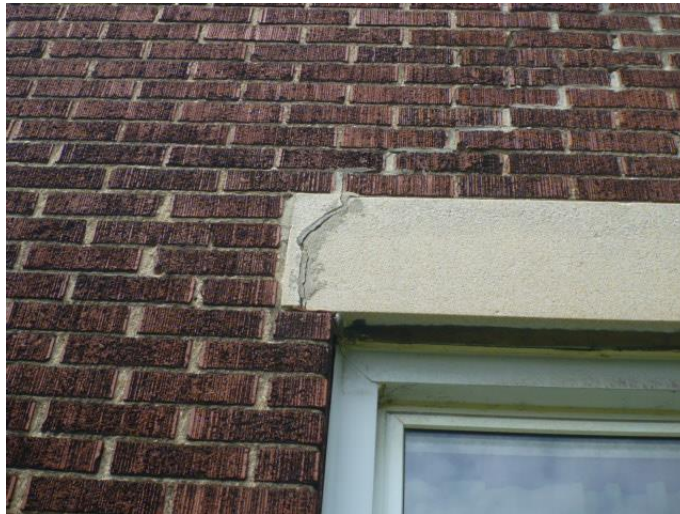
Suggest sealing gaps at all windows, doors, and any voids where necessary.

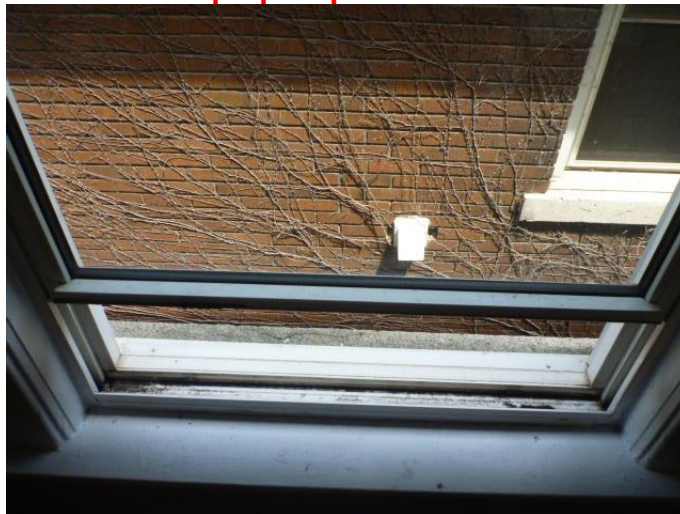
1105. Window & Frames

Review. Hardware is damaged at some windows; corrections are needed for proper operation.

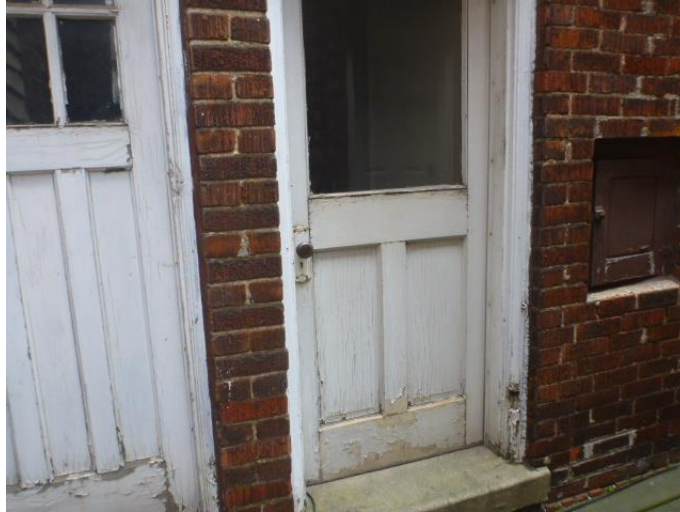
1106. Exterior
Door(s)

Review. In the inspectors opinion some of the exterior doors are near the end of their useful life due to age. Recommend review for repair or replacement as necessary.

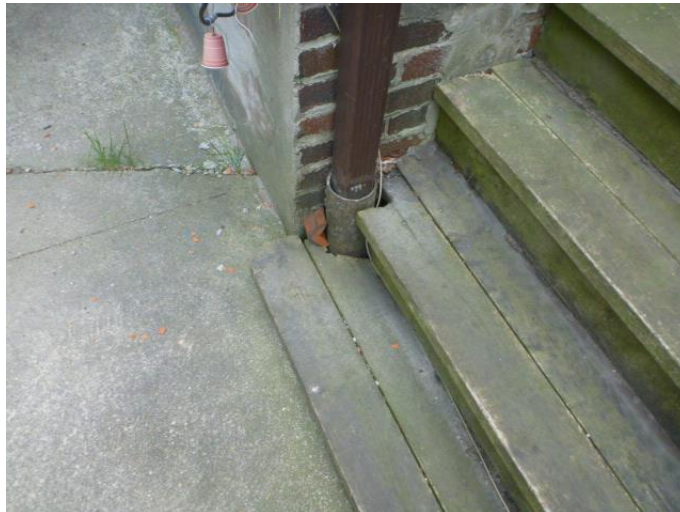
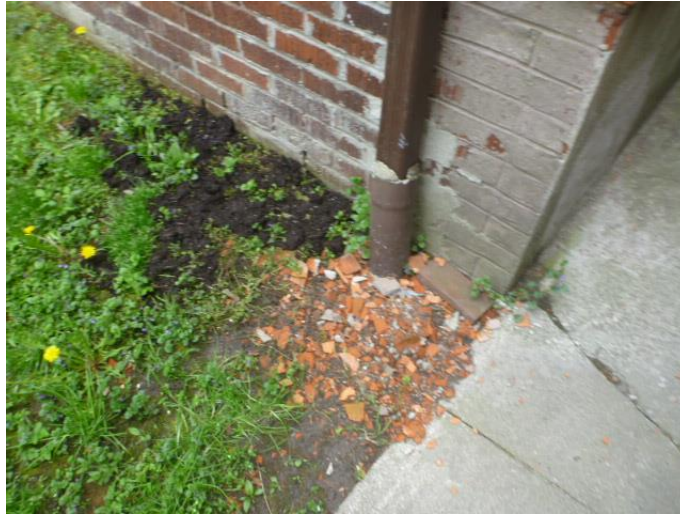
1107. Gutters /
Downspouts

Review. Suggest disconnecting and extending downspouts and improving grade at exterior to prevent moisture intrusion into the basement.

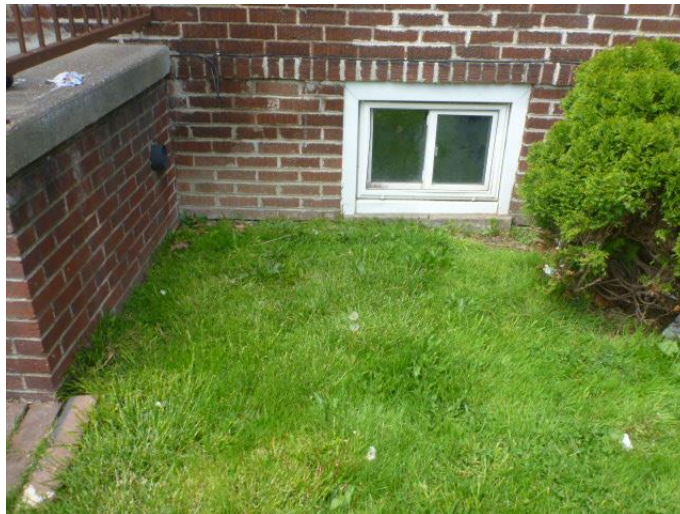
1115. Lot / Grade
Drainage

Review. We suggest re-grading and maintaining a positive grade away from the foundation walls around the entire house wherever possible to further channel water away from the foundation walls and to reduce further moisture infiltration into the home.

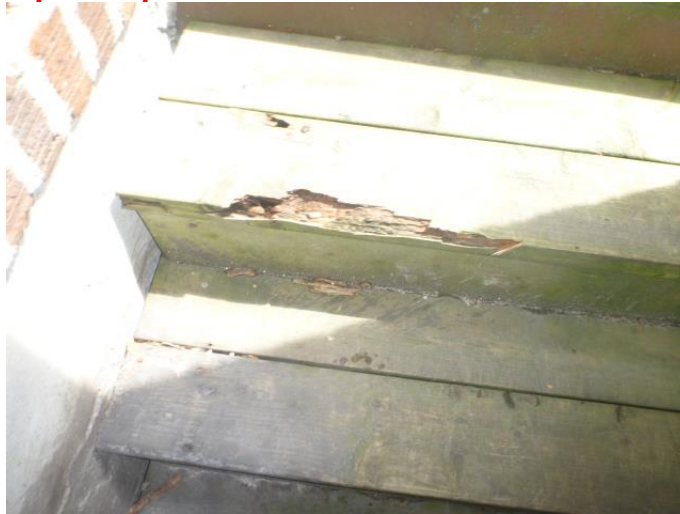
1119. Deck

Review. Wood deterioration observed. Suggest repairs/replacement as needed.

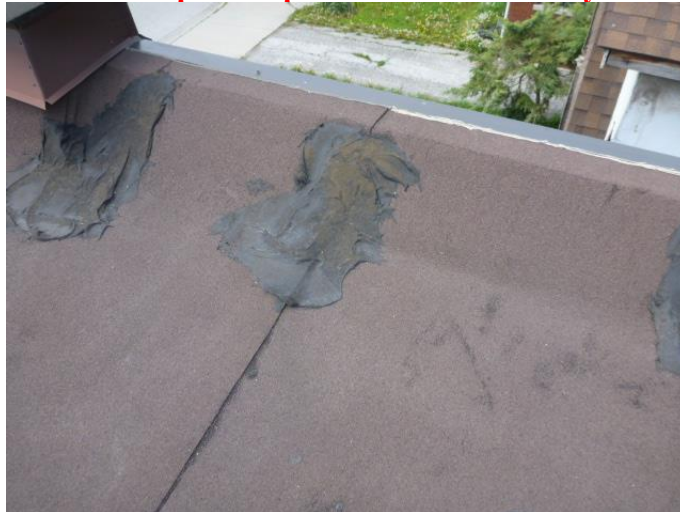
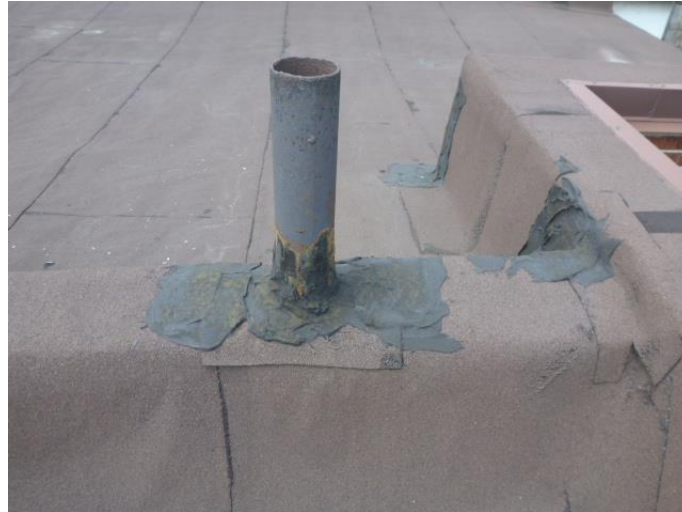
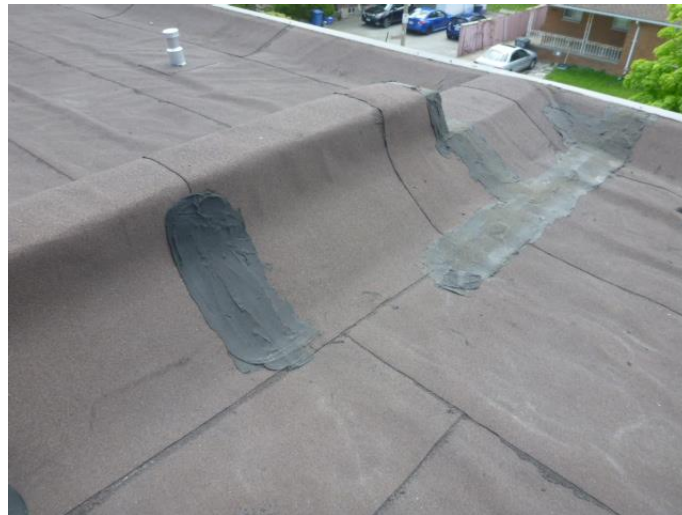
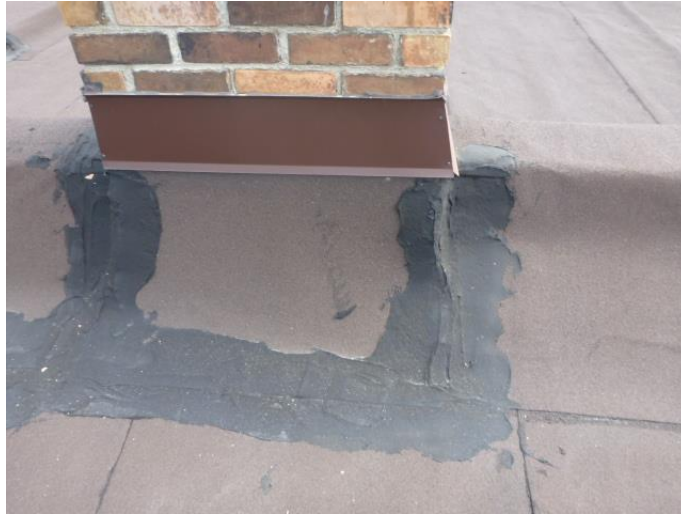
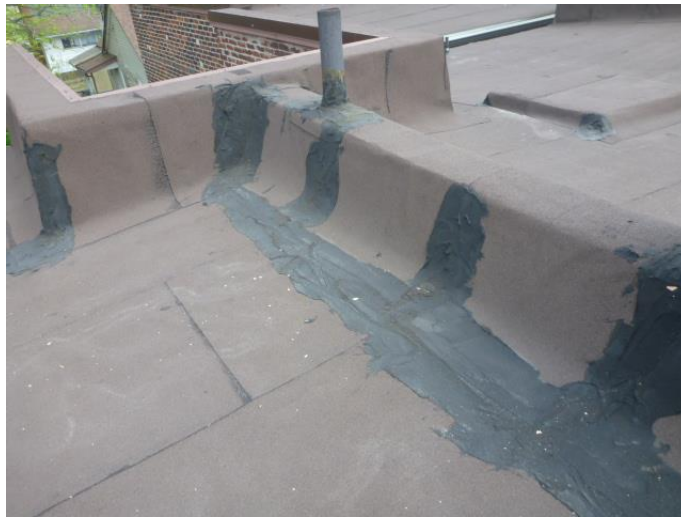
1203. Exposed Flashings

Review. Patching observed. Inspector is unable to determine the effectiveness of these repairs. Suggest review by qualified roofer for repairs/replacement as necessary.

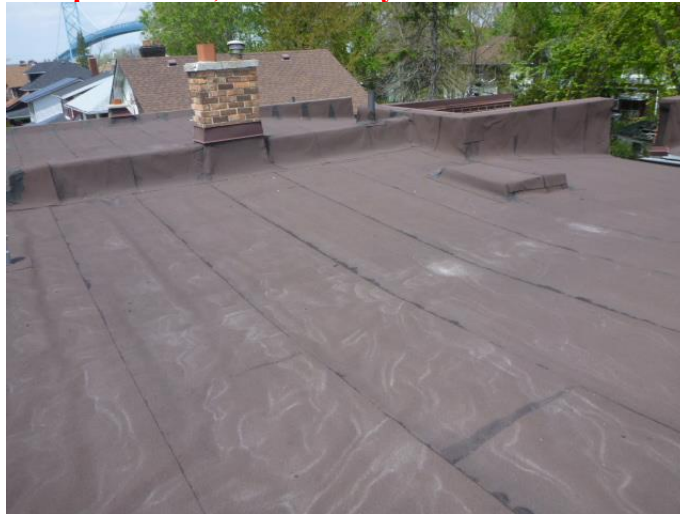
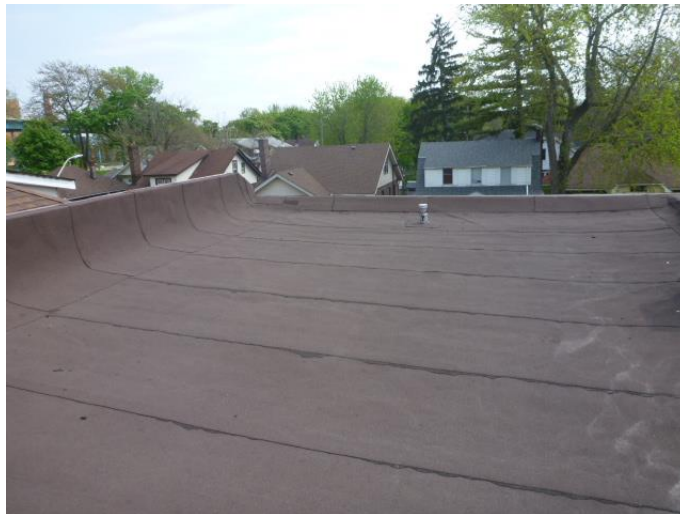
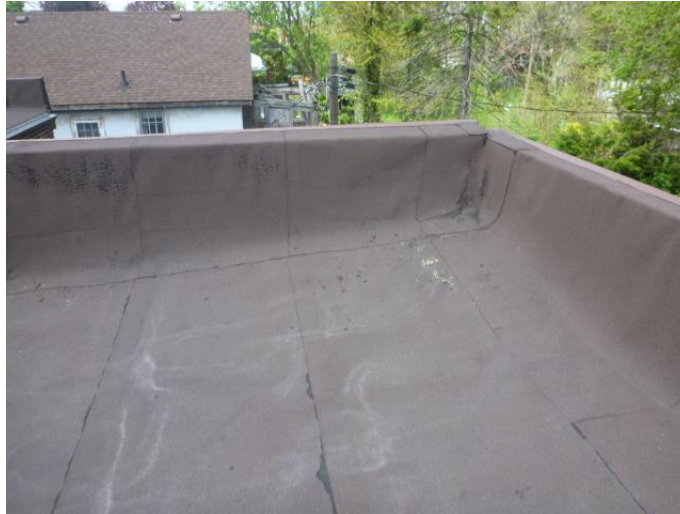
1205. Conditions **Review. Recommend review by a qualified roofer for repair or replacement, as necessary.**

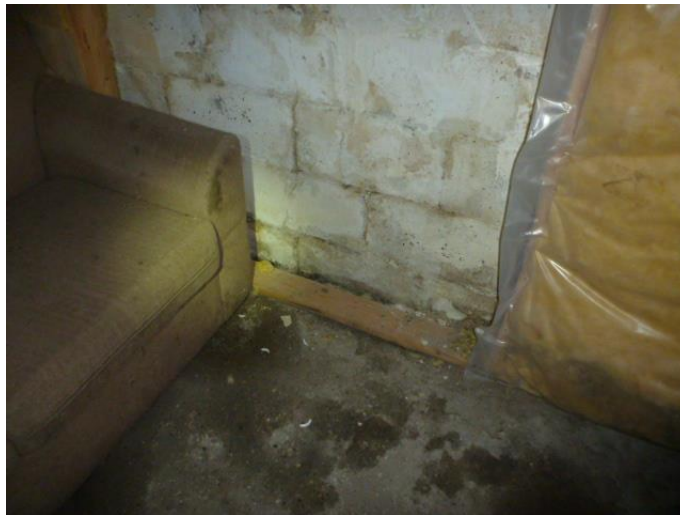
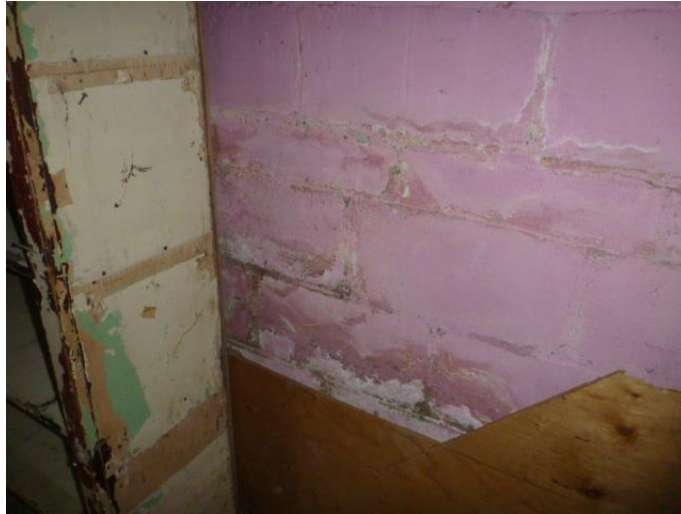
1604. Walls

Review. Efflorescence observed at walls; this is a mineral deposit left behind from exterior water infiltration, recommend disconnecting and extending downspouts and maintaining a positive grade away from the foundation and further extending downspouts to limit further moisture intrusion.

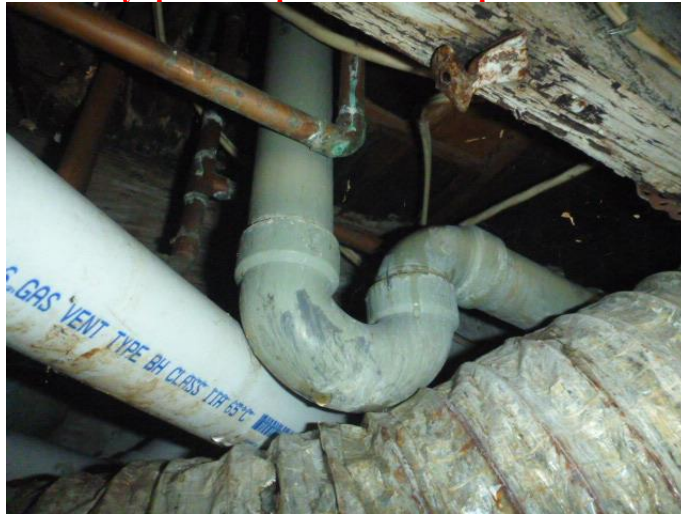
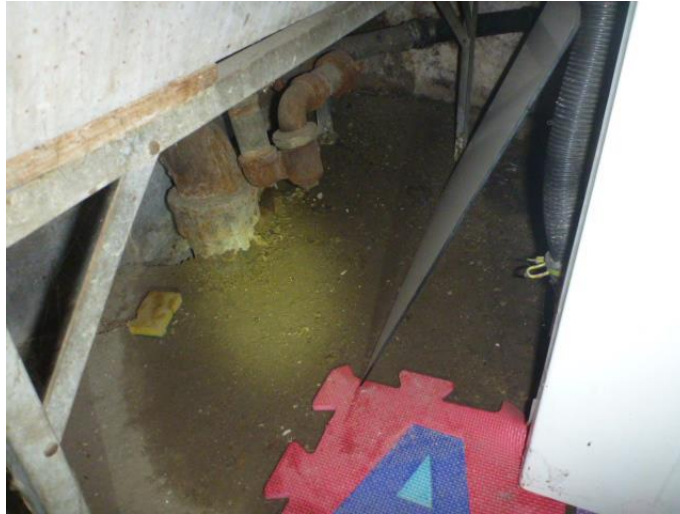
1620. Visible
Plumbing

Review. Active leaks observed at waste plumbing, suggest review by qualified plumber for repairs as necessary.

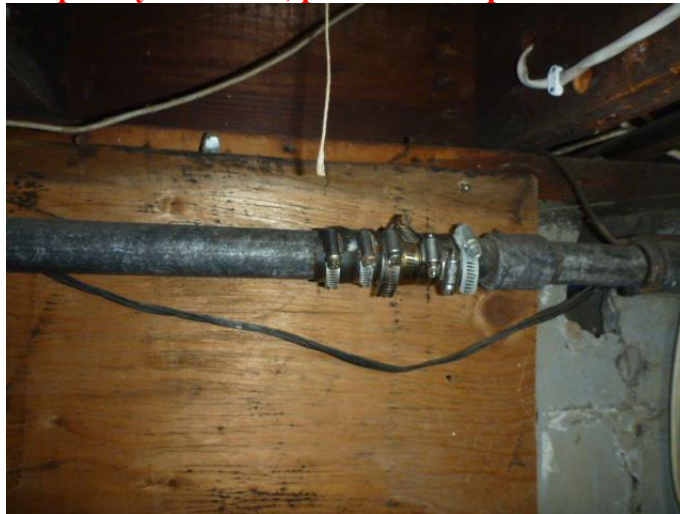
Although no leakage was detected, there appears to be a non-standard repair at the drain line at basement, which is temporary in nature, permanent repairs are needed.

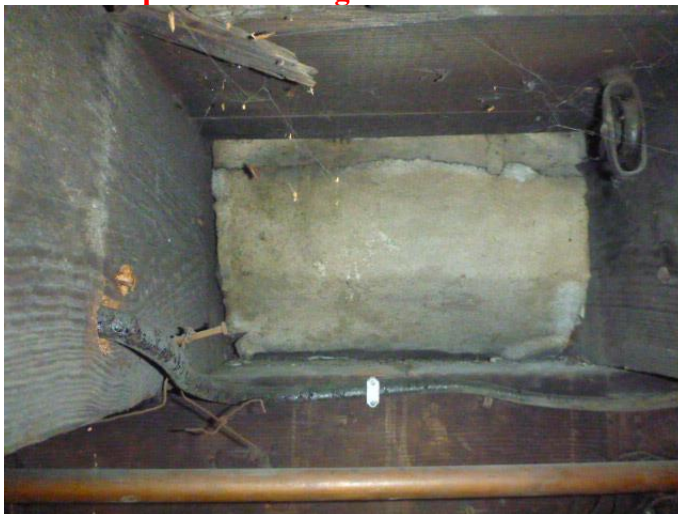
1624. Distribution / Ducting **Review. While asbestos detection and other chemical testing are beyond the scope of the inspection, the inspector's experience leads him to suspect that some building materials in this home may contain asbestos. If client has any concerns regarding this possibility, an asbestos testing lab should be consulted prior to closing.**

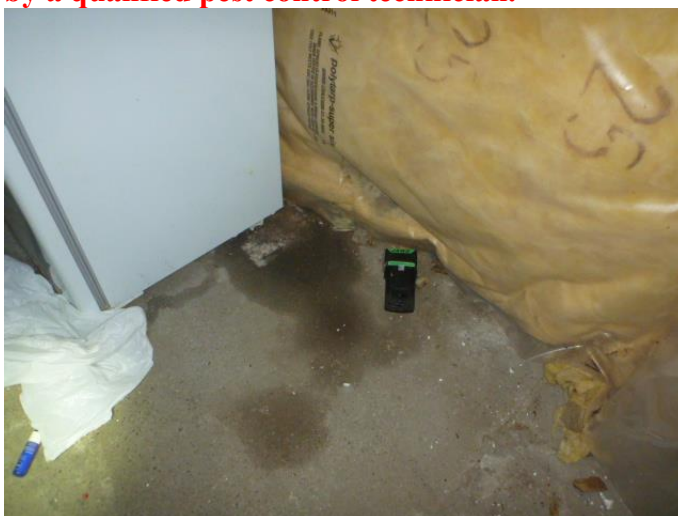
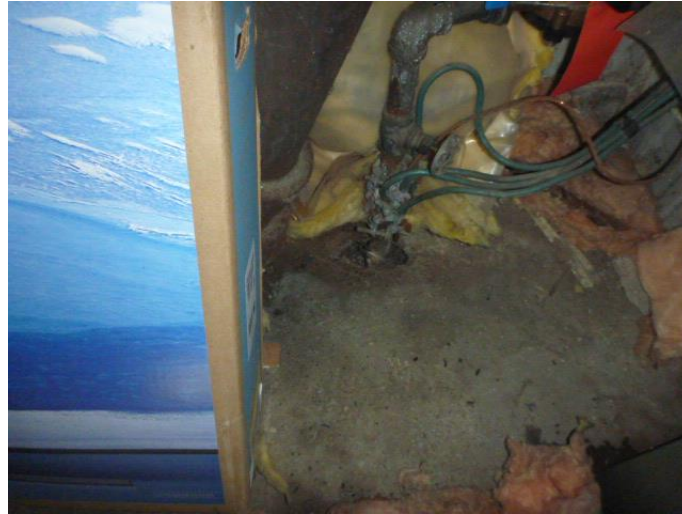
1625. Maintenance **Review. Evidence of rodent activity observed, suggest review by a qualified pest control technician.**

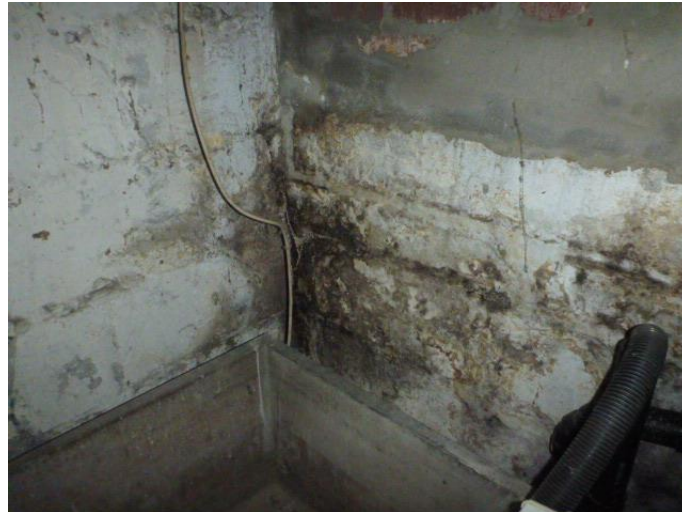
1626. Basement
Comments

Review. Stains, discoloration, growth and/or evidence of moisture observed. These conditions may indicate mold and/or fungus growth and were discovered during the home inspection. Because certain types of mold may be toxic and result in adverse health effects, it is strongly recommended that corrective measures be taken to limit moisture inside the home.

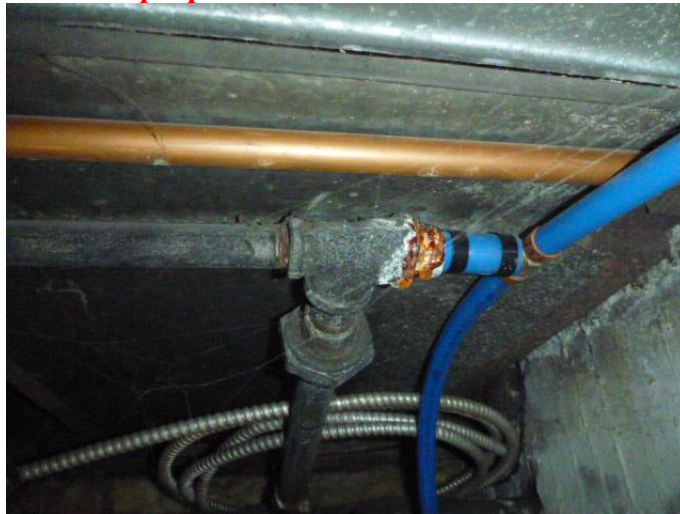
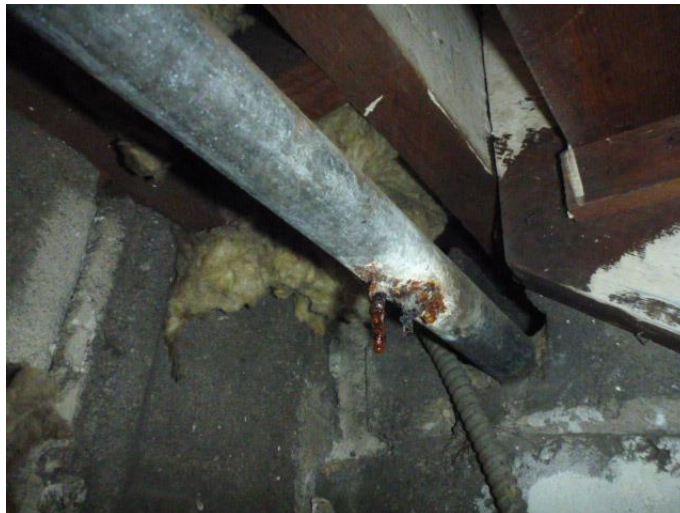
1702. Supply
Lines

Review. Galvanized water lines rust from the inside out and can become restricted over time. When low water flow is noted at plumbing fixtures, some restriction may have occurred. Extensive corrosion observed. Leaks visible. We suggest further review by a qualified licensed plumbing contractor prior to closing for repairs/replacement as needed to ensure proper water flow.

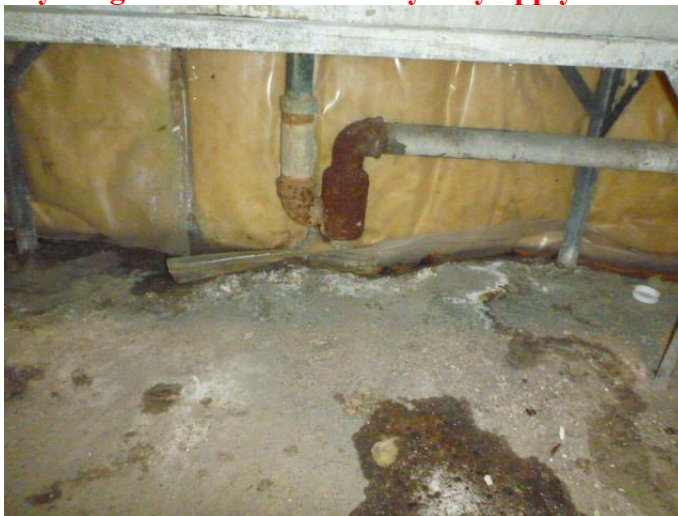
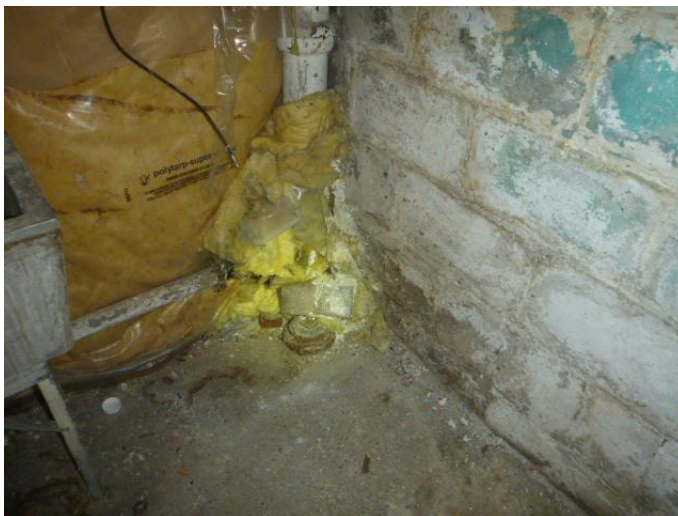
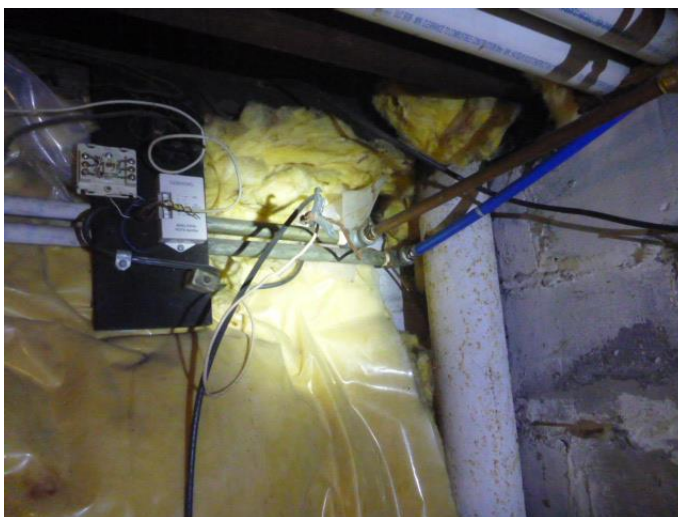
1703. Drain
Waste
Lines &
Vent Pipes

Review. Waste lines are mostly original & will likely need ongoing maintenance/replacement. Older drains are more likely to be of poor material, have hidden damage, root problems or other blockage, which can affect drainage or increase risk of sewer gas escape. Tip: your municipal plumbing inspector or department of public works may be able to advise you of any known neighborhood problems. We suggest you obtain the maintenance history for the home's plumbing and obtain receipts for any recent work or for anything for which a warranty may apply.

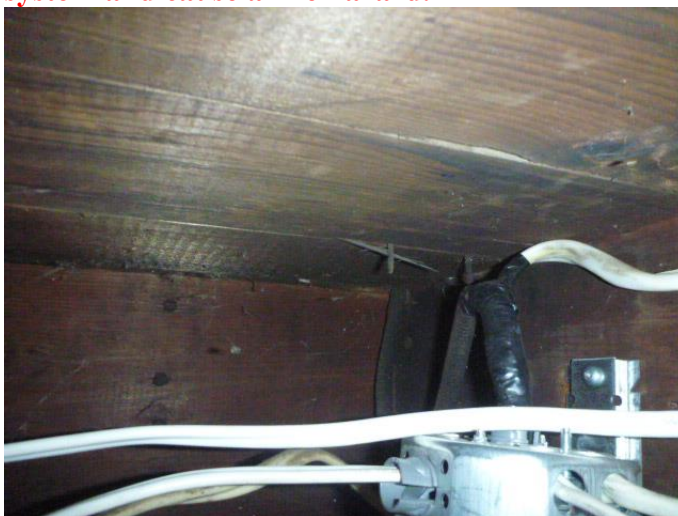
1804. Wiring
Method

Review. Knob and tube electric wiring was observed in this home. This type of wiring was standard at the time of construction. Client should consult with a licensed electrician prior to closing to verify its integrity, and/or if expansion to the system is planned. Expansion or additions to knob and tube wiring normally are not allowed as it can overload the system and cause a fire hazard.

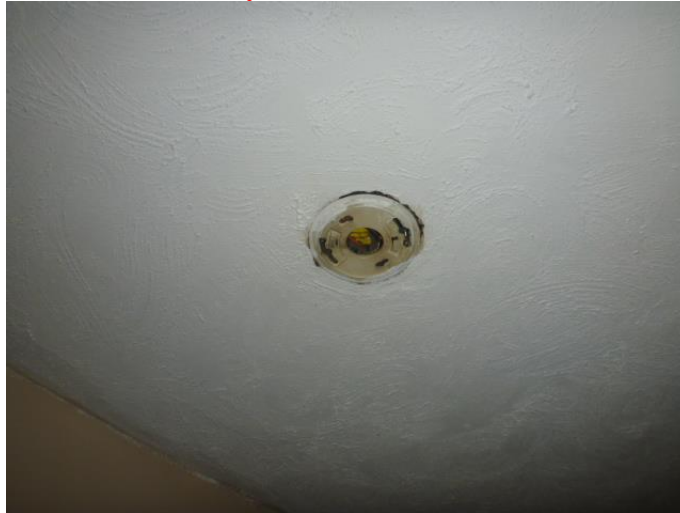
1806. Smoke
Detectors

Review. Suggest installing additional smoke detectors in appropriate areas as needed to enhance fire safety. Periodic testing is suggested to ensure proper working order and to enhance fire safety.

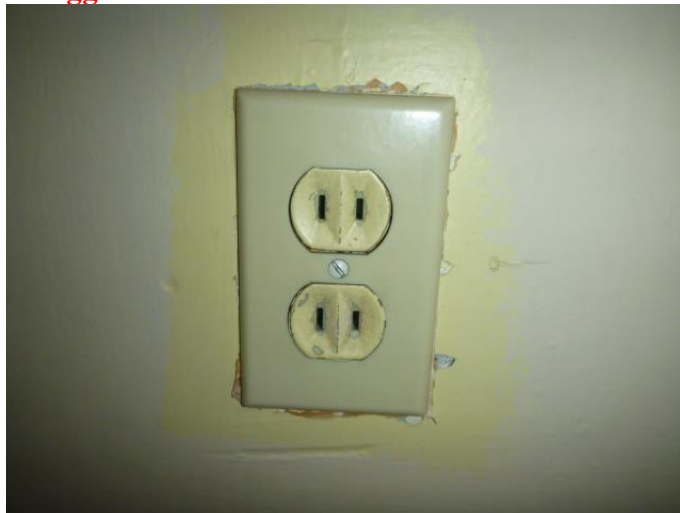
1809. Electrical
Comments

Review. The electrical system is an older non-grounded 2-wire system. This was common practice when this house was built. Due to safety concerns, it is suggested client consider upgrading to a new 3-wire grounded system or GFCI protection to enhance electrical safety. A review by a licensed electrician prior to closing for upgrading the electrical system is suggested.

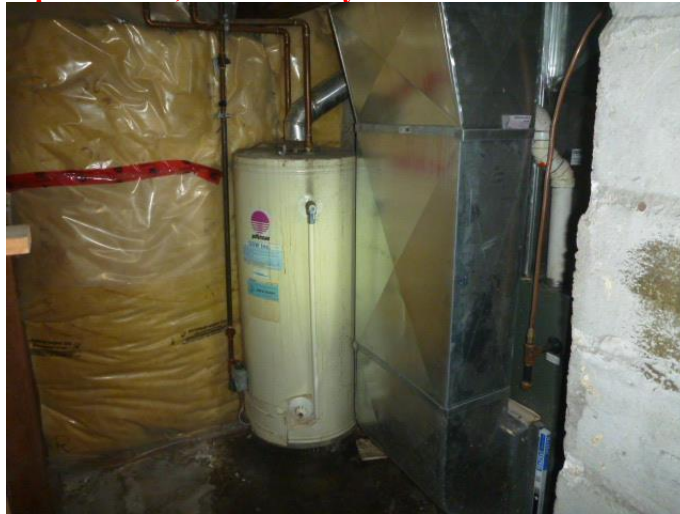
2108. Water
Heater
Condition

Review. In the inspectors opinion some of the water heaters are near the end of their useful life due to age and condition. Recommend review by a licensed plumber for repair or replacement, as necessary.

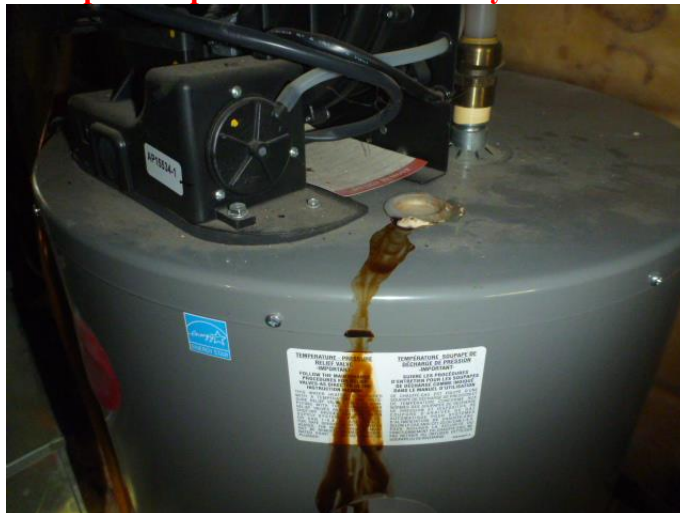
2111. Maintenan
e

Review. Leaks observed, suggest review by qualified plumber for repairs/replacement as necessary.

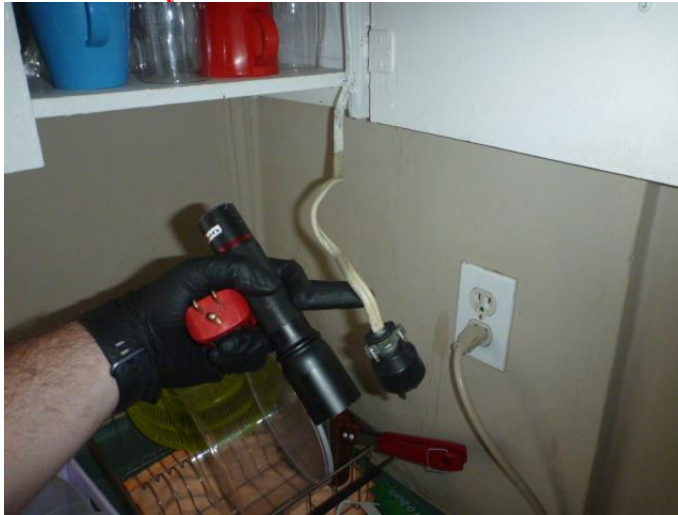
2208. Electrical

Review. Extension cords improperly used as permanent wiring. Extension cords should not be used for permanent wiring due to fire safety concerns. Client should consider review by a licensed electrician prior to closing for installation of proper electrical wiring and receptacles to ensure safety.

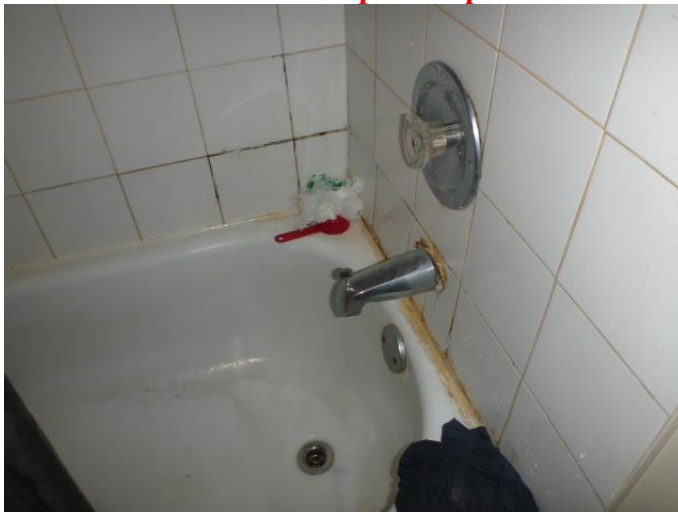
2311. Tub Surround

Review. In the inspectors opinion some of the tub/shower surrounds are near the end of its useful life due to condition. Recommend review for repairs/replacement as needed.

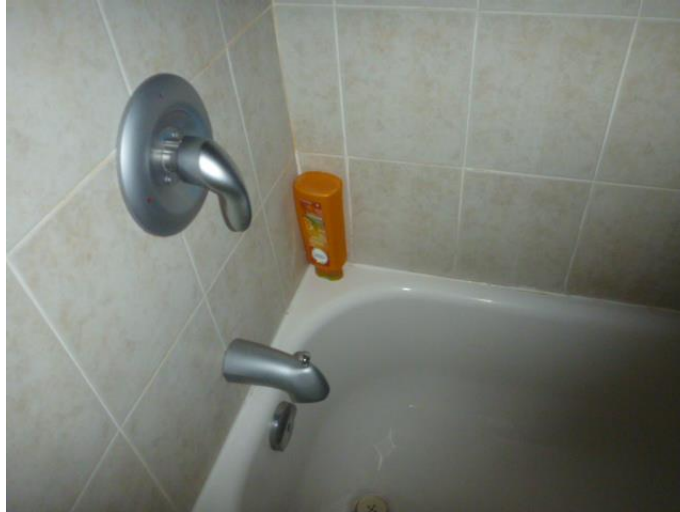
Damaged/deteriorated grout observed; suggest re-grouting as necessary, to prevent further damage.

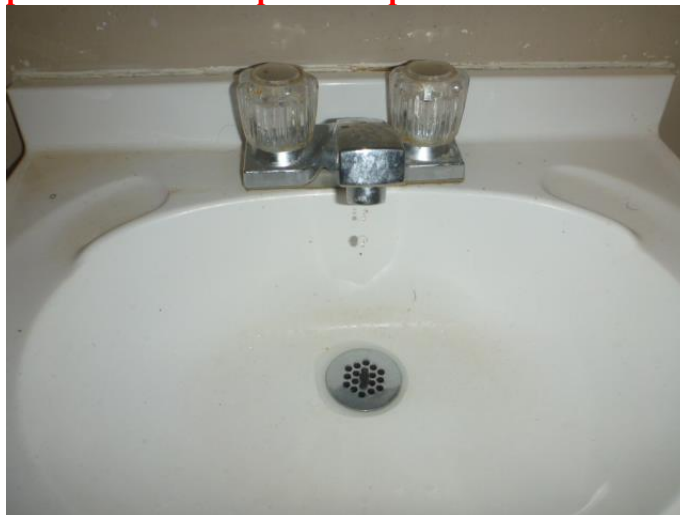
2319. Sink
Faucets

Review. Faucets drip. Recommend review by qualified professional for repair or replacement as necessary.

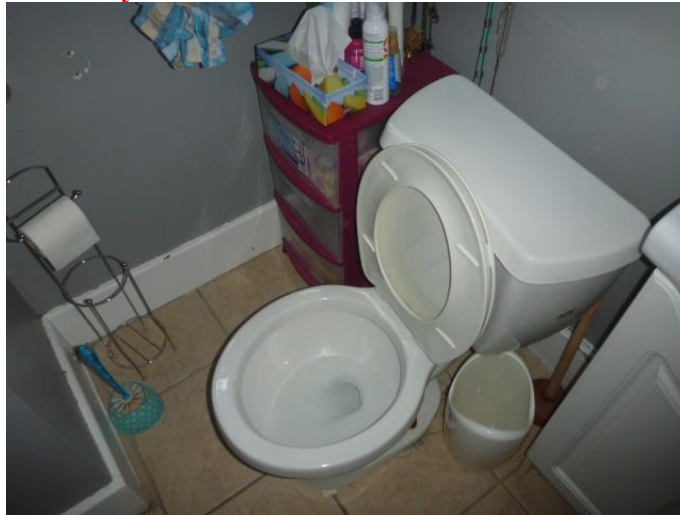
2321. Toilet

Review. Some toilet bowls are loose at floor anchor bolts. The wax ring inside the units must have a snug, secure fit in order to keep from leaking. Properly resealing and re-securing this unit is suggested to prevent water leakage and damage to the sub-floor area. This type of damage is not always visible or accessible to the inspector at time of inspection. Recommend review by a qualified plumber for repair or replacement, as necessary.

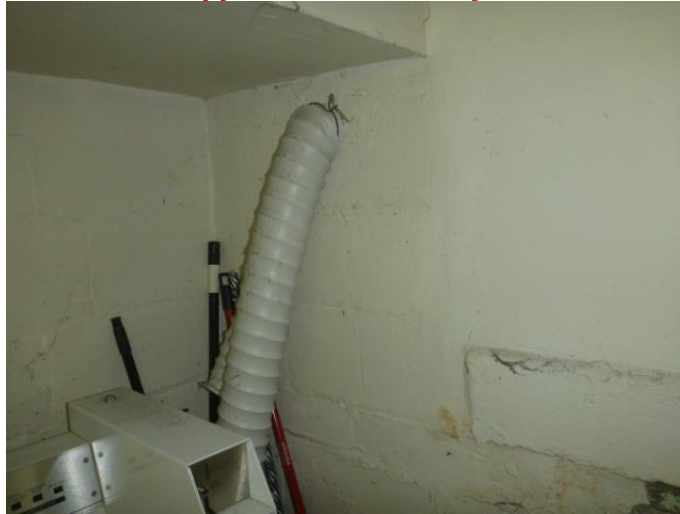
2513. Dryer
Hookups

Review. The flex hose at the dryer exhaust is a material that, under certain conditions, has been known to be a fire hazard. As a safety measure, we recommend replacing this exhaust hose with an approved metallic dryer vent duct.

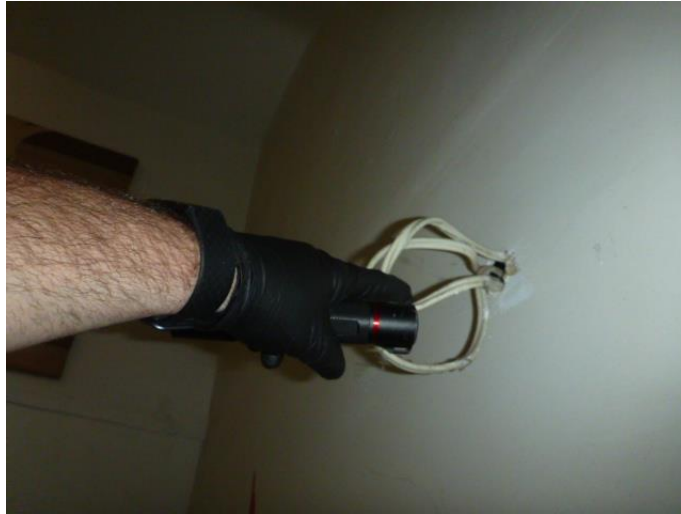
2608. Electrical

Review. Exposed electrical wiring observed. This is a safety concern if used where it could be subject to "Physical Damage". Exposed electrical wires are normally encased in conduit to ensure safety. Client should consult with a licensed electrician prior to closing for repairs/replacement as needed to ensure safety.

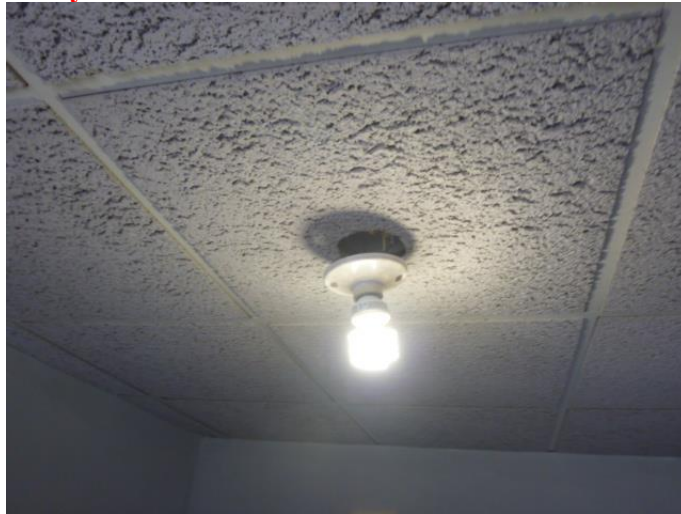
Loose hanging light fixture observed, suggest repairing for safety.
