## AmeriSpec Home Inspections

Doc #:                      Sample Inspection                      Inspector:                      Ryan Leavitt

# Home Inspection Report

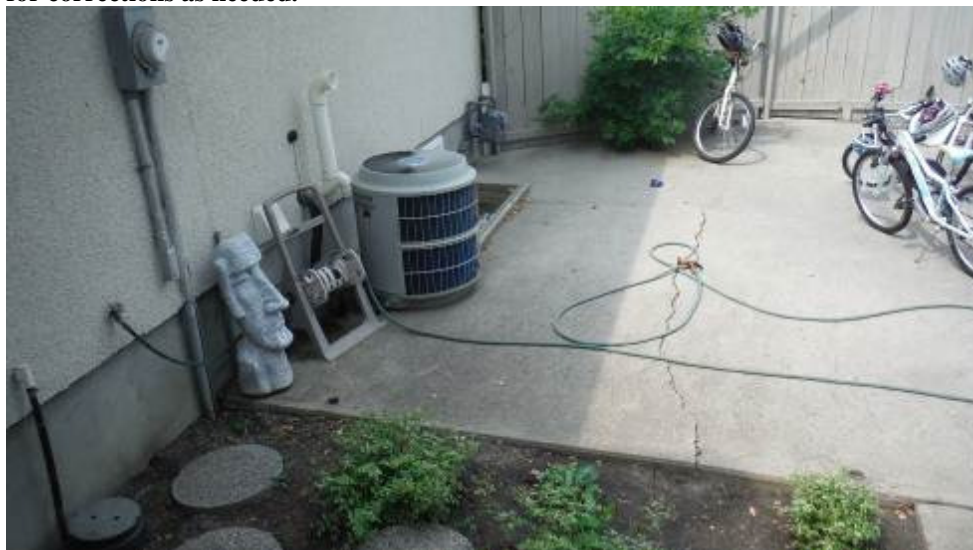
Step #	Component	Comment
1101.	Driveway	Serviceable. Concrete.
1102.	Walkways	<b>Pitched Toward Structure. Rear concrete patio is pitched towards the structure. This may result in basement/crawlspace seepage. Suggest review by qualified contractor for corrections as needed.</b>

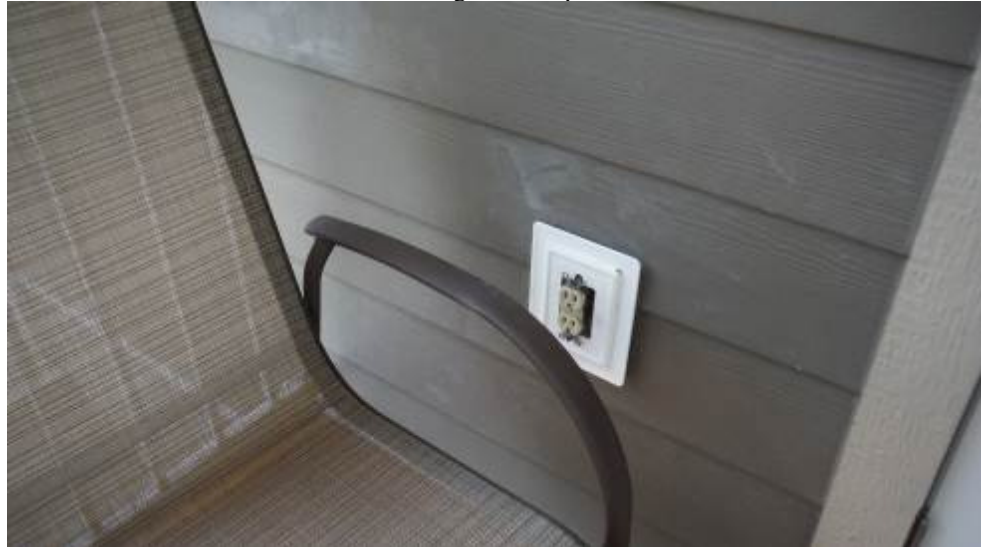
Outlet at the rear deck is loose and missing weather proof cover.

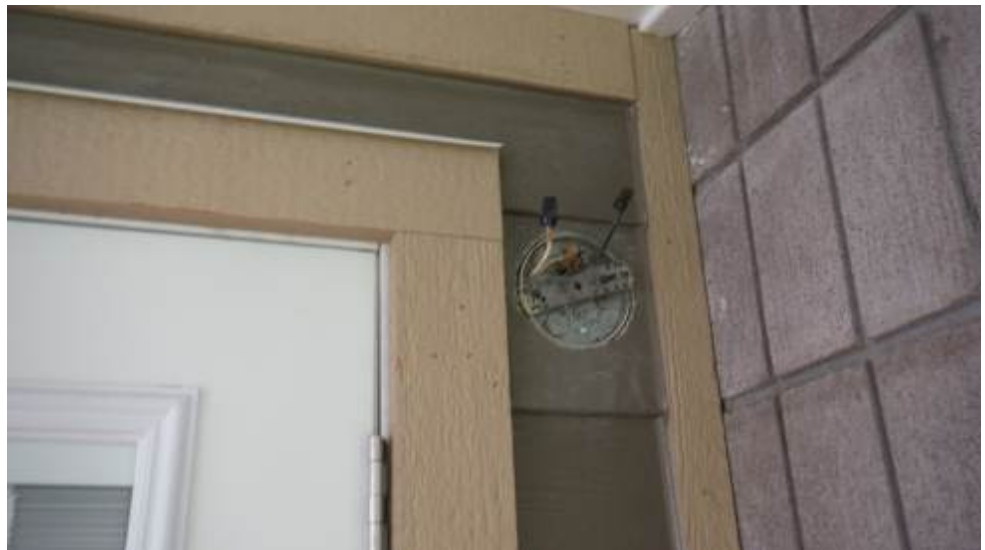
Light fixture is missing. Suggest repairs by electrician.

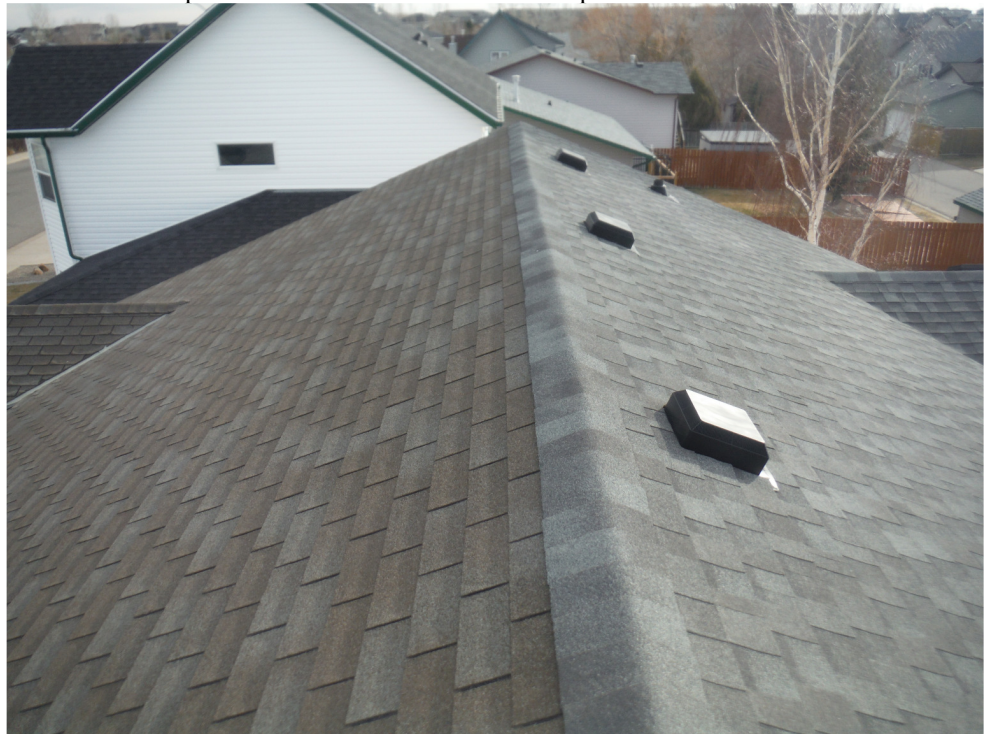
Step #	Component	Comment
1301.	Methods Used To Inspect	The roof was inspected from the roof. Partial roof replacement observed.

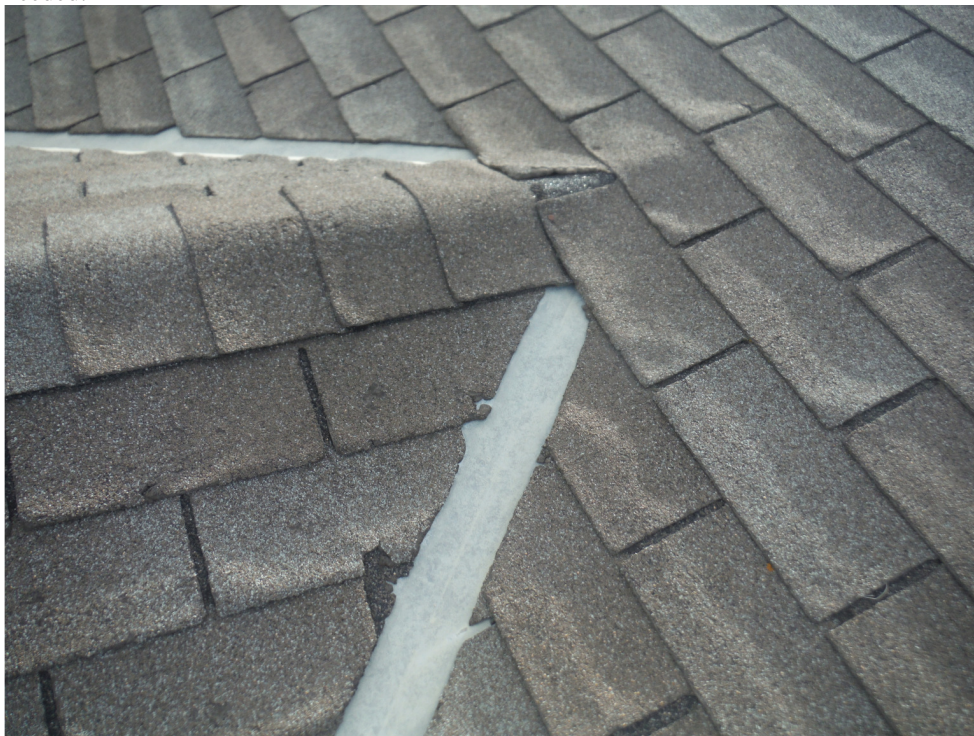
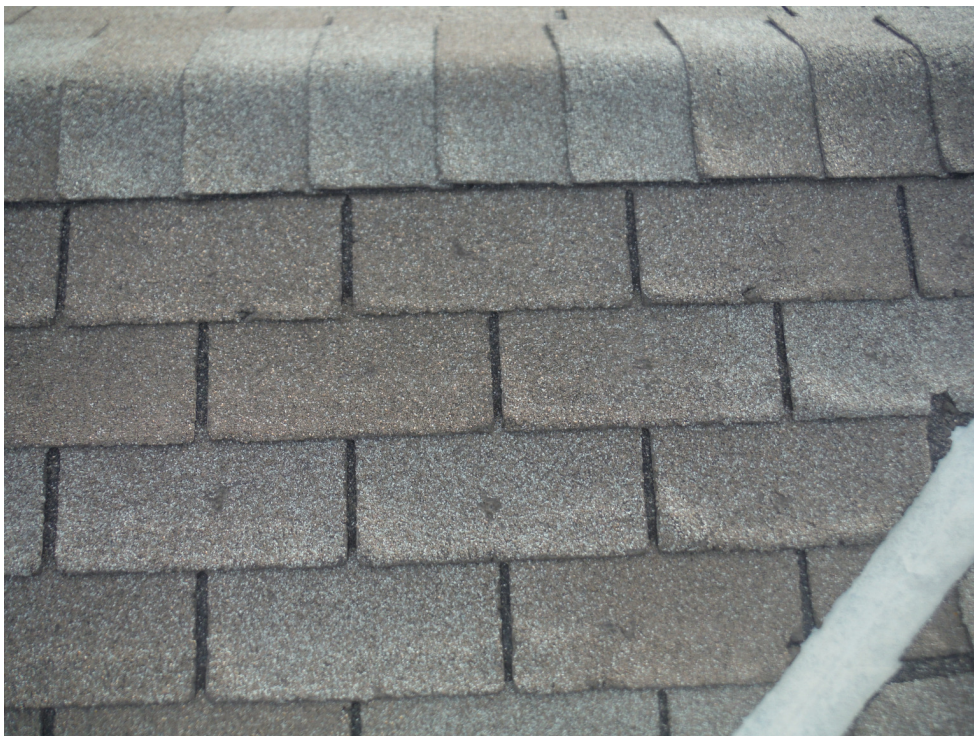
1305. Conditions

Hail damaged observed on the North side. Review and repair by roofing contractor is needed.

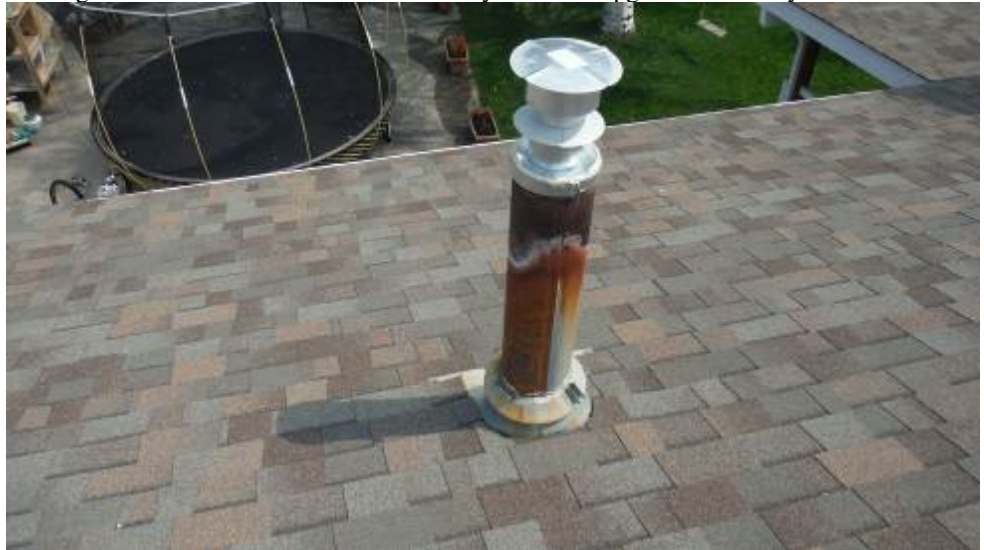
Step #	Component	Comment
1401.	Chimney Type	Metal chimney.
1402.	Visible Condition	Rusting observed to the water heater chimney. Future upgrade will likely be needed.

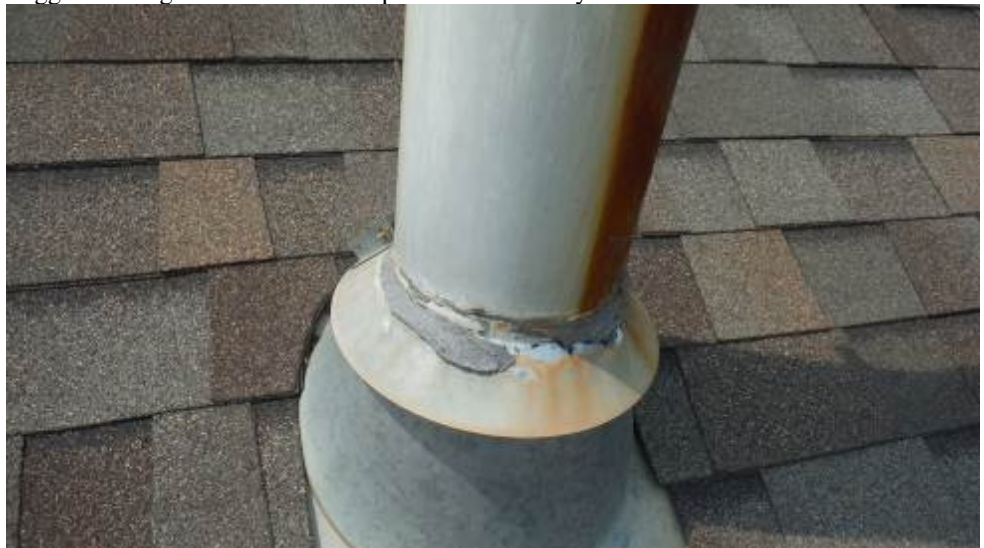
Suggest sealing the storm collar to prevent water entry.

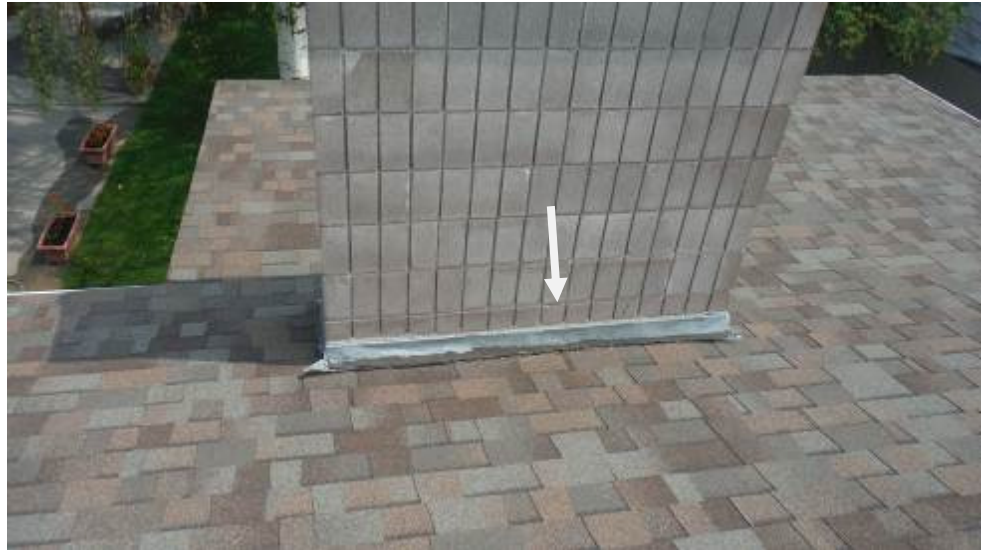
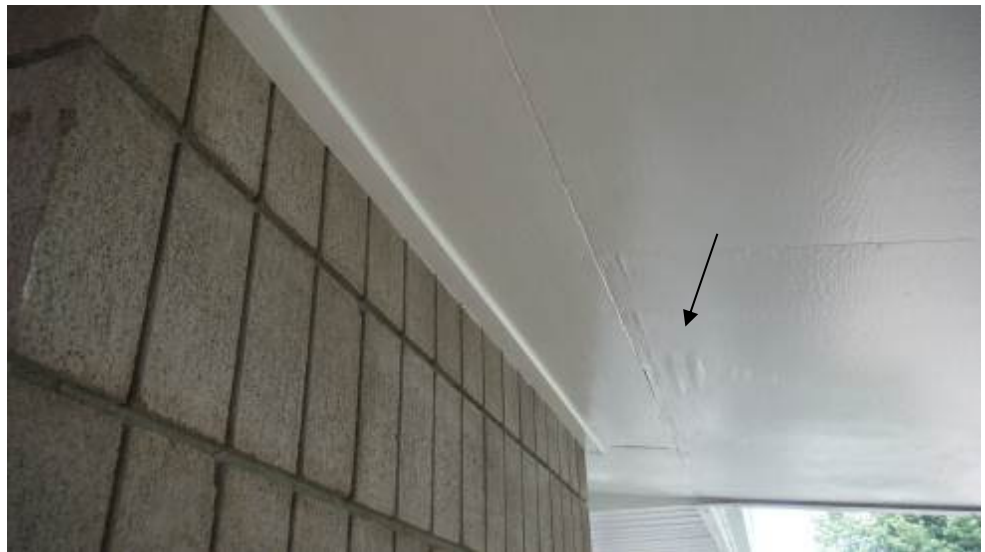
1406. Saddle/Cricket

No saddle observed. This may not have been required when home was built. Chimneys 30" or wider should have a saddle installed to help shed water. Evidence of water staining observed around the fireplace chimney in the wood soffit near deck. Unable to verify the extent of the water intrusion. Suggest review by licensed contractor for further review and corrections as needed.

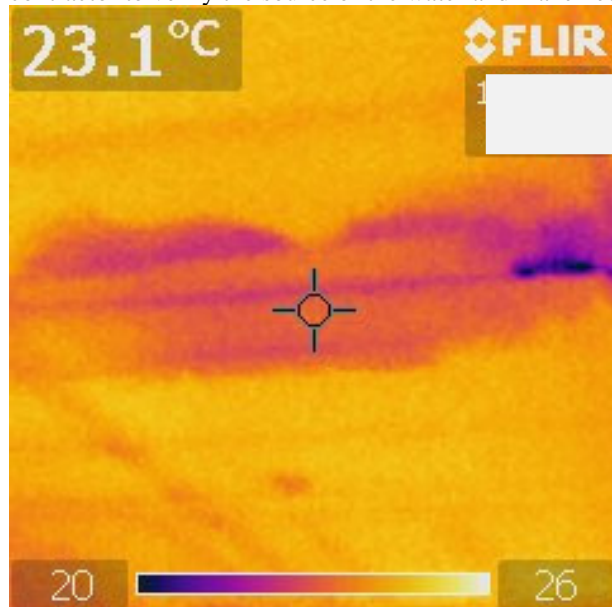
1516. Ceiling

Stains observed on ceiling. Moisture detected with an infrared camera. Suggest review by contractor to verify the source of the water and make necessary corrections.

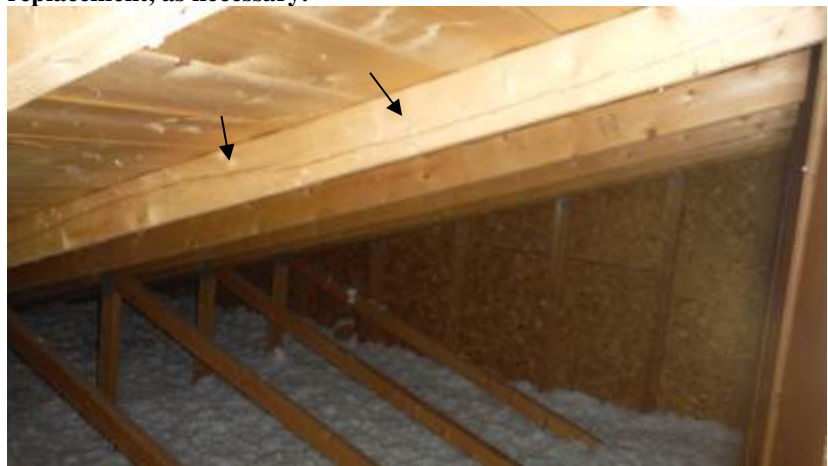
1602      Framing

**Trusses. Wood truss construction noted.**  
**Cracking trusses observed. Recommend review by contractor for repair or replacement, as necessary.**

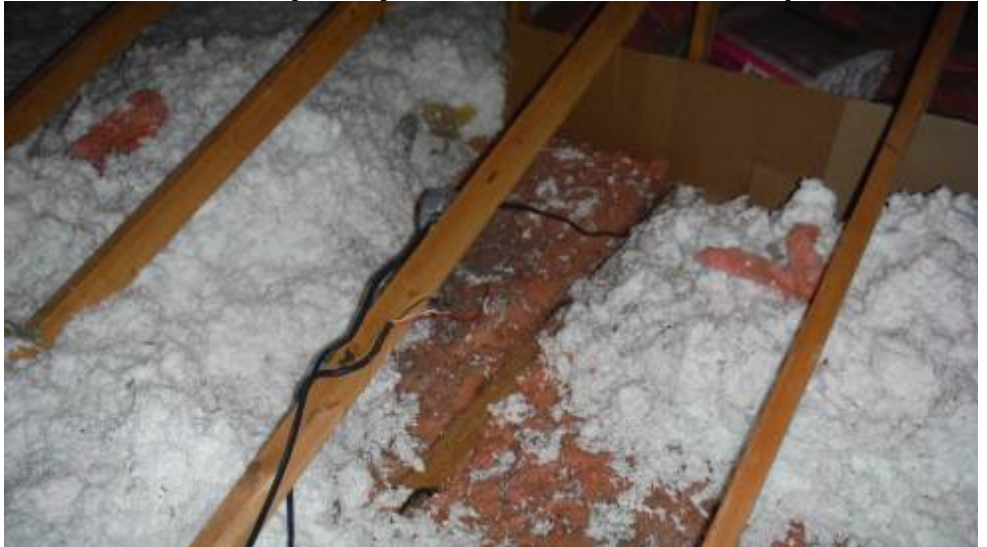
1604.	Evidence of Leaking	Serviceable. No Leaking*. At the time of the inspection there were no signs of leaking.
1605.	Insulation	<b>Maintenance. Fiberglas; Loose fill insulation. 10 inches of insulation present. Approximate R value: 30</b>
1606.	Ventilation	Hooded roof vents. Soffit vents are blocked with insulation. Recommend addition of soffit guards to soffit areas to ensure proper attic ventilation.
1608.	Electrical	<b>Maintenance. Open splice observed. This is a "Safety Concern". Whenever an electric wire is cut and reconnected, the "splice" should be encased in a covered "junction box" to prevent shocks and separation of the splice. Client is advised to consult with a licensed electrician for repairs/replacement as needed to ensure safety.</b>

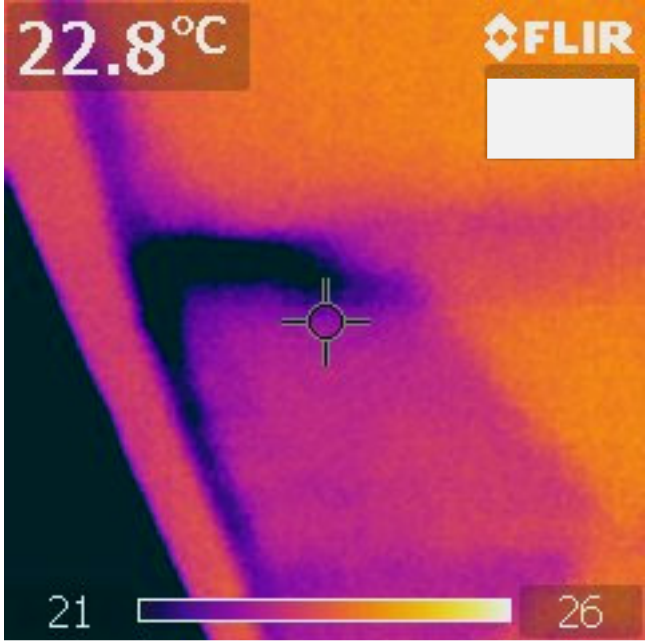
Step #	Component	Comment
2001.	Floors	Serviceable. Wood.
2002.	Walls	Serviceable. Drywall; Paint.
2003.	Ceilings	<b>Maintenance. Stains observed on ceiling above fireplace. Moisture detected with a infrared camera. Review by a licensed roofing contractor is needed to make repairs.</b>

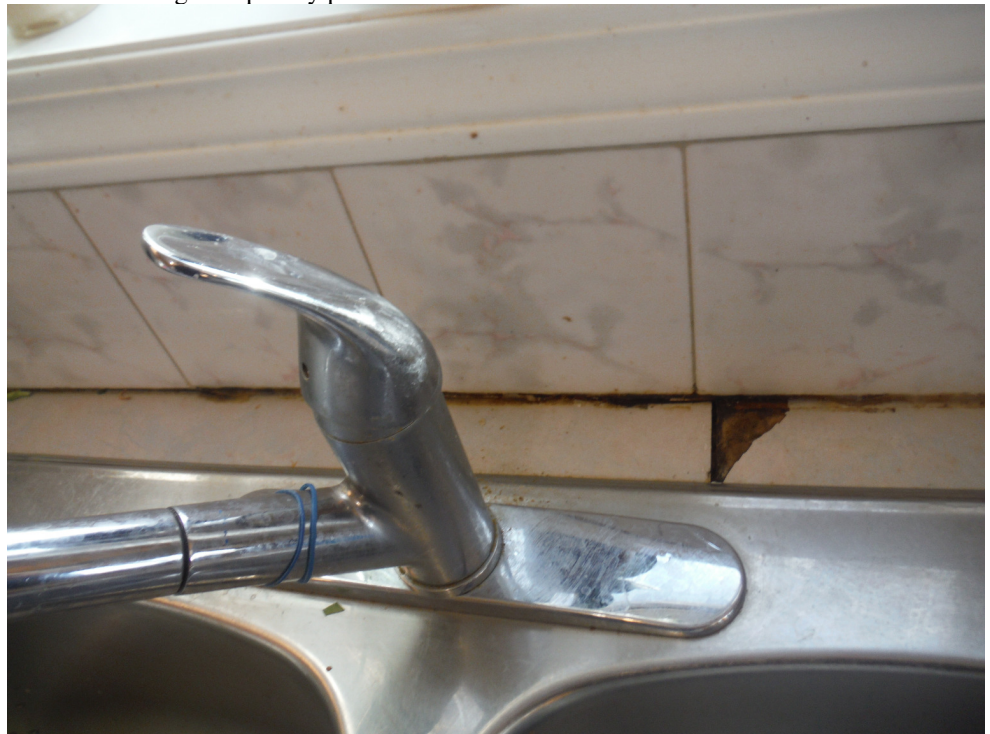
Step #	Component	Comment
2201.	Floor	Serviceable. Wood.
2202.	Walls	Serviceable. Drywall; Paint.
2203.	Ceiling	Serviceable. Drywall; Paint.
2204.	Doors	Serviceable. Rear entry.
2206.	Windows	Serviceable. Double glazed insulated.
2207.	Heat / Cooling Source	Serviceable. Central heating.
2208.	Electrical	<b>Maintenance. Ground Fault Circuit Interrupters (GFCI) may not have been required when the home was built. Suggest client consider upgrading with GFCI's at all receptacles near sinks for safety.</b>
2209.	Cabinets	Serviceable.
2210.	Counter Tops	Serviceable. Laminated.
2211.	Sinks	Serviceable. Stainless steel.
2212.	Faucets	Faucet is leaking. Repair by plumber is needed.

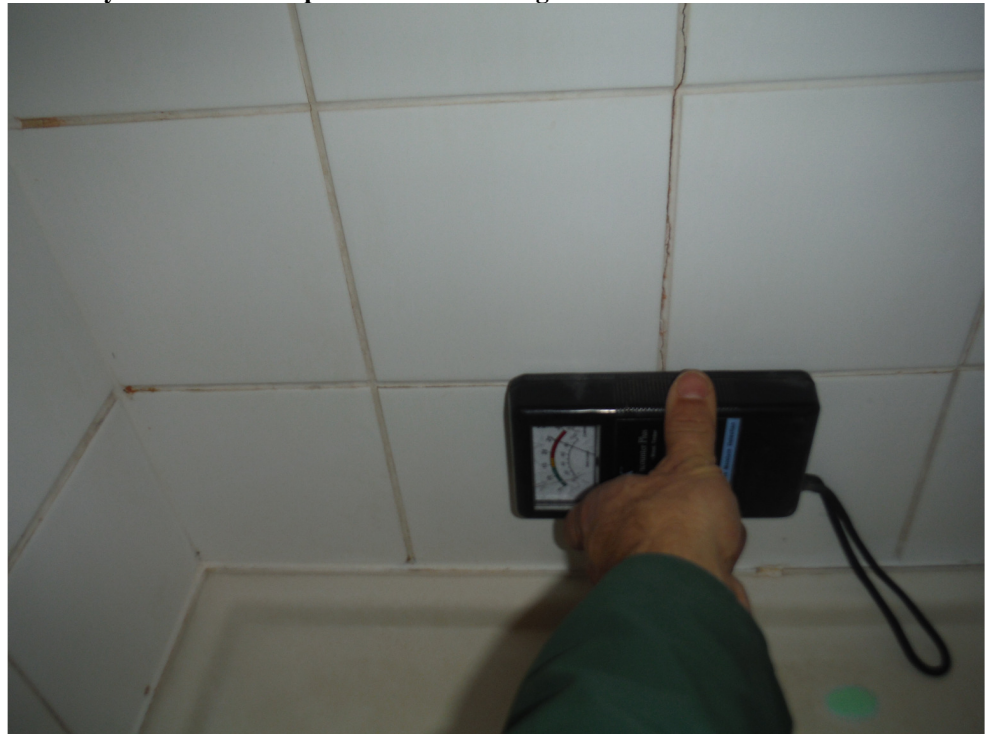
2414. Shower Surround

**Active water detected behind the tile surround with a moisture meter. Suggest review by contractor to repair the water damaged wall.**

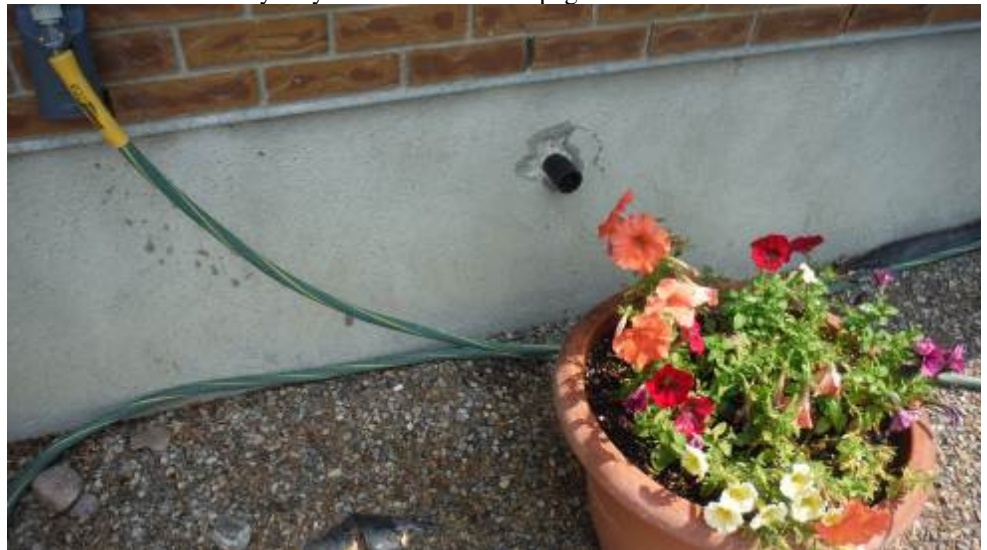
Sump pump drains to the front exterior. Recommend the client ensure the discharge line extends a minimum of 6 feet from the home during raining periods. Sump discharge lines not extended sufficiently may cause basement seepage.

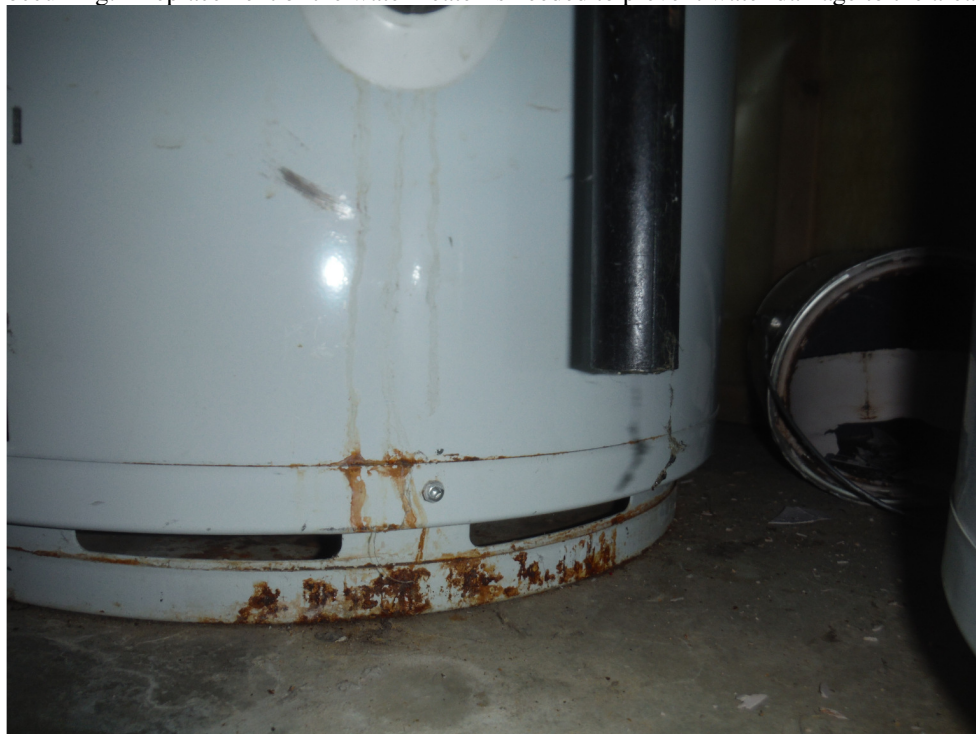
3108.      Water Heater Condition      Water heater is original to the home. Unit is 26 years old.    Rusting and minor leaking occurring.    Replacement of the water heater is needed to prevent water damage to the area.

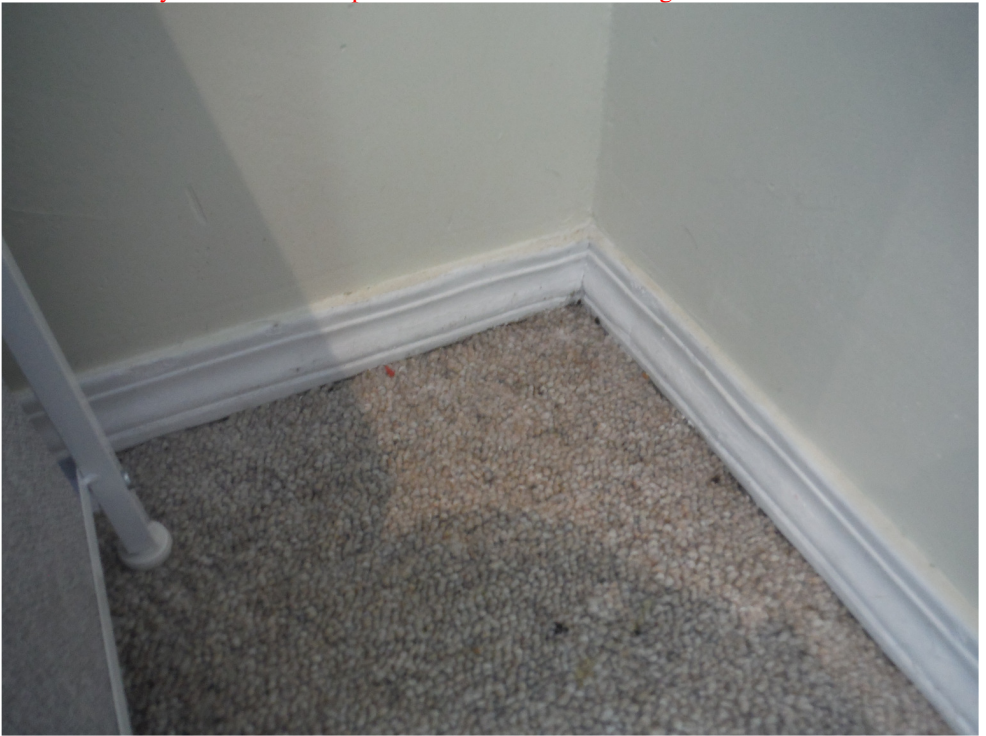
Step #	Component	Comment
3301.	Access	Finished areas in basement were observed.  It appears recent basement development or renovations have been made. No city inspection sticker present. Verification of proper permits is beyond the scope of this inspection. Suggest contacting the city for further information. Client may wish to also obtain a water disclosure from the sellers to verify any past water entry.
3302.	Stairs	<b>Maintenance. Wood. Handrail is missing. Corrections are needed to ensure safety.</b>
3303.	Floor	Concrete; Carpet. Dry water staining observed to the carpet tack strip. Suggest consulting with the current owners for information on any previous water entry to the basement.
3304.	Walls	<b>Evidence of past moisture entry observed in the basement. Water staining and swelling noted on the baseboards. No active water detected with a moisture meter and/or infrared camera. Suggest verification with the sellers as to the source of the water and any corrections they have made. Replacement of the water damaged walls is needed.</b>
