Thermal Imaging Inspection Report

1 Thermal Imaging Sample Way
Toronto ON

AmeriSpec Inspection Services Toronto East

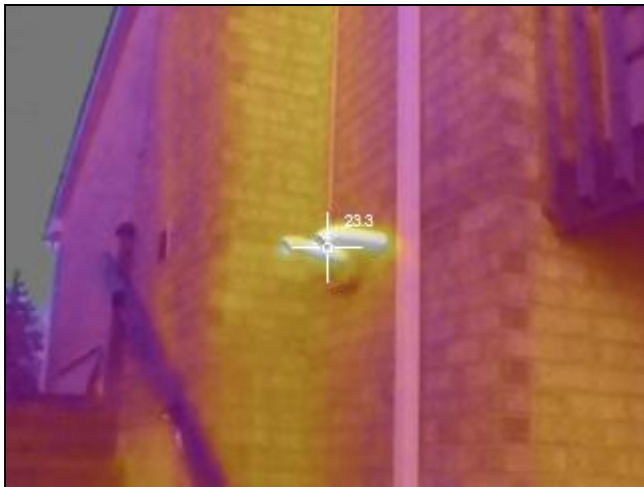
2.1 Item 1(Picture) Exterior Right Side

Based on our evaluation thermal anomalies were not detected.

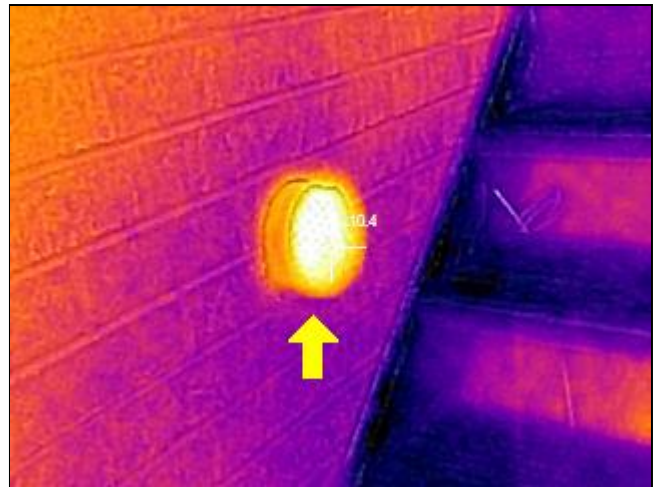
2.1 Item 2(Picture) Missing Vent Cover - Stove Vent

We recommend vent cover be added at exterior rear stove vent to help deter heat loss through openings vented to the exterior.

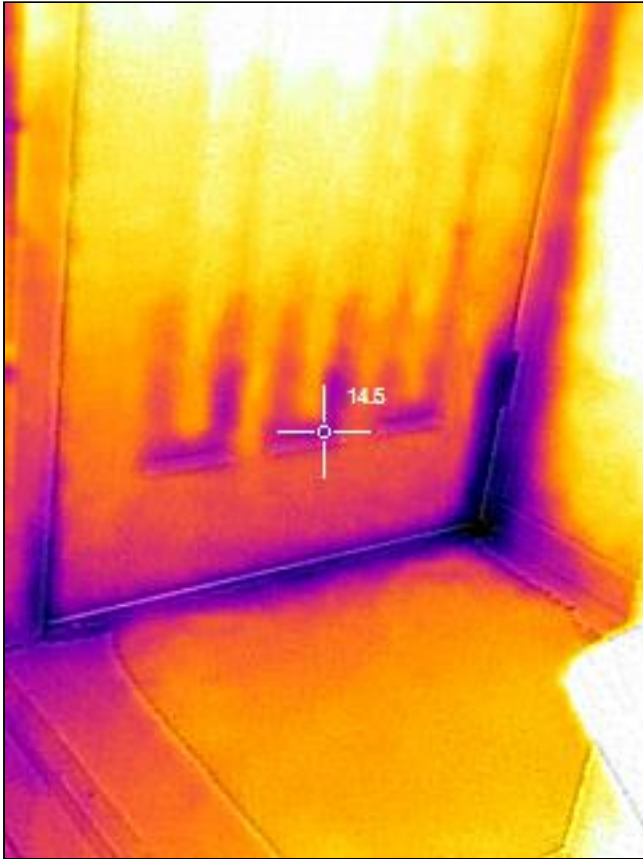
2.3 Item 1(Picture) Left/Driveway Side Exterior Door

(1) We noted that the Exterior Door(s) at the left side appears to be older/deteriorated or is a solid wood type door. Reducing heat loss in your home can significantly contribute to energy savings. As discussed with your inspector. We recommend replacing your door(s) with an Energy Star Qualified steel or fibreglass insulated door.

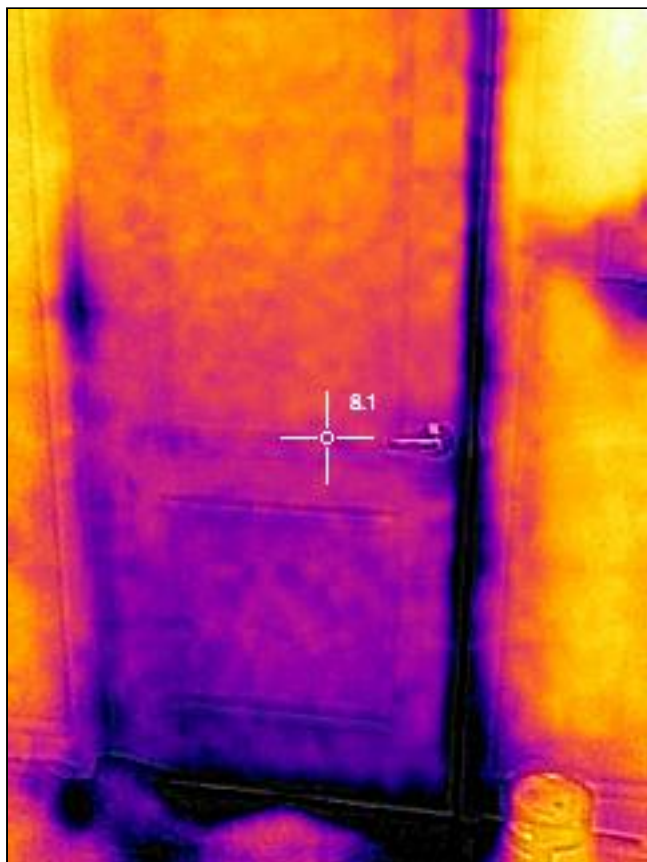
(2) We noted that the Cold Room Door at the basement appears to be a hollow cord door which has little or no insulative value. Reducing heat loss in your home can significantly contribute to energy savings. As discussed with your inspector. We recommend replacing your door(s) with an Energy Star Qualified steel/insulated or Solid Core door as needed.

2.3 Item 2(Picture) Cold Room Door - Basement - Heat Loss

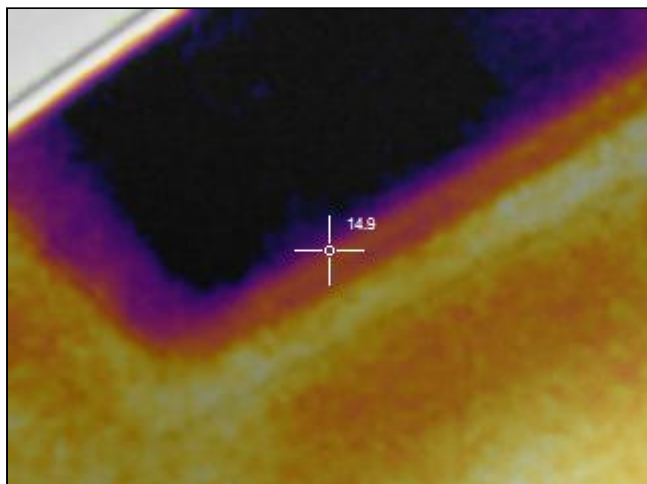
(2) The attic hatch is not insulated/poorly insulated. This contributes to significant heat loss from the living area of the home. We recommend installing an insulative backer to the hatch panel, or have a new hatch installed as needed for better heating efficiency of the home.

3.0 Item 1(Picture) Attic Hatch Not Insulated

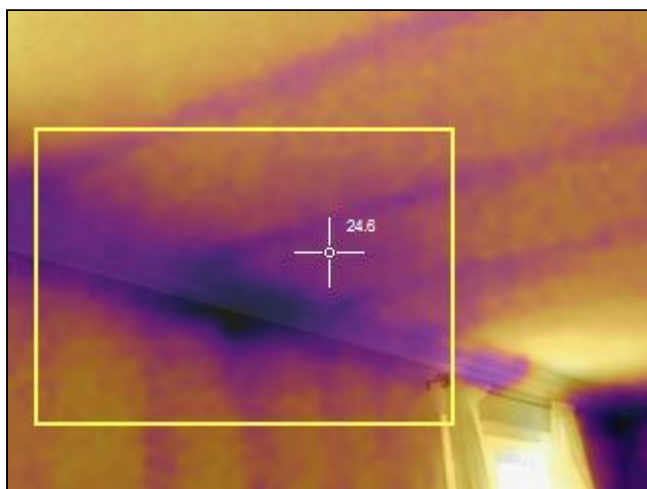
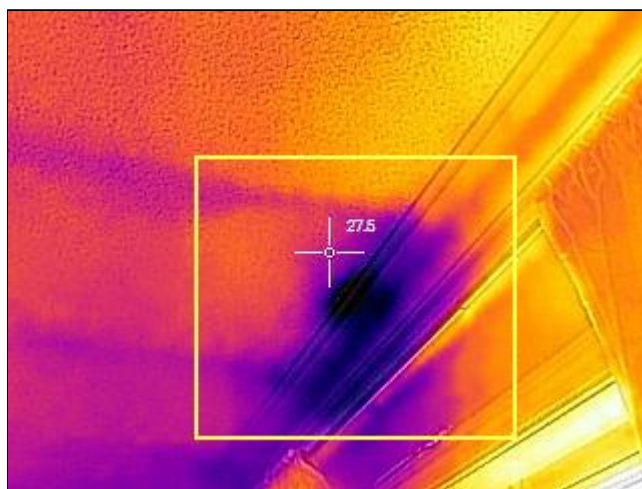
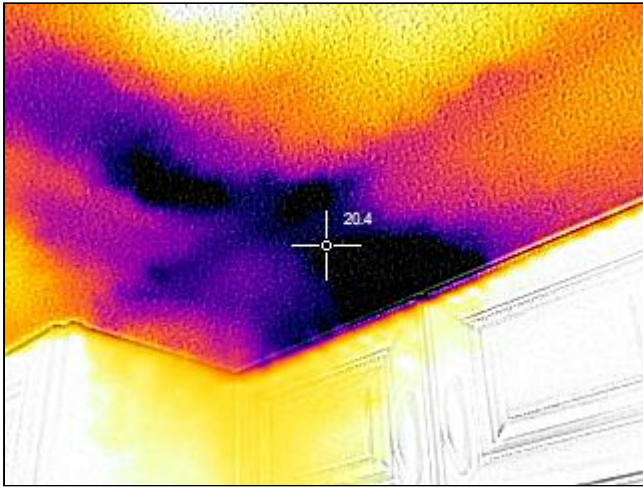
Thermal Anomalies were observed at the exterior wall of the master bedroom. It appears that cold areas were observed at the ceiling (above bed) at the outer wall. When viewed inside attic it appears the insulation has been blown back or is low in this area. We recommend adding additional insulation as needed in this area.

3.1 Item 1(Picture) Master Bedroom Ceiling above bed

3.1 Item 2(Picture) Master Bedroom Ceiling above Window

3.1 Item 3(Picture) Master Bedroom - Southwest corner - above built-in cabinets

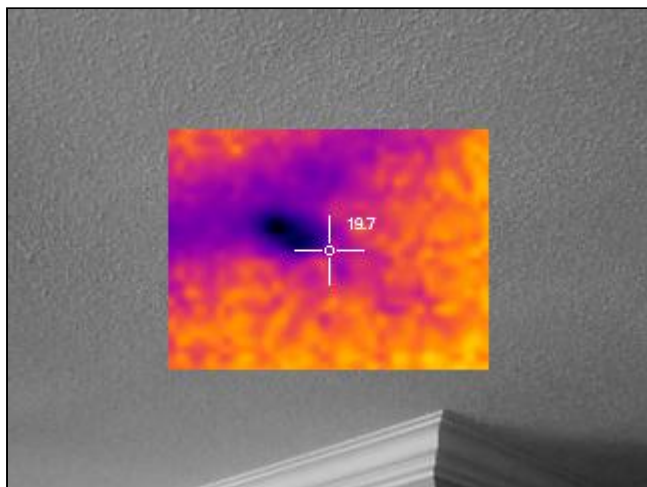
We detected a thermal anomaly using our thermal imaging camera. See photo or Comments below.

A thermal Anomaly was detected at the upper ceiling of the home. As we cannot determine the exact cause of this anomaly we recommend further investigation with a qualified professional (Roofing or Insulation Contractor)

4.1 Item 1(Picture) Thermal Anomaly - Front Bedroom Ceiling

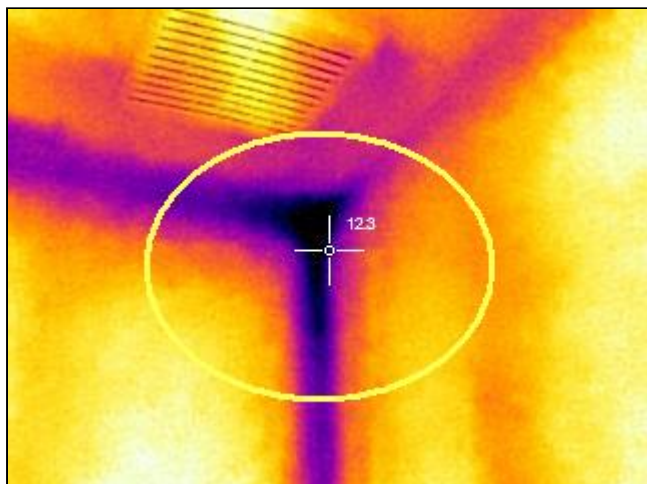
5.0 Item 1(Picture) Bathroom Ceiling area

The outer/exterior wall at the bathroom wall/ceiling is missing insulation or shows gaps which affect the heat efficiency of this area as detected using a thermal imaging camera. We recommend consulting with a professional insulation contractor to have this area repaired - adding insulation at the walls to a level of at least R14.

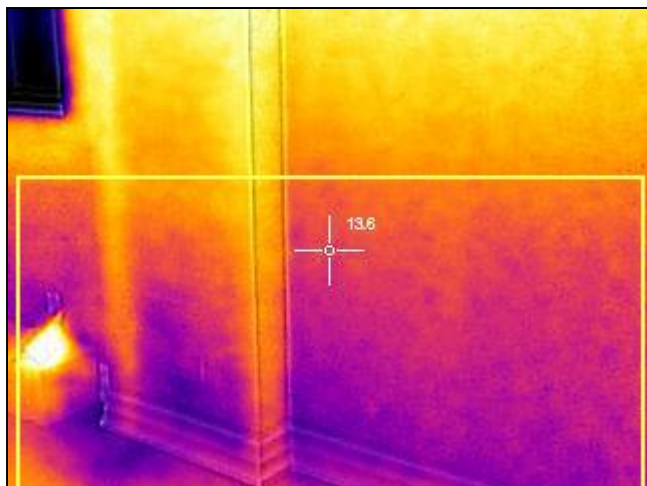
5.2 Item 1(Picture) Basement Bedroom - Exterior Fdtn Wall

Thermal Anomaly was observed - the outer/exterior walls of the basement bedroom are currently uninsulated/partially insulated. Due to the surface area of the walls, a significant amount of heat loss may be occurring in this area. Recommend consulting with an insulation contractor should client wish a further review.

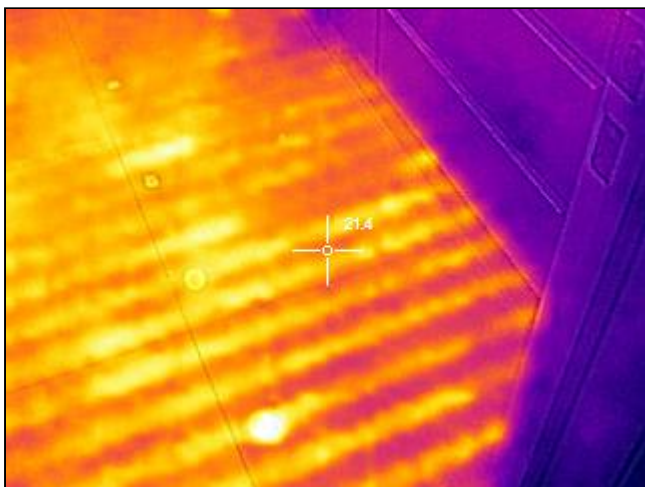
Heated (Electric) floor observed in the basement bathroom tiled floor. No thermal anomalies were detected as observed.

5.3 Item 1(Picture) Heated Floor - Basement Bathroom

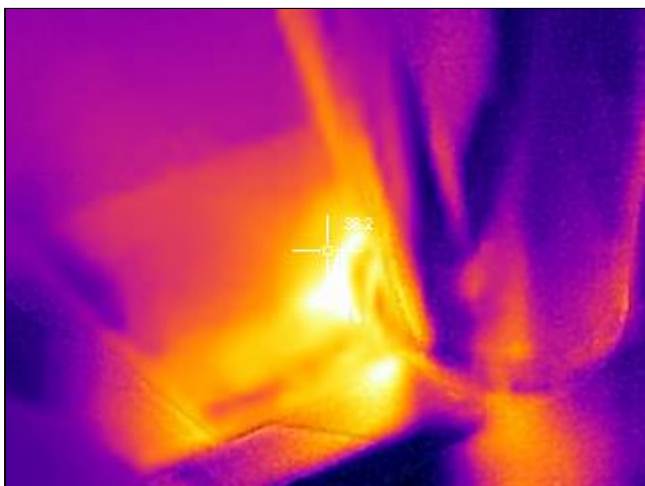
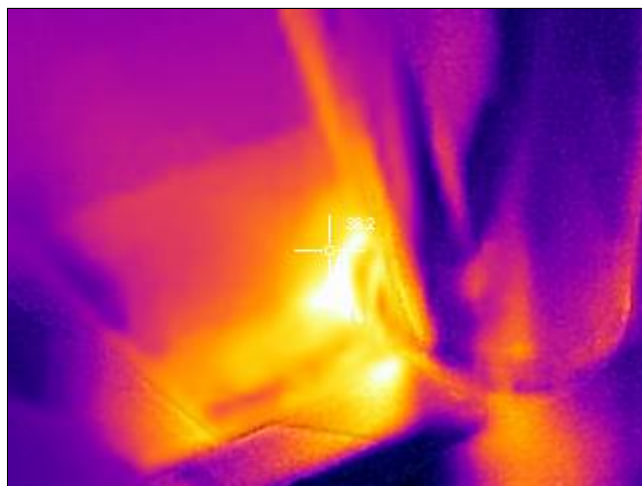
We detected a thermal anomaly using our thermal imaging camera. See photo or Comments below.

Dryer vent behind wall is not sealed properly. Recommend sealing to prevent moisture/lint escape which can affect the comfort level inside the home.

6.1 Item 2(Picture) Dryer Vent Not Sealed

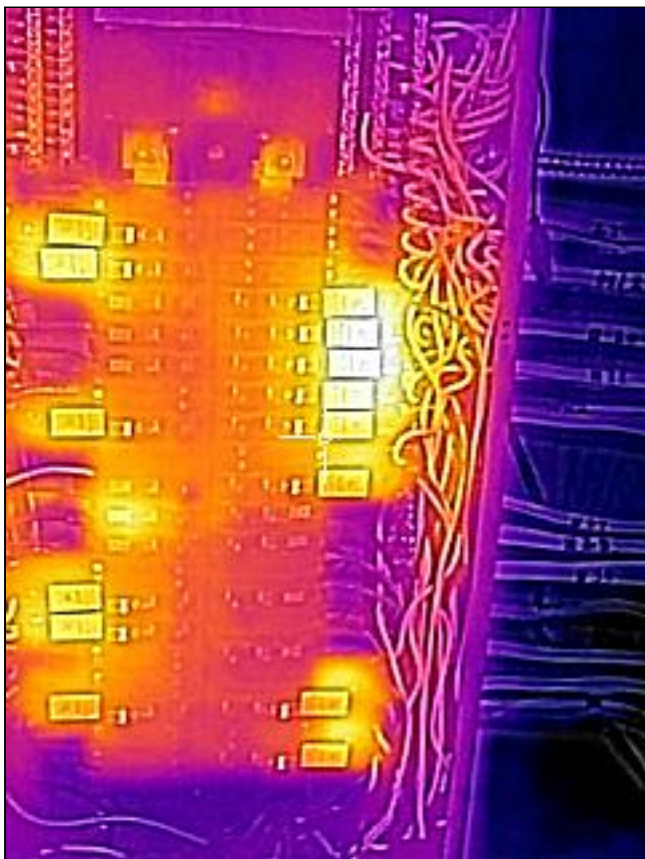
Based on our evaluation thermal anomalies were not detected. Main electrical panel showed no signs of 'hot spots' when major appliances were operated under normal circumstances and viewed with the thermal imaging camera at the main electrical panel.

7.0 Item 1(Picture) AFCI's were observed - normal observations
