## AmeriSpec Inspection Services

Doc #: XXXXX -Eng Inspector: Steve Fortin  
Date: 2018-10-24  
Dwelling Address:: Unknown address  
Client Name: report example English  
Client's Agent: Real Estate Company:

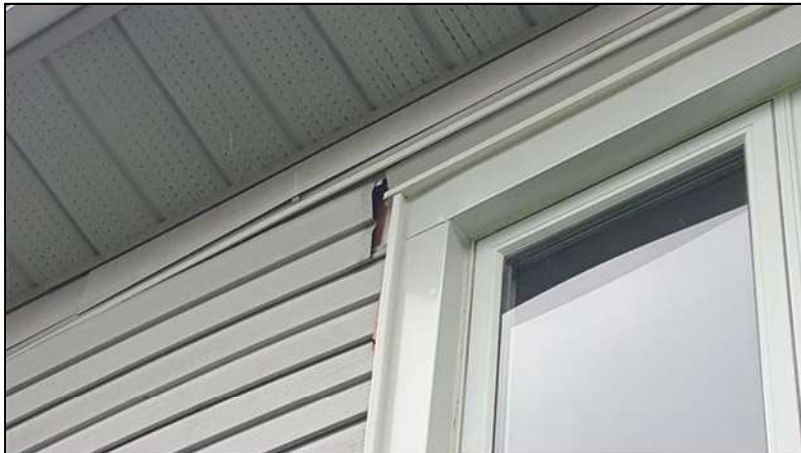
1.1 Item 1(Picture)

Step #	Component	Comment
1.0	Driveway	<b>Serviceable.</b>
1.1 (1)	Exterior Wall Cladding	<b>Minor Case. Home is covered with vinyl Siding. The inspector is unable to view the condition of covered areas. It is important to keep siding well caulked and sealed to prevent moisture penetration.</b>
1.1 (2)	Exterior Wall Cladding	<b>Minor Case. We notice openings/ holes in wall cladding. It is important to keep cladding well caulked and sealed to prevent moisture penetration. Recommend review by licensed professional for repairs or replacement as needed.</b>

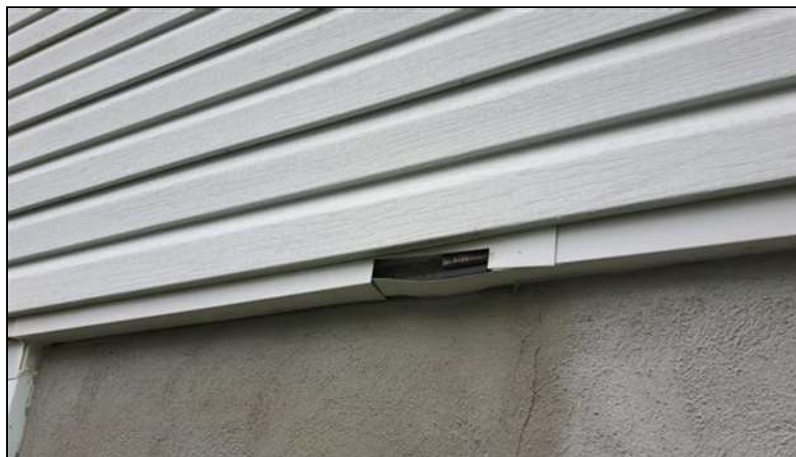
1.1 Item 2(Picture)

- 1.1 Exterior Wall Cladding  
**Minor Case**  
**(2) We notice openings/ holes in wall cladding. It is important to keep cladding well caulked and sealed to prevent moisture penetration. Recommend review by licensed professional for repairs or replacement as needed.**

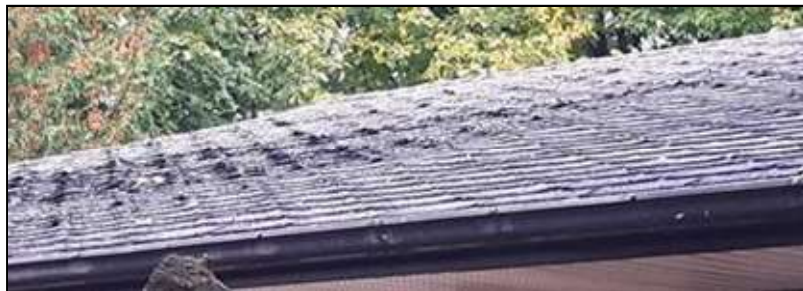
2.1 Item 1(Picture)

Step #	Component	Comment
2.0	Exposed Flashings	<b>Serviceable.</b>
2.1	Roof Condition	<b>Major Case. Roofing materials show extensive wear and deterioration and may be at the end of their useful life. A licensed roofer should be consulted for further review prior to closing for repairs/replacement as required.</b>

- 2.1 Roof Condition  
**Major Case**  
**Roofing materials show extensive wear and deterioration and may be at the end of their useful life. A licensed roofer should be consulted for further review prior to closing for repairs/replacement as required.**
-

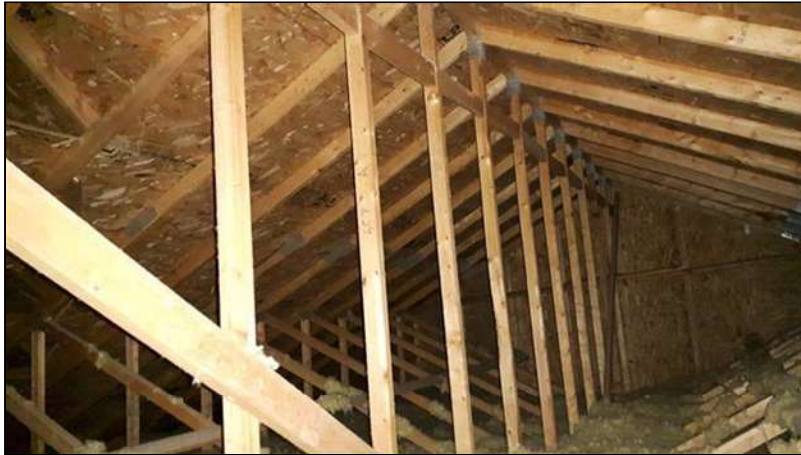
3.0 Item 1(Picture)

- 3.0 Framing **Serviceable. Wood truss construction noted. Trusses are often used to provide additional headroom and wider spans than is common with wood joist systems. This is a specialized system which is intended for site-specific engineering. The integrity of a truss system depends on the builder following a truss engineer's instructions, which we do not have. Verifying appropriate installation is beyond the scope of this inspection. Trusses should not be cut or notched as this will damage their structural integrity.**

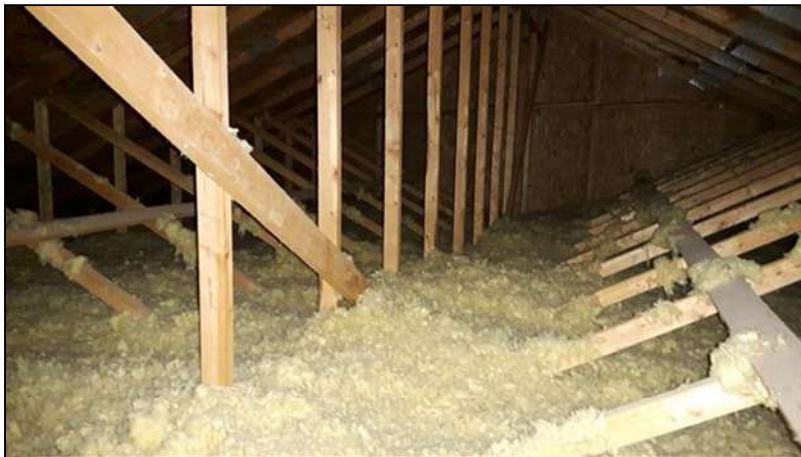
3.2 Item 1(Picture)

- 3.2 Insulation **Serviceable.**

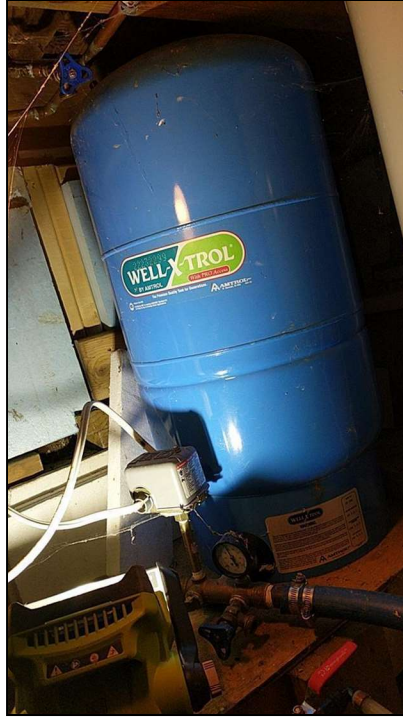
5.1 Item 1(Picture)

- 5.1 (2) Water Supply System .. **Water treatment equipment was present in the home at the time of the inspection. In accordance with the scope of work, the assessment of the homes water treatment system(s) was not completed as part of the home inspection. A water treatment device in controlled by an automatic timer and need proper calibration. We recommend consulting with the current owner and/ or a qualified water treatment contractor to determine operations and maintenance requirements for the water treatment system(s) and to verify proper operation.**

**(2) Water treatment equipment was present in the home at the time of the inspection. In accordance with the scope of work, the assessment of the homes water treatment system(s) was not completed as part of the home inspection. A water treatment device in controlled by an automatic timer and need proper calibration. We recommend consulting with the current owner and/ or a qualified water treatment contractor to determine operations and maintenance requirements for the water treatment system(s) and to verify proper operation.**

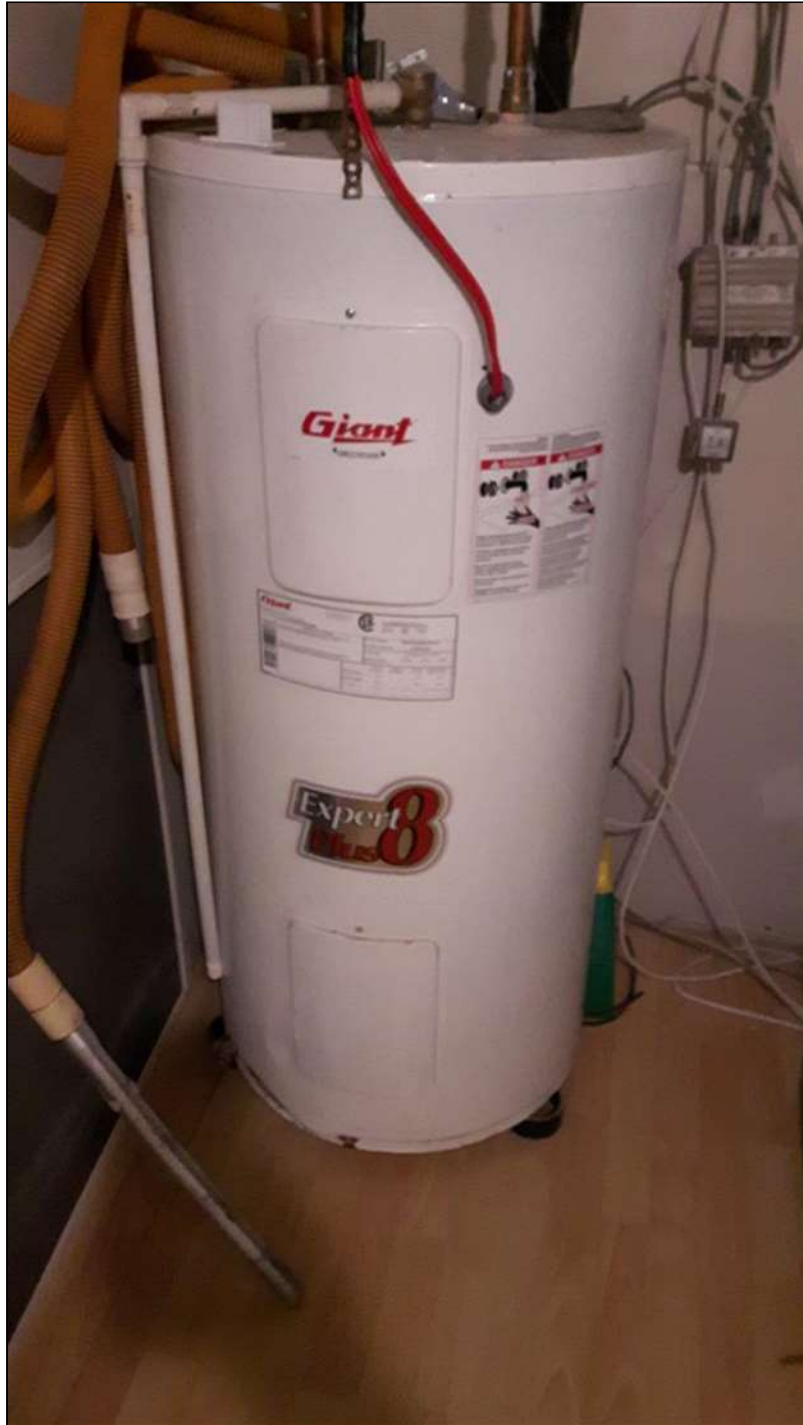
5.3 Item 1(Picture)

**Serviceable. Water Heater is 3 years old. The life expectancy of a water heater is 10 to 15 years. Some insurances do not cover damage caused by a water heater more than ten years old**

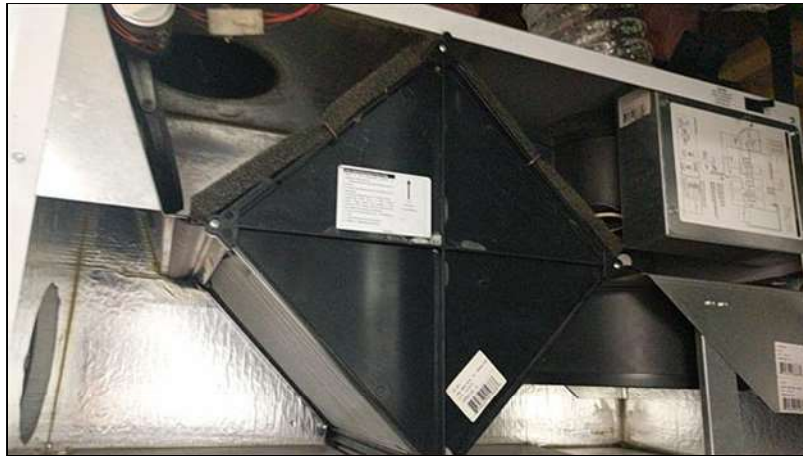
5.5 Item 1(Picture)

**Serviceable. The air exchanger was activated to check the operation of the motor, which appear to be in serviceable condition.**

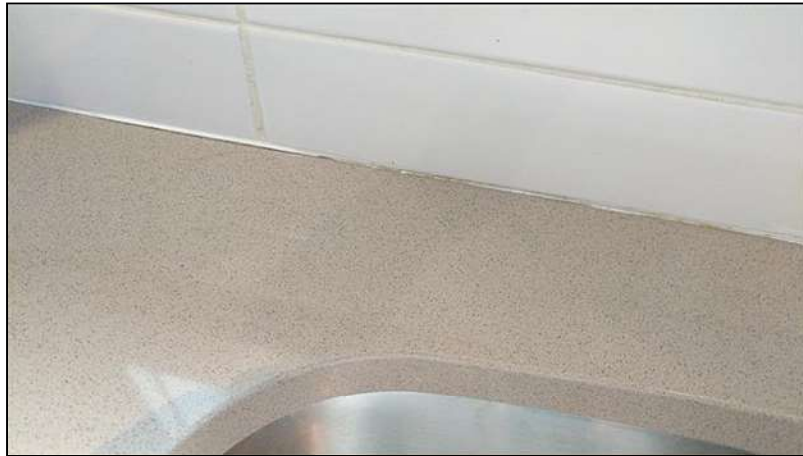
7.7 Item 1(Picture)

7.7 Counter Tops **Maintenance required. We recommend caulking the edge of the counter top and the wall/backsplash to help prevent water damage.**

**We recommend caulking the edge of the counter top and the wall/backsplash to help prevent water damage.**

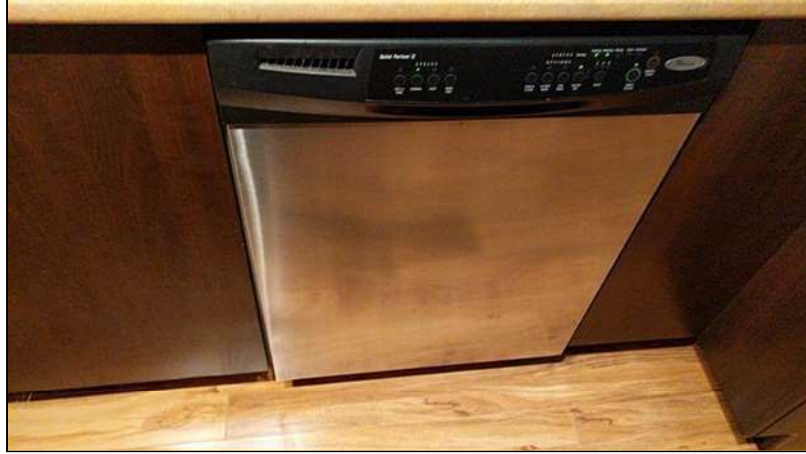
7.11 Item 1(Picture)

**Minor Case. Door springs loose, recommend corrections for proper operation.**

**Door springs loose, recommend corrections for proper operation.**

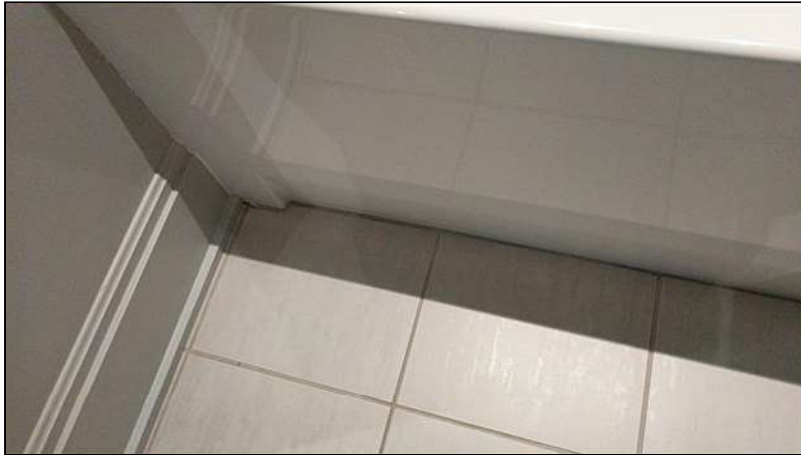
11.15 Item 1(Picture)

- 11.12 Toilet **Serviceable.**
- 11.13 Exhaust Fan **Improvement recommended. None observed, we recommend an exhaust fan be installed in all bathrooms for proper ventilation and moisture control.**
- 11.14 Tub/Whirlpool **Serviceable.**
- 11.15 Tub Surround **Maintenance required. The tile edges and base of the tub should be caulked to prevent moisture penetration. Failure to keep walls and base sealed could cause deterioration and moisture damage to the interior walls and/or floor, which is not always visible to the inspector at the time of inspection.**

**The tile edges and base of the tub should be caulked to prevent moisture penetration. Failure to keep walls and base sealed could cause deterioration and moisture damage to the interior walls and/or floor, which is not always visible to the inspector at the time of inspection.**

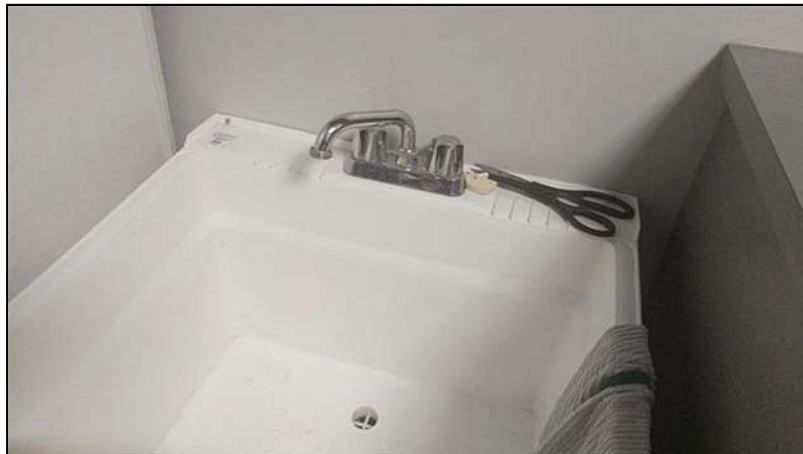
12.8 Item 1(Picture)

12.8 Sinks **Minor Case. Sink is loose, corrections are needed for proper operation.**

**Sink is loose, corrections are needed for proper operation.**

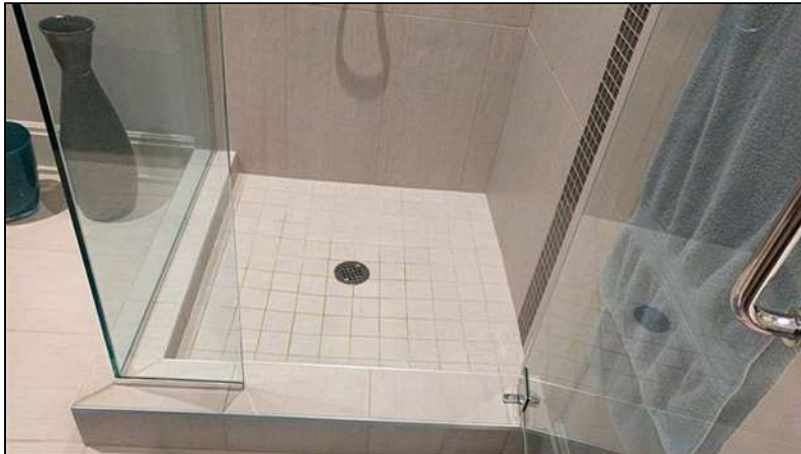
12.13 Item 1(Picture)

- 12.13 (1) Shower Base **Maintenance required. The tile edges of the shower walls/base should be caulked to prevent moisture penetration. Failure to keep walls sealed can cause deterioration and moisture damage to the interior walls, which is not always visible to the inspector at the time of inspection.**

- 12.13 (2) Shower Base **Maintenance required. Ceramic tile base. The impermeability of a shower depends on the membrane installed under the ceramics. The installed grout between the ceramic is a porous material and absorbs water and moisture. If no membrane was install plywood and drywall will deteriorate. Therefore the membrane is essential in order to ensure impermeability. During our inspection, it is impossible to check the presence of this membrane.**

**(1) The tile edges of the shower walls/base should be caulked to prevent moisture penetration. Failure to keep walls sealed can cause deterioration and moisture damage to the interior walls, which is not always visible to the inspector at the time of inspection.**

**(2) Ceramic tile base. The impermeability of a shower depends on the membrane installed under the ceramics. The installed grout between the ceramic is a porous material and absorbs water and moisture. If no membrane was install plywood and drywall will deteriorate. Therefore the membrane is essential in order to ensure impermeability. During our inspection, it is impossible to check the presence of this membrane.**
