AMERISPEC
INSPECTION SERVICES

Prepared for: Mr. & Mrs. Buyer
Property address: 123 Any Street, Kelowna BC
Inspection Date: March 01, 2019
Inspection #: 03188340
Prepared by: Murray Klingbeil CPBC#47501
Box 20035 Kelowna BC V1Y 9H2 bigmur@shaw.ca

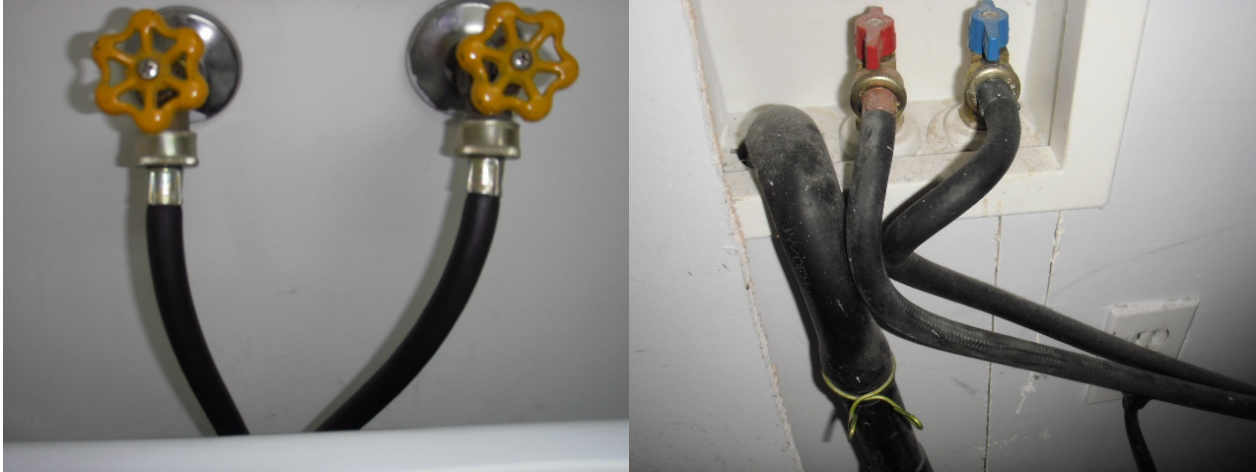
S
S **We recommend the installation of steel braided water supply lines to prevent possible leaking.**
Electric/240 volts. Appears to be vented to the exterior.
None.

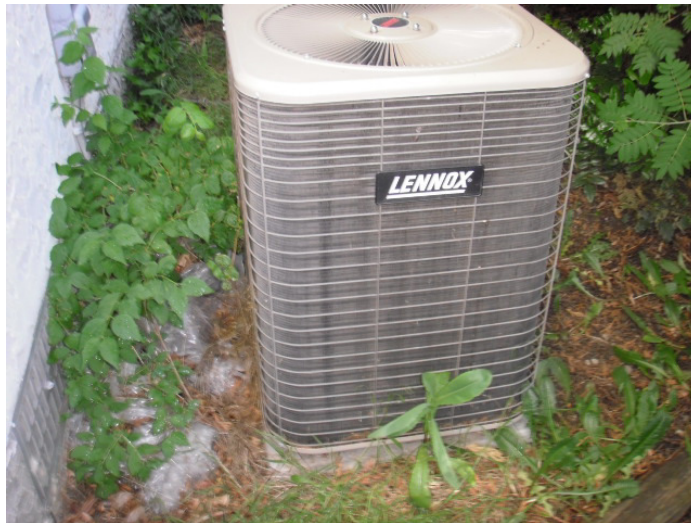
402 Air Conditioning:

Appears to be a 2002 model year "Lennox" brand, electric fired, air-cooled unit. Electrical disconnect is provided at the exterior compressor. The air conditioner was activated to check the operation of the motor & the compressor, both of which appear to be in serviceable condition.

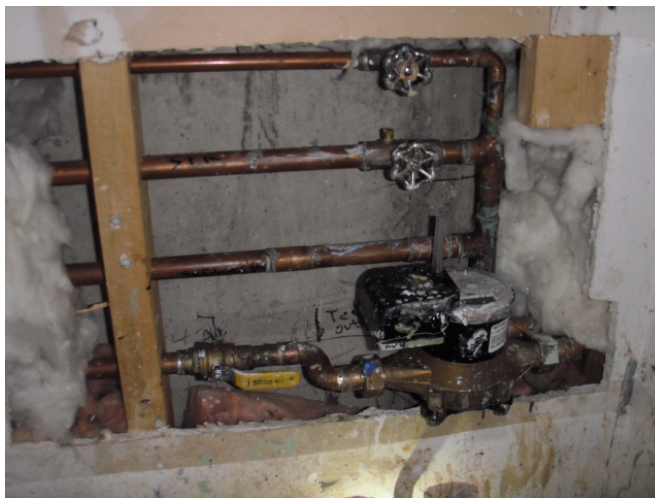
405 Plumbing:

Water supply provided by public system. Main water shut off is located at the basement laundry area. Water pressure regulator noted. Piping, where visible, is copper and plastic. **See comments #161.** We are unable to determine what type of plumbing is behind walls or ceilings. Shut off valves and angle stops under kitchen or bathroom sinks and toilets are not turned or tested during the inspection due to the possibility of leaking. We suggest all shut-off valves or angle stops be turned regularly to ensure free movement in case of an emergency.

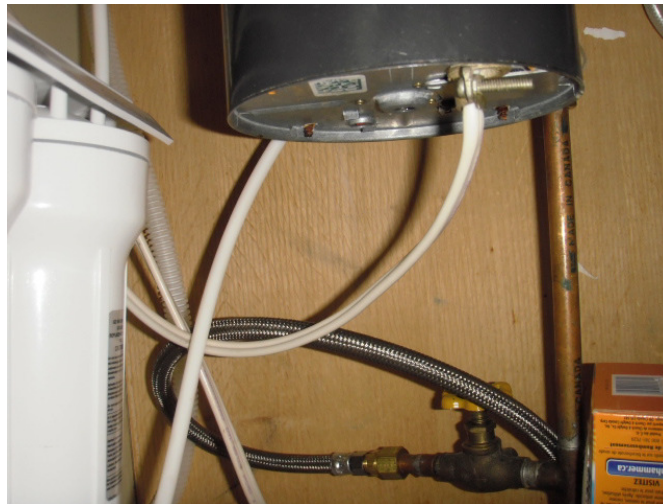
S Ideally, the power line to the disposal unit should be armoured "BX" cable or enclosed in conduit to protect from physical damage. These units are no longer allowed on municipal sewer systems.

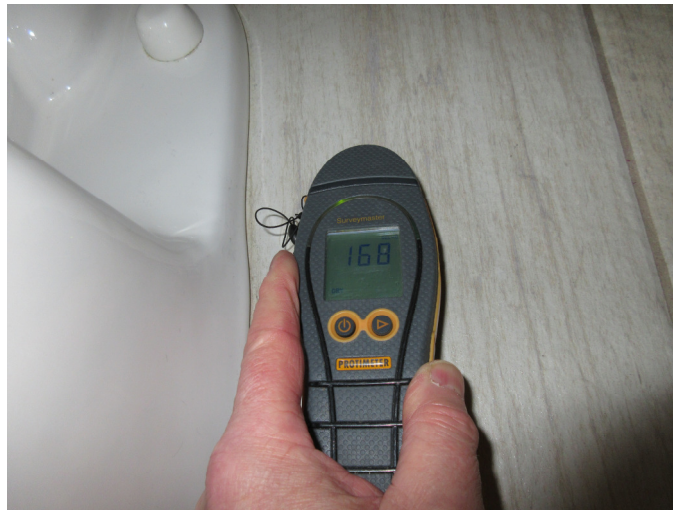
BATHROOM – MAIN LEVEL – 2PC

- 701 Floor: S
- 702 Walls: S
- 703 Ceiling: S
- 704 Doors: S
- 705 Electrical: S **We recommend the installation of a “GFI” protected outlet for added safety. See #408.**
- 706 Windows/Skylights: S
- 707 Exhaust Fan: N
- 708 Heating: S
- 715 Sink: S
- 716 Sink Faucet: S
- 717 Drain/Supply Pipes: S
- 718 Toilet: S The sub-floor around the toilet was dry when tested on the day of our inspection with a “Protometer” moisture meter.

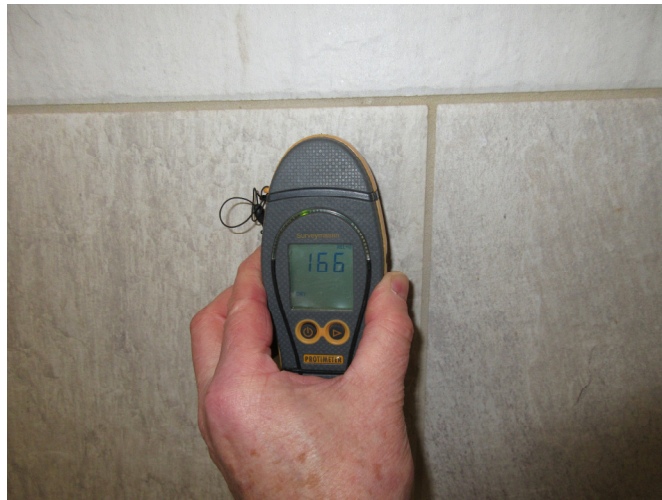
BATHROOM – MASTER ENSUITE – 4PC

- 726 Floor: S
- 727 Walls: S
- 728 Ceiling: S
- 729 Doors: S
- 730 Electrical: S **A GFCI protected outlet is provided for safety. See #408.**
- 731 Windows/Skylights: S
- 732 Exhaust Fan: N
- 733 Heating: S
- 734 Tub/Surround: S
- 735 Tub Encl.: S
- 736 Tub Faucet: S
- 737 Shower/Surround: S The walls behind the ceramic tiles in the shower were dry when tested on the day of our inspection with a “Protometer” moisture meter. We recommend re-sealing the grout as part of routine maintenance to prevent possible water penetration and subsequent damage to the inner wall.

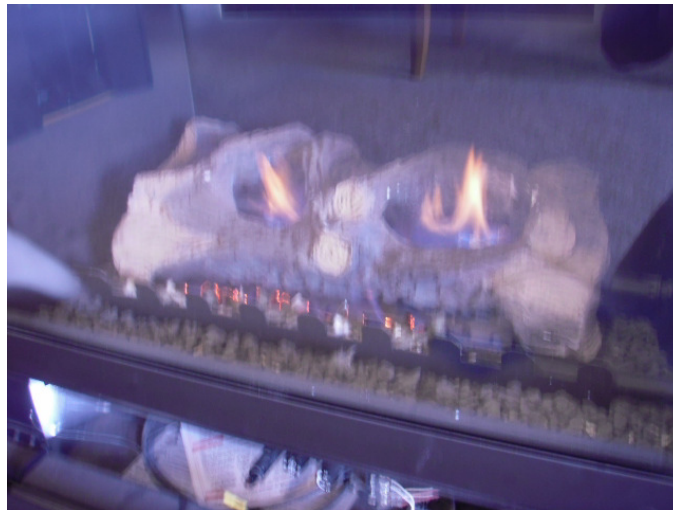
- 941 Floors: S
- 942 Walls: S
- 943 Ceilings: S
- 944 Doors: S
- 945 Window/Skylights: S
- 946 Electrical: S
- 947 Heating: S
- 948 Closets: S
- 949 Stairs: S
- 949a Railings: S
- 950 Fireplaces: S Gas burning model located at the family room. **No measureable amount of carbon monoxide was detected at the fireplace when tested on the day of our inspection with a “Universal Enterprises” brand commercial grade detector.**
