AmeriSpec Home Inspections

Doc #: 2019-07-1853 Inspector: Chris Hill

Date: 7/11/2019

Dwelling Address: 40 Groomsport Cres.
Toronto, On

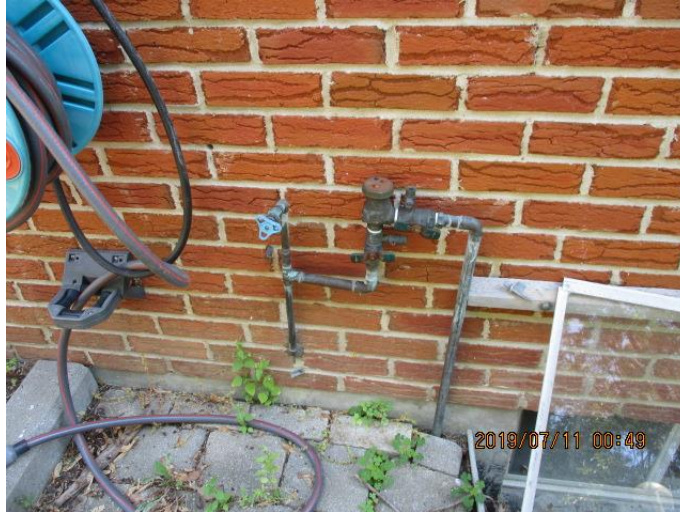
1117. Hose Bibs

At the exterior, open exterior hose bib. At the interior shut off valve there should be a small brass cap (bleeder valve) remove and let any water in pipe leading to exterior, drain out or into a hand held container. After draining replace and hand tighten the bleeder valve. Hose bibs were located at the garage and rear of the house.

We recommend proper winterizing of all your exterior hose bibs to prevent possible freezing and water damage caused by a damaged pipe. Turn off interior shut off to exterior hose bib.

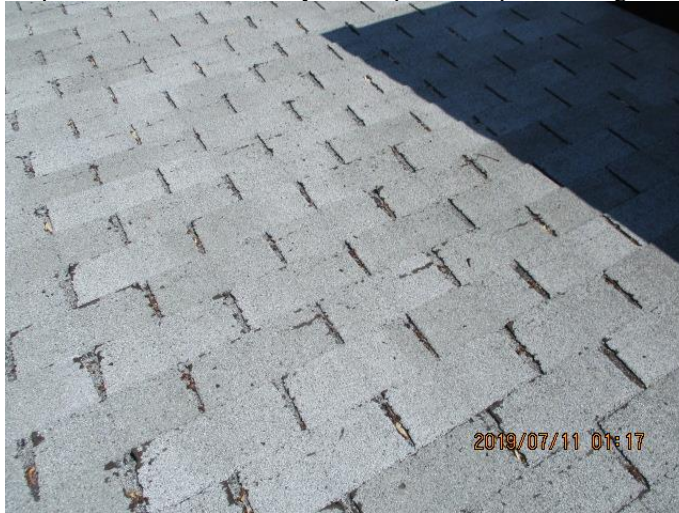
Step #	Component	Comment
1400.	Roofing Type & Materials	Sloped construction. One layer of asphalt composite shingle material.

1405.	Age	The roof covering appears to be approximately 14-16 years old. The average life expectancy of shingles of this type is 15-20 years. The roofing material shows normal wear for its age and type. We recommend consulting with a qualified roofing contractor to discuss repair/maintenance options and associated costs in the areas where materials are missing, damaged or compromised to prolong the functional life of roof and reduce the potential for roof leaks.
-------	-----	--

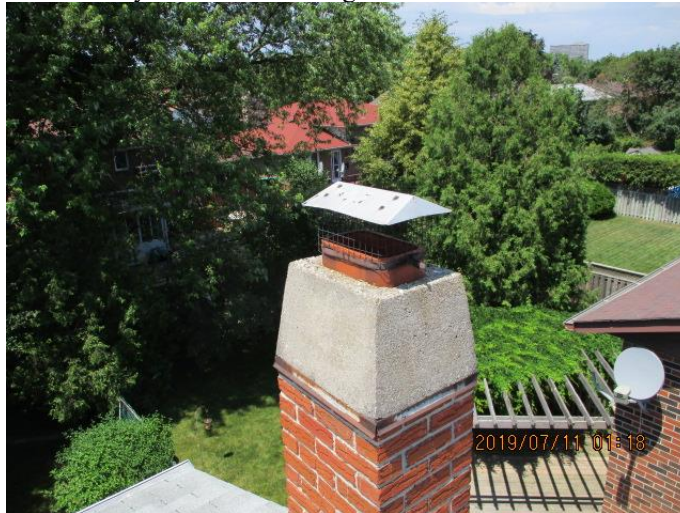
1435. Chimney

The chimney is located at the right side of the house.

A spark arrester/rain cap has been installed as a safety feature and to minimize the possibility for pest intrusion and water infiltration into the home.

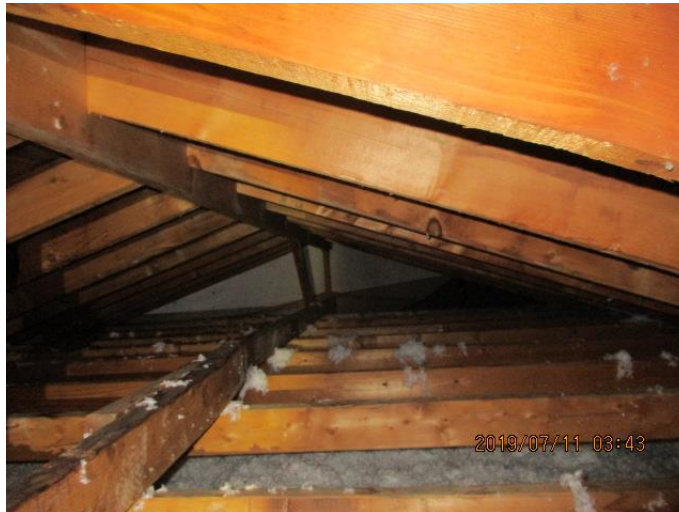
Step #	Component	Comment
1505.	Access	Attic access located at upper hallway ceiling. The attic was partially accessed and viewed from hatch area only. Entering attics that are insulated can cause damage to the insulation and attic framing. In addition attics with insulation cannot be safely or completely, inspected due to the limited visibility of the framing members. Based on this our review of the attic space is limited to visually accessible areas as observed from the hatch only. Missing weather-stripping noted around the attic access hatch. We suggest installing foam weather stripping and hooks and eyes to provide a tight seal to the attic for energy efficiency. No insulation was noted above the access hatch. We suggest having rigid type insulation installed to increase energy efficiency.
1510.	Framing	Rafters.

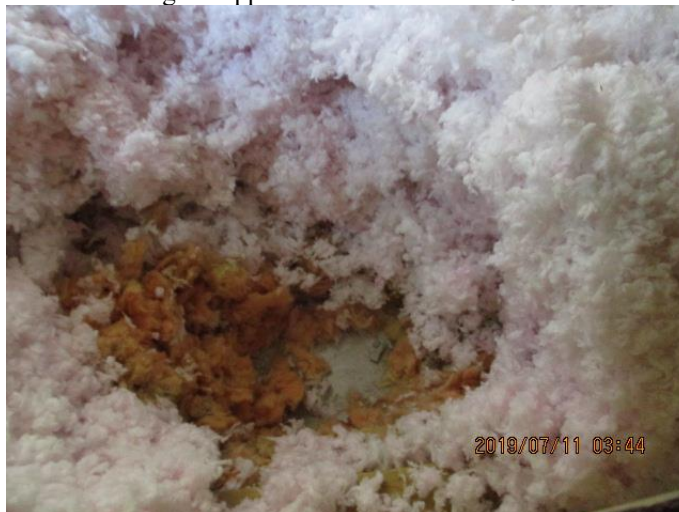
1525. Insulation Blown in fiberglass approximate thickness is 10" to 12".

Approximate thermal resistance value is up to R32. Plastic air/vapour barrier noted under the insulation. Due to insulation covered conditions, we were unable to determine the continuity of the barrier. R Values obtained with current insulation are below modern standards. We recommend increasing the quantity of insulation to modern standards as an energy conservation measure and to assist with the prevention of ice damming.

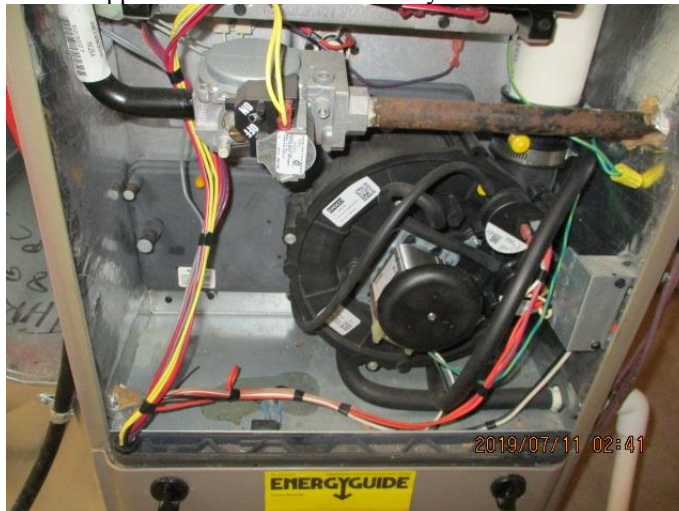
Step #	Component	Comment
1605.	Fuel/System Type	Gas. Forced air system.
1610.	System Description	High efficiency (or condensing) system noted. A high-efficiency furnace has an annual fuel utilization efficiency (AFUE) rating of 90% to 97%. Typical life expectancies for this type of system range from 15 to 25 years when the system is properly serviced and maintained. Based on observations made at the time of the inspection, information provided by the Current Owner or found on the unit's manufacturers tag, the unit appears to be on the order of 7 years old.

Gas shut off and electrical disconnects provided.

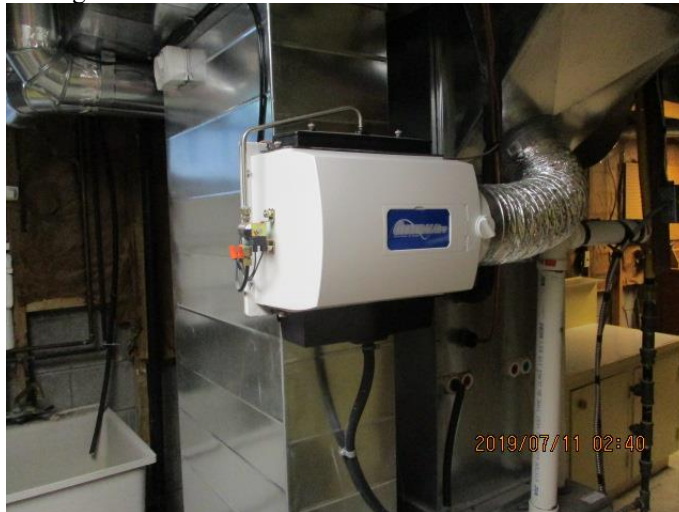
- A humidifier system is connected to the home's air handling system. In accordance with the CAHPI Standards of Practice, inspection of humidifier systems is not within the scope of a home inspection. We recommend consulting with the current owner or a qualified contractor to determine/obtain operations and maintenance information associated with the humidifier.
1620. Condition At the time of the inspection the heating equipment tested operable under normal operating controls. No evidence of any obvious significant corrosion or deterioration was observed at the time of the inspection.
1625. Exhaust Venting Plastic vent piping noted.
1630. Thermostat Thermostat located at the main hallway. Programmable thermostat present. We suggest you reprogram the thermostat to your family's requirements.
1635. Distribution Appears intact. We recommend that all ventilation ducts/piping be cleaned as part of routine maintenance in order to maintain optimum working operating conditions and good air quality.

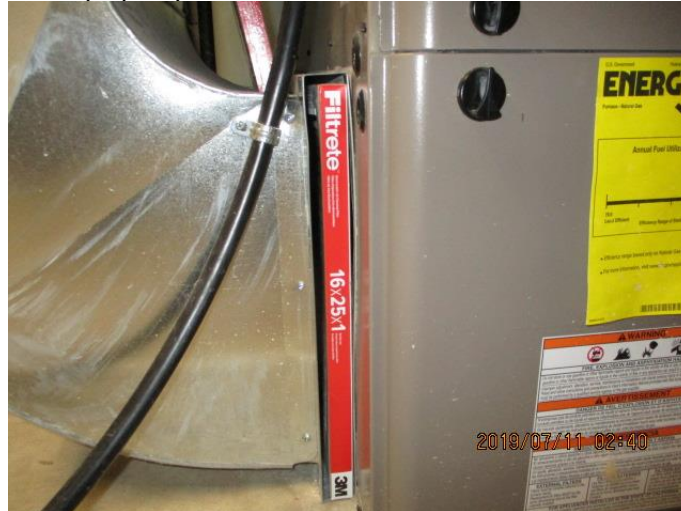
1640. Maintenance

We recommend that the client commence an annual maintenance, cleaning, and parts service/replacement program with the local utility company or a qualified heating contractor in order to keep the heating equipment in optimum and safe working order. We recommend cleaning/replacing the furnace filter on a regular basis to optimize the unit's operating efficiency and life expectancy. We recommend that the client consult with the current owner and obtain any documentation and service records that may be available for this system. If recent service records cannot be produced (i.e. completion of service within the past year), the furnace should be serviced by a qualified heating contractor to ensure proper operation. Filter 16 x 25 x 1

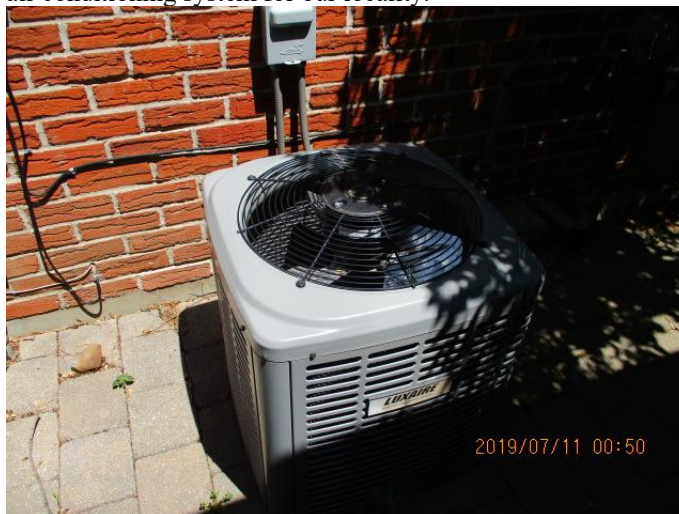
Step #	Component	Comment
1705.	Description/Conditions	The air conditioning system is electric. The condenser/compressor components of the air conditioner are located at the left side of the house of the home. The air conditioning system is electric. This is a split system where the condensing unit, (located on the exterior of the house), works in conjunction with the furnace fan to deliver cooled air throughout the house via the heating ducts. This is the standard type of air conditioning system for our locality.

An electric disconnect was noted for this equipment. We recommend maintaining disconnect in a secured (i.e. cable tied or locked) state to prevent tampering.
1710.	Age/Life Expectancy	Based on the information observed on the air conditioner manufacturer's tag or information provided by the current owner, the unit appears to be on the order of 7 years old. The average life expectancy of a unit of this type in this geographic location is about 15-20 years.
1715.	Test Status	The air conditioner was tested under normal operating controls at the time of the inspection to check for functionality of the system. At the time of the inspection the air conditioner appeared to be operable under normal operating controls. It is noted that a detailed review of the cooling capacity of this unit is beyond the scope of the inspection; we therefore cannot make any warranty as to the system's adequacy.

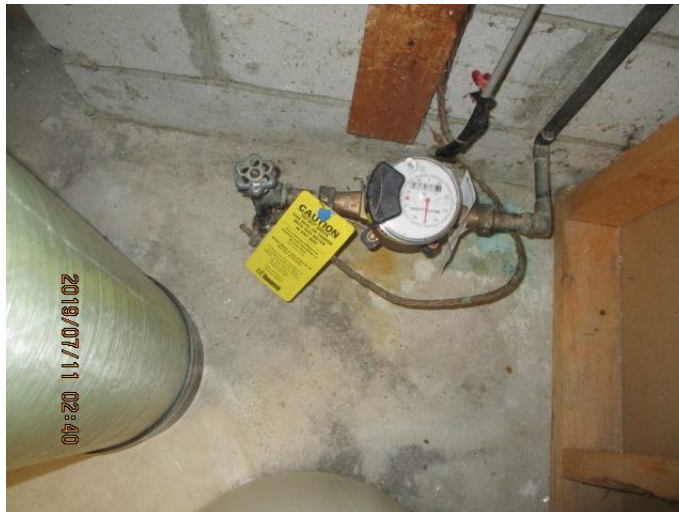
Step #	Component	Comment
1805.	Water Supply	Water supply to the home is from a public system. The main water shut off is located at the furnace area.

We recommend testing water shut off valve to ensure proper operation in case of emergency. Lubricate valve with penetrating oil and/or grease, shut off valve and proceed to the highest faucet open and allow water to stop. This will verify water shut off is functioning properly. Water filtering equipment installed in the home are beyond the scope of the inspection. We recommend further review and service as needed to ensure proper safe operation. No water softener was present in the home at the time of the home inspection. Due to the presence of scale and mineral deposits on some of the plumbing fixtures in the home and/or the known elevated concentrations of hardness compounds (calcium and magnesium), we recommend consulting with a qualified water treatment specialist for further assessment and to determine water softener installation options and associated costs.

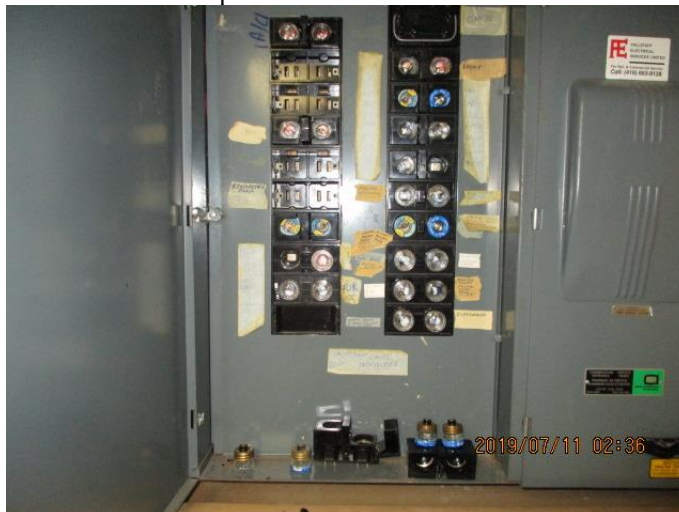
1910.	Main Service Panel	The main electrical panel is located at the left basement.
-------	--------------------	--

Overload protection of the main service wires is provided by fuses. Main disconnect noted. The main conductor is copper. The system appears to be properly grounded.

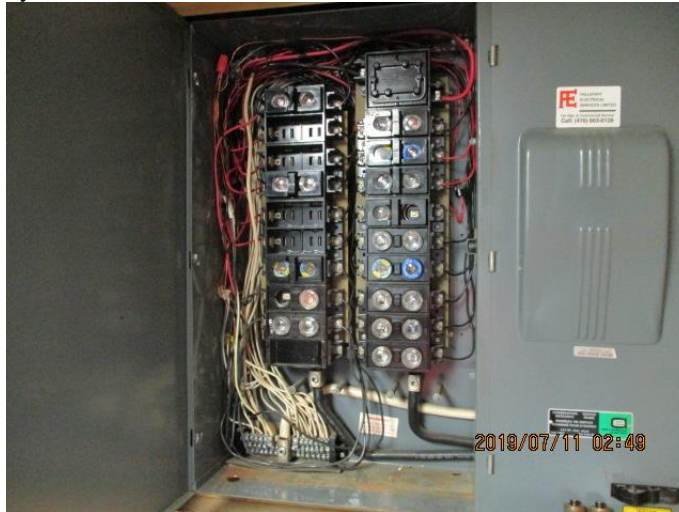
1915. Distribution Panel The electrical distribution wiring in the home is of copper composition. Overload protection of the distribution wiring in the home is provided by fuses.

Ground Fault Circuit Interrupters (GFCIs) are special electrical devices that shut the power off to a circuit when as little as 0.005 amp of electricity is leaking from the electrical system. GFCIs/GFIs may be incorporated into circuit breakers or outlets. GFCIs/GFIs should ideally be installed on all outdoor outlets and bathroom outlets to enhance safety and where electricity may be in close proximity to water. One or more of the metal knock outs were missing from the electrical panel. This is an unsafe condition as it allows access to the live buss bars and possible shocks. We suggest that new cover plates be installed for safety.

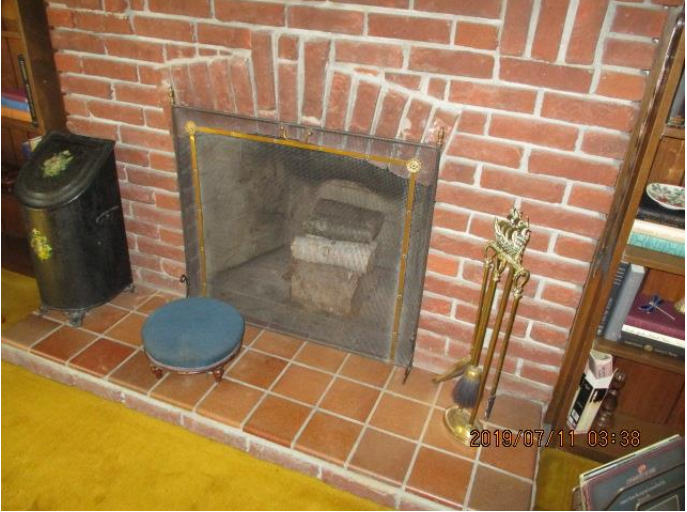
Step #	Component	Comment
2105.	Location	Fireplace is located in the main floor family room.

2110.	Type	Unit is a wood burning fireplace.
2115.	Condition	Fireplace damper was operable at time of inspection. Due to the inaccessible nature of chimney flues, our inspection of the clay flue tiles for signs of cracking, deterioration, or evidence of previous chimney fires is extremely limited. We recommend having the flue professionally cleaned and inspected by a qualified Wood Energy Technology Transfer (WETT) contractor prior to using the chimney to ensure safe and proper flue conditions.
