SUMMARY REPORT

AmeriSpec Inspection Services of Hamilton, Brantford and Stratford
32 Livingstone Cres
Cambridge ON N3H 5S7
226-341-9569

URGENT REVIEW SUMMARY

Doc #: 010621SH2

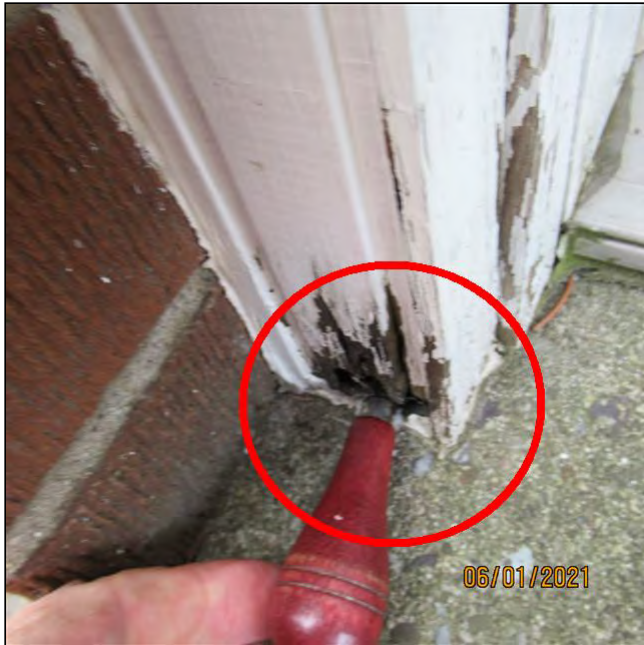
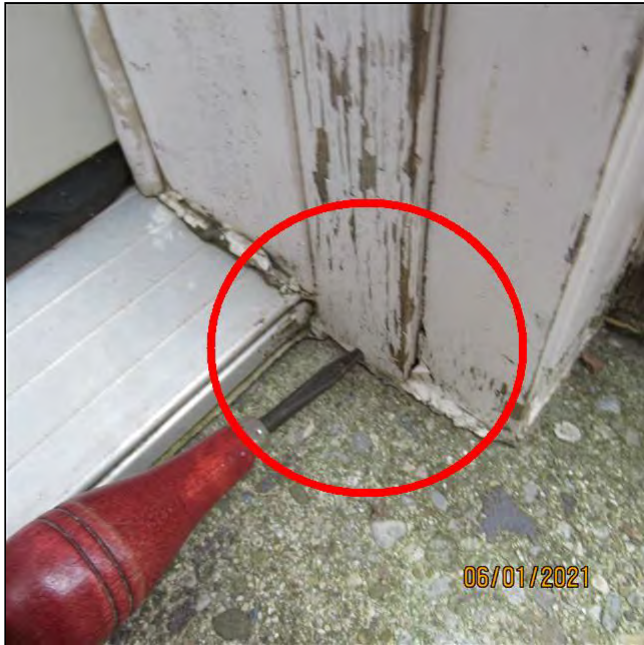
(3) Moisture damage, wood rot, observed at rear entry door and left side garage entry door (frame and trim). We recommend review for repair as necessary.

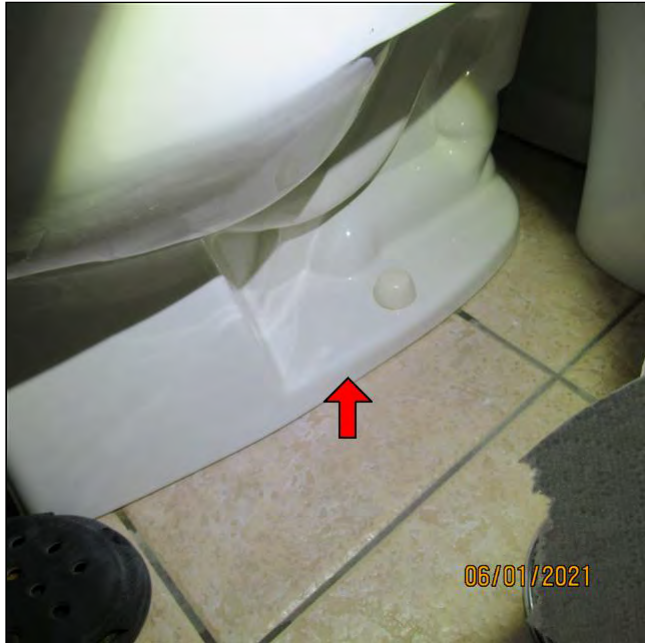
8.17.C Item 1(Picture)

The toilet bowl is loose at floor anchor bolts. The wax ring inside the unit must have a snug, secure fit in order to keep from leaking. Properly resealing and re-securing this unit is suggested to prevent water leakage and damage to the sub-floor area. This type of damage is not always visible or accessible to the inspector at time of inspection. Recommend review by a qualified plumber for repair or replacement, as necessary.

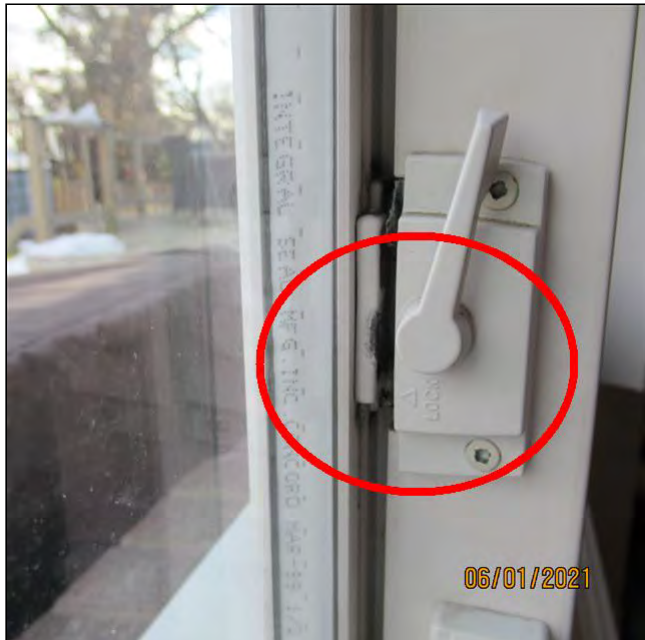
11.4 Item 1(Picture)

(1) The sliding window latching hardware is inoperable in the family room. We recommend corrections as needed for proper operation.

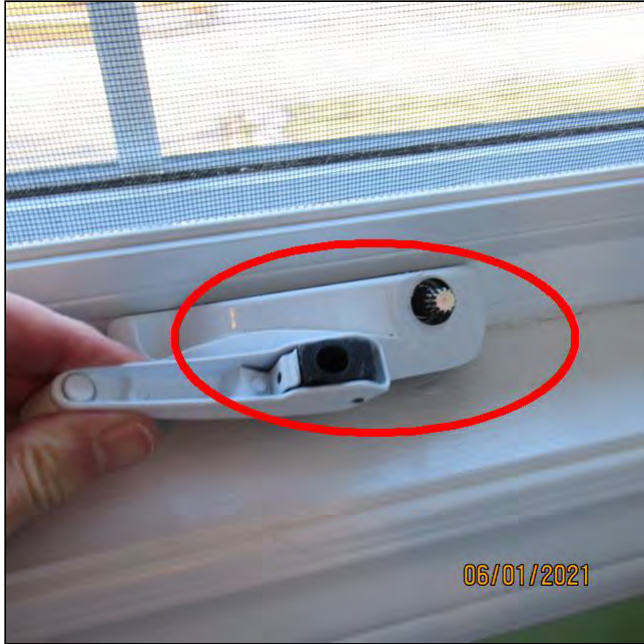
11.4 Item 2(Picture)

(2) Crank mechanism is not operational at the front left bedroom. Hardware repair/replace is needed for proper operation.

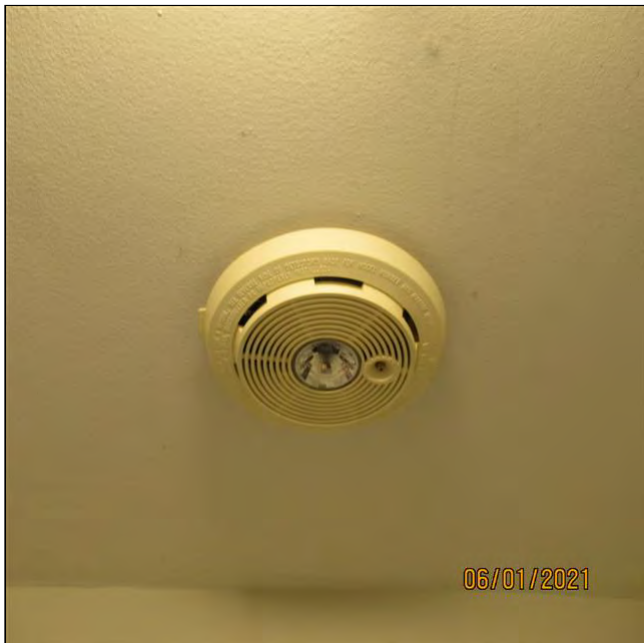
11.5 Item 1(Picture)

In the inspectors opinion the smoke detector(s) are near the end of their useful life due to age. Smoke detectors are required on all levels of the home and carbon monoxide detectors are required in the proximity of all bedroom areas. We recommend replacement for safety and for regulatory compliance.

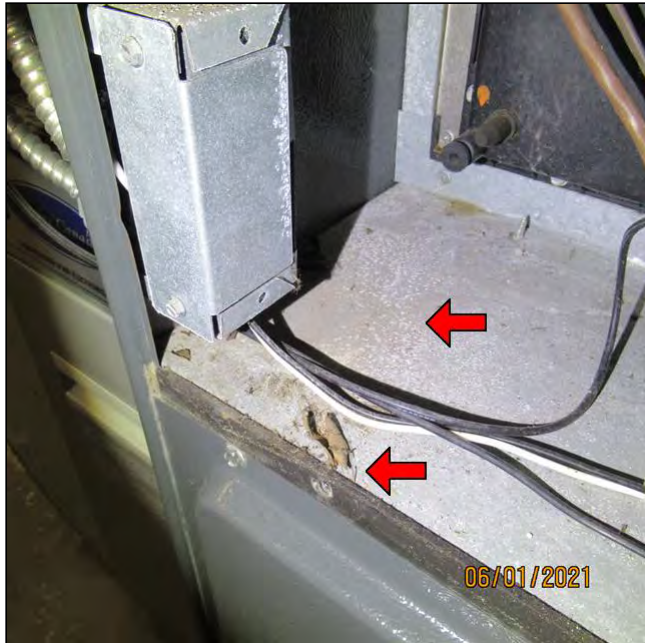
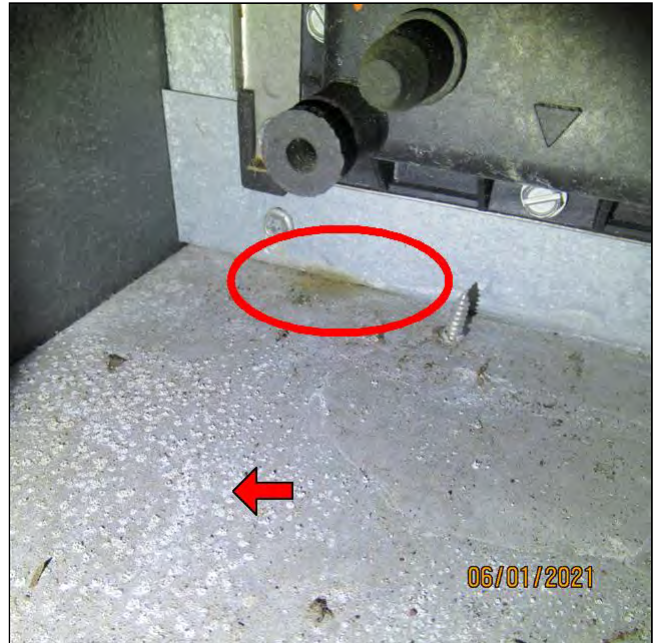
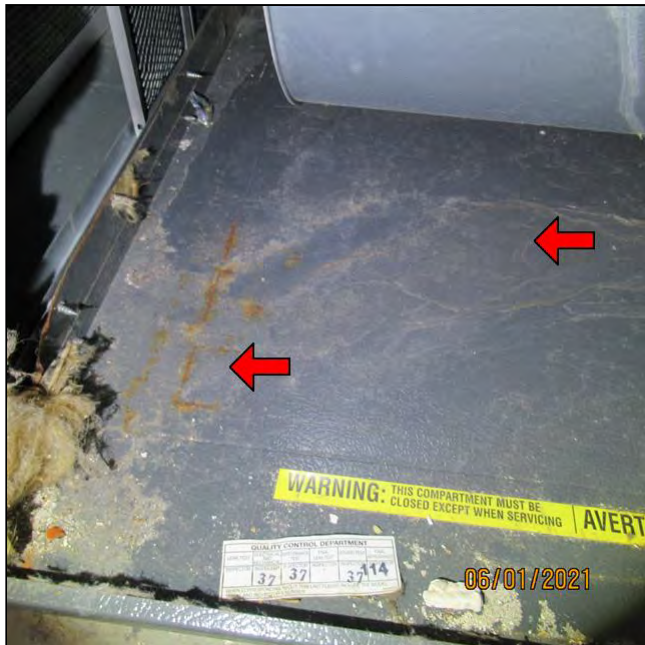
(2) Based upon the conditions observed at the time of the inspection (dust and debris in the furnace cabinet, rust staining and condensate staining in the filter cabinets, rust in the combustion and heat exchanger), we recommend review by a licensed HVAC contractor for repair or servicing, as necessary, prior to close.

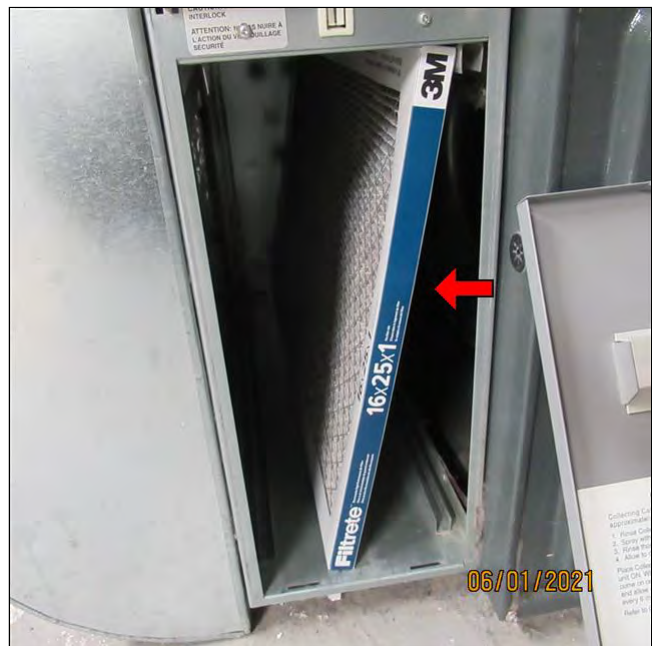
An electronic air filter was observed at this unit. This type of filter systems is not within the scope of this inspection. The unit was turned off and the filter elements were stored behind the furnace. A improperly fitted disposable filter was placed in the filter cabinet. The client is advised to consult seller's to ensure proper operation.

12.5 Item 2(Picture) Poorly fitting disposable filter media

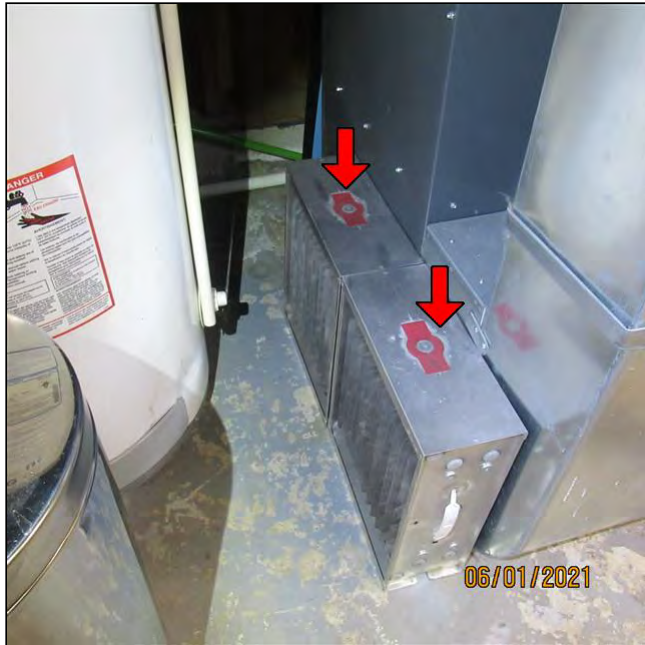
12.5 Item 3(Picture) Electric filter elements

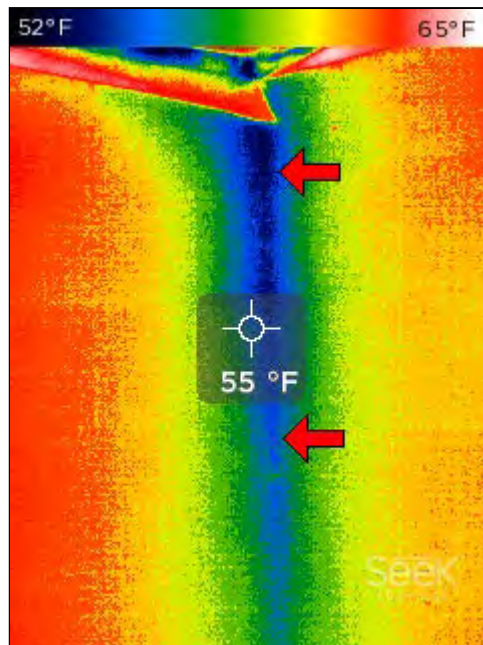
(1) Water staining and efflorescence observed at crawlspace (corners); this is a mineral deposit left behind from exterior water infiltration. We recommend consulting sellers as to moisture problems in these areas, and correct the exterior grading around the foundation in these areas to ensure effective drainage away from the foundation.

13.2 Item 2(Picture) Water infiltrating into the foundation from the exterior results in cooling of the wall

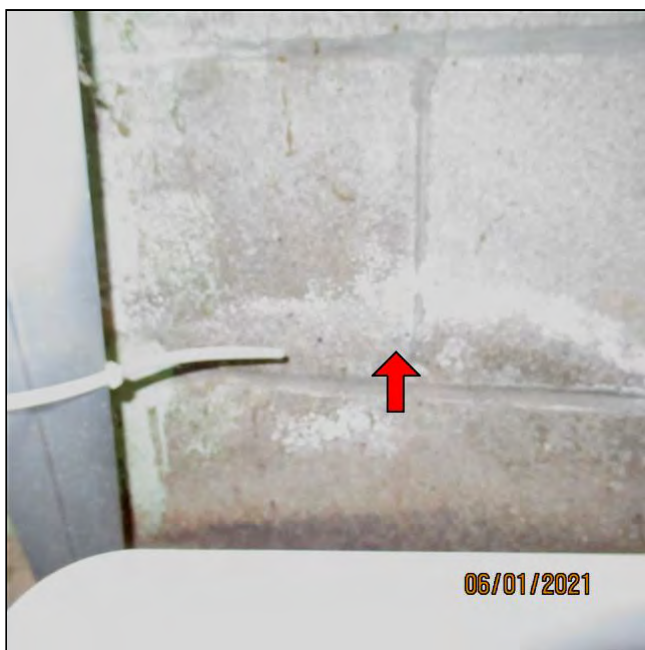
13.2 Item 5(Picture) Laundry wall

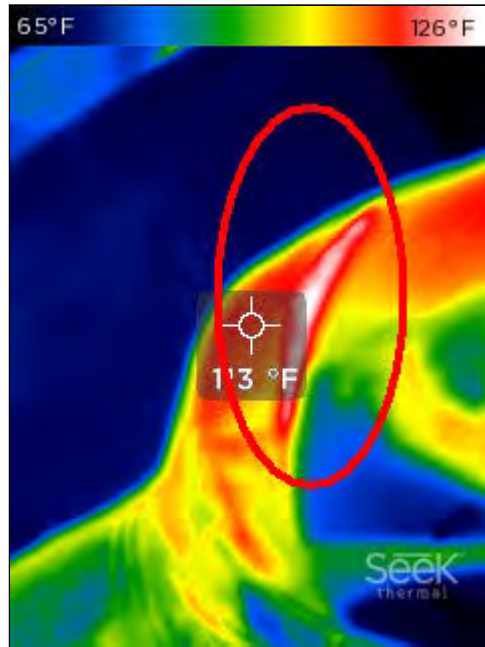
Vent pipe is disconnected or poorly fitted, which is a safety concern. We recommend review for repair or replacement, as necessary, prior to close.

16.2 Item 2(Picture) Combustion air escaping from the water heater vent pipe

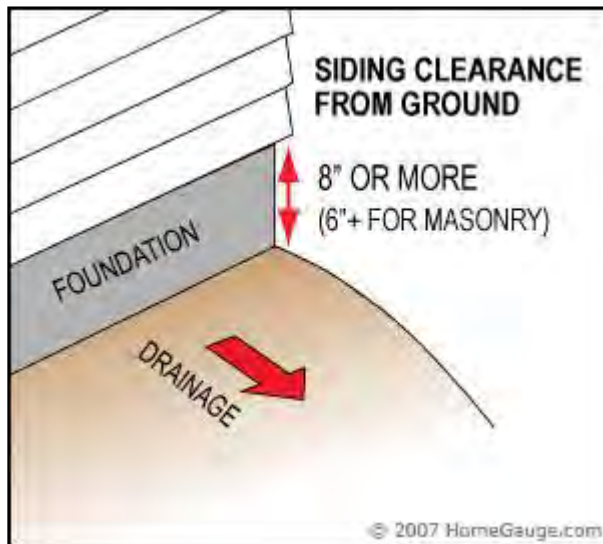
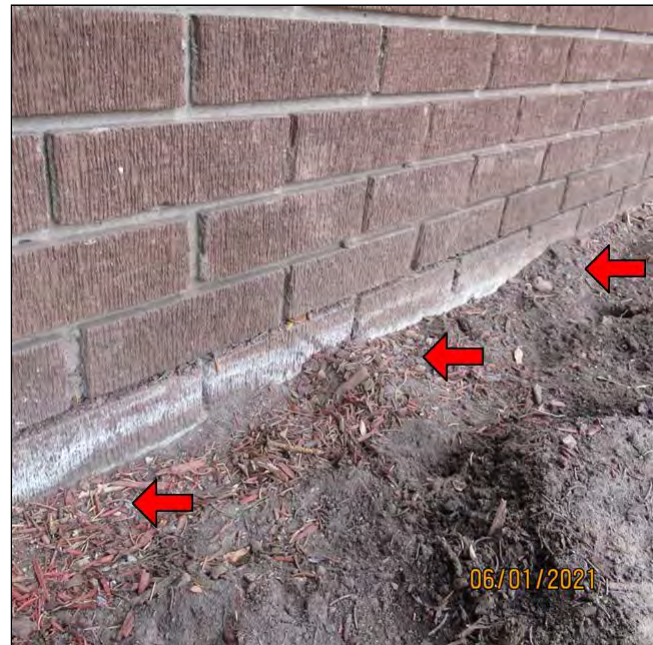
(3) Portions of the brick at front are in direct contact with the ground (front garden). This can cause accelerated deterioration of the brick, possible water intrusion at the rim plate and a higher probability of pest infestation. We recommend corrections to limit further damage/deterioration.

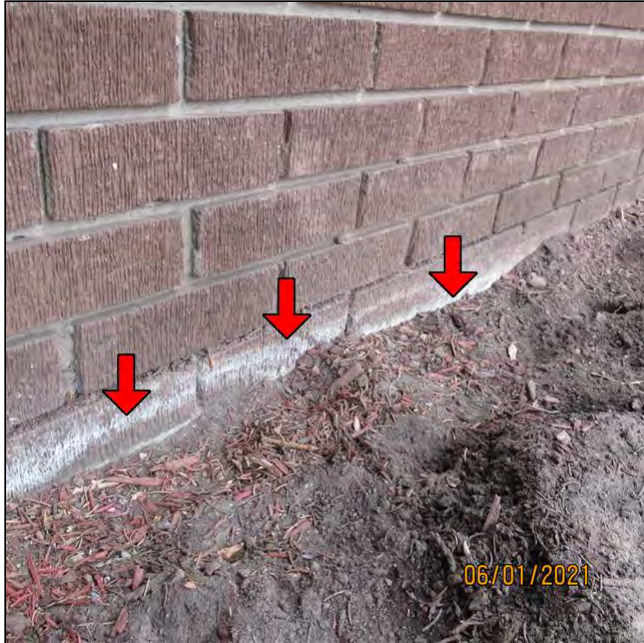
1.2 Item 4(Picture)

(4) Efflorescence observed at front brick above the garden; this is a mineral deposit left behind from exterior water movement through the brick. We recommend lowering the garden to maintain a 6 inch gap between the ground and the brick.

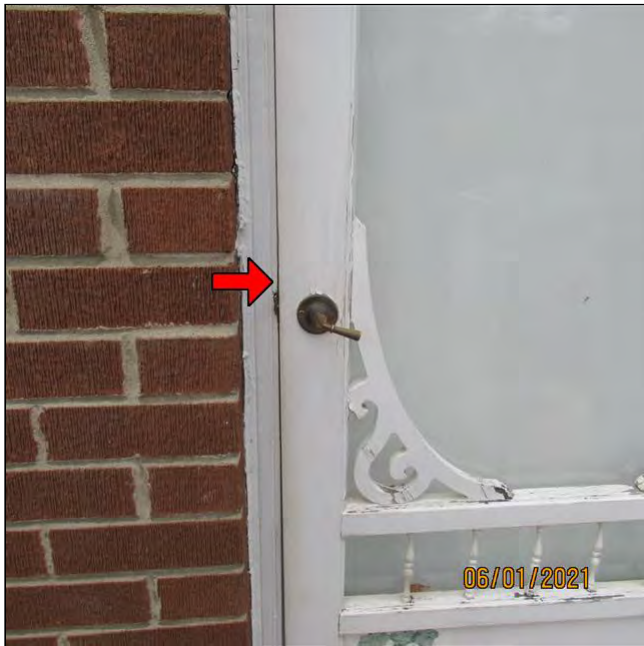
1.5 Item 4(Picture)

(2) Rear entry screen door does not close properly. Adjustments are required to restore proper operation.

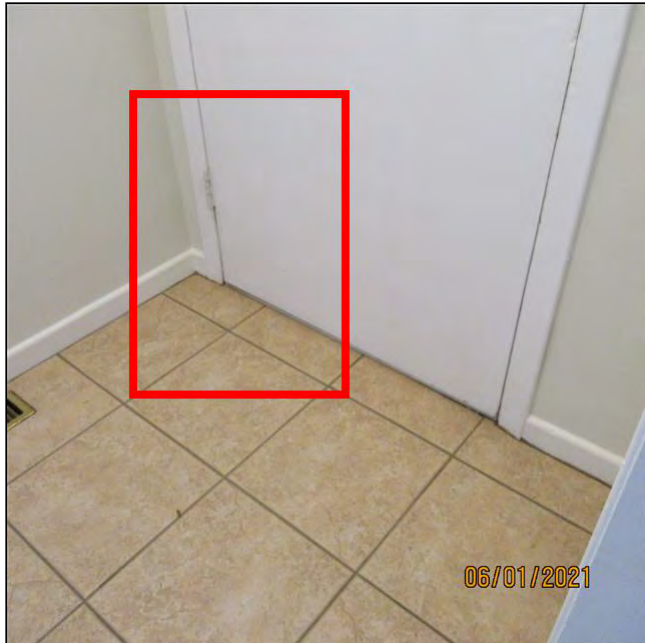
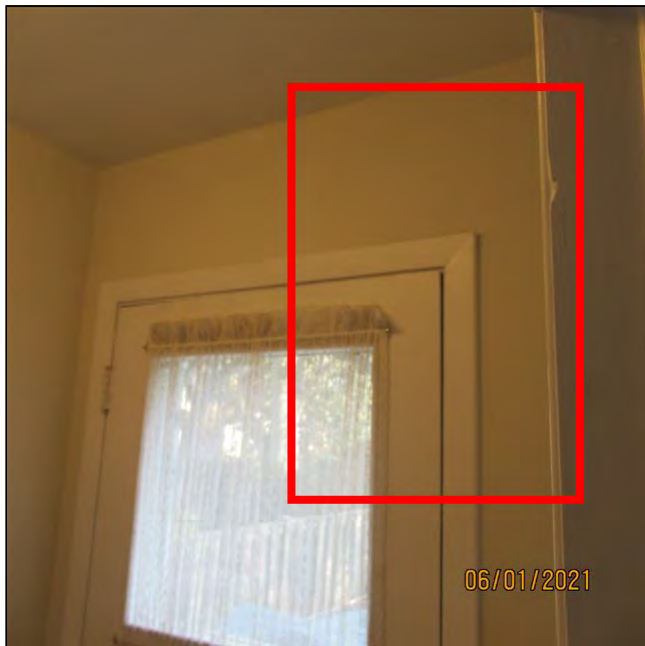
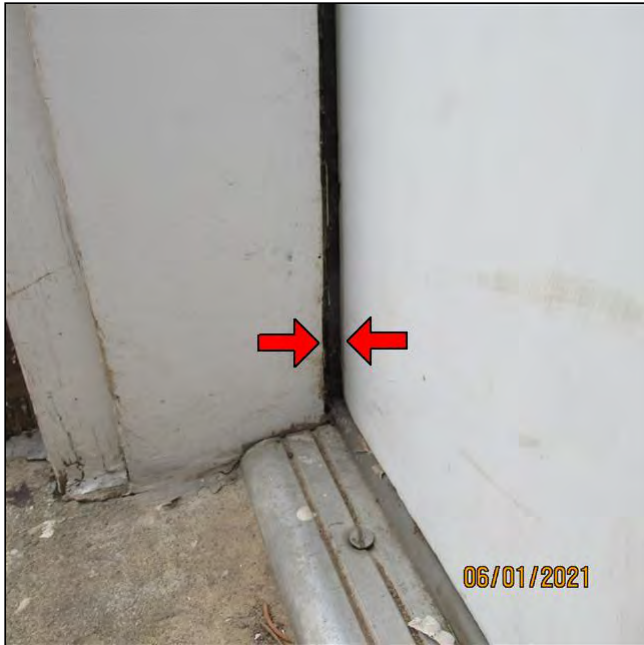
(5) Rear entry wood door is warped and does not contact the weather sealing uniformly. Air intrusion observed around the door where the weather seal is failing. We recommend review by a qualified contractor for replacement to restore energy efficiency and home comfort.

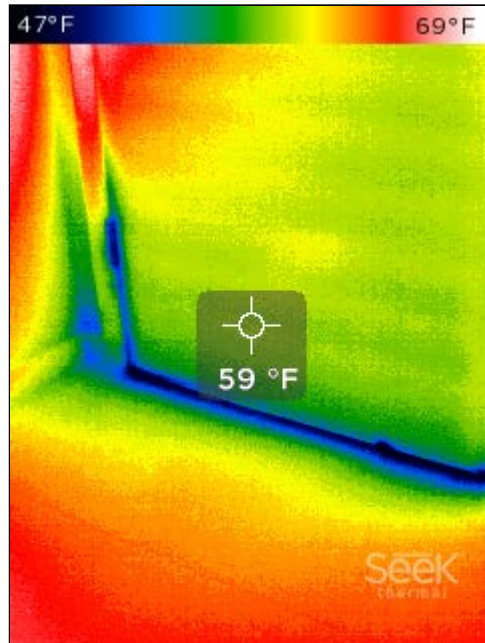
1.5 Item 9(Picture) Air infiltrating under the rear entry door

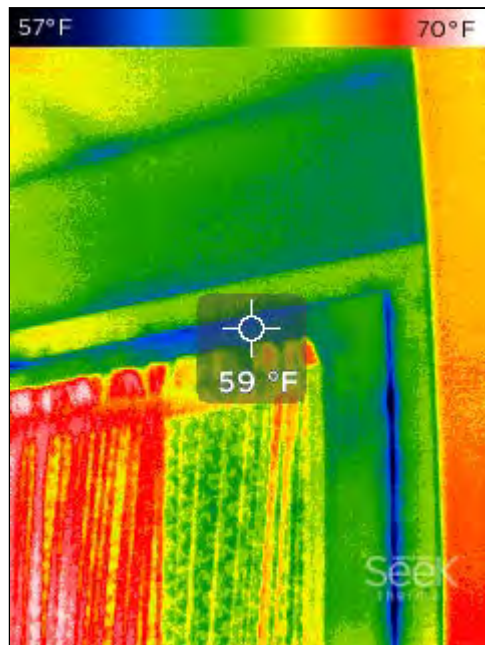
1.5 Item 11(Picture) Air infiltrating around the rear entry door

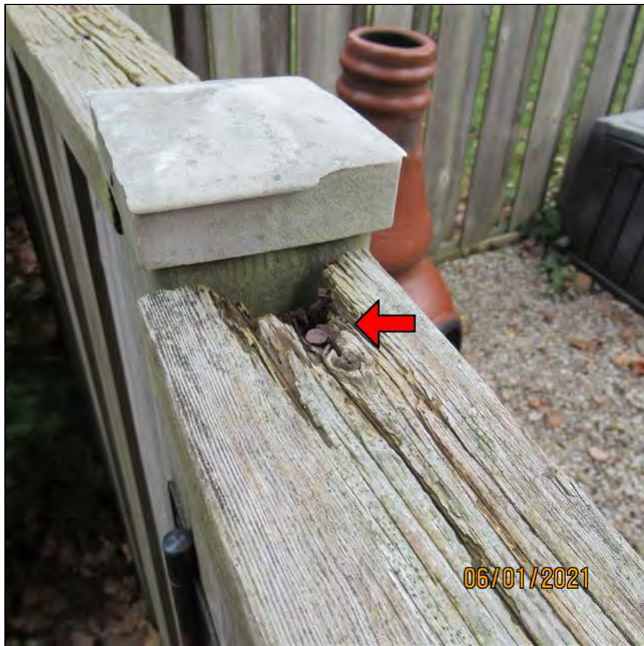
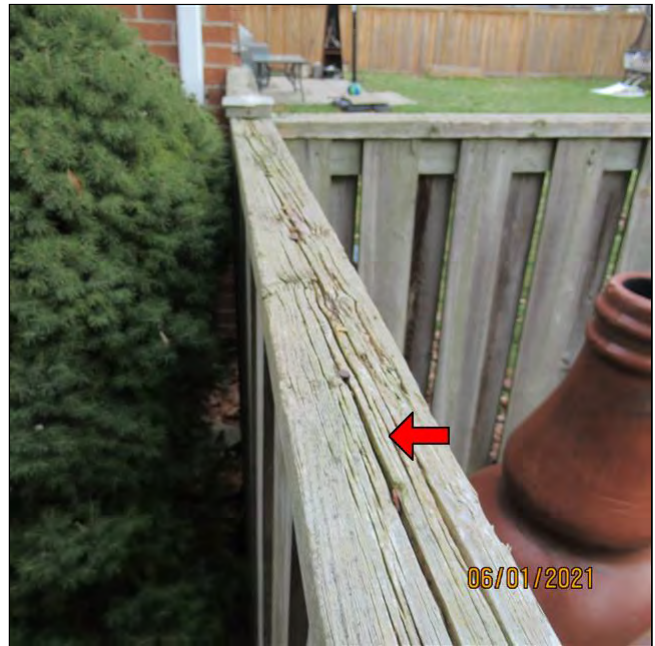
Wood deterioration observed at the left side gate and fence top rail. We suggest repairs/replacement as needed.

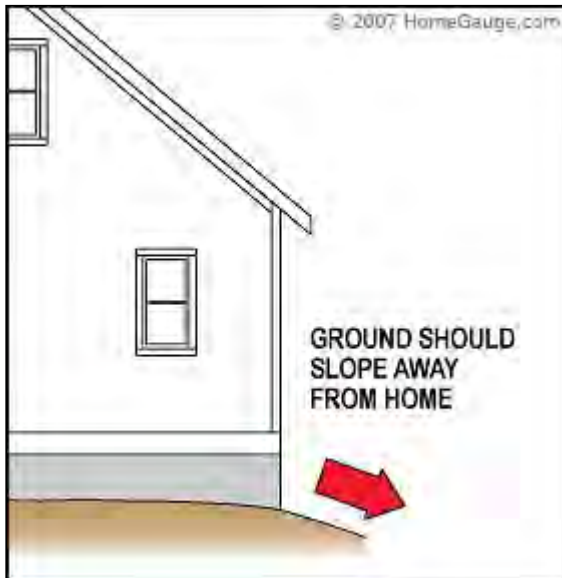
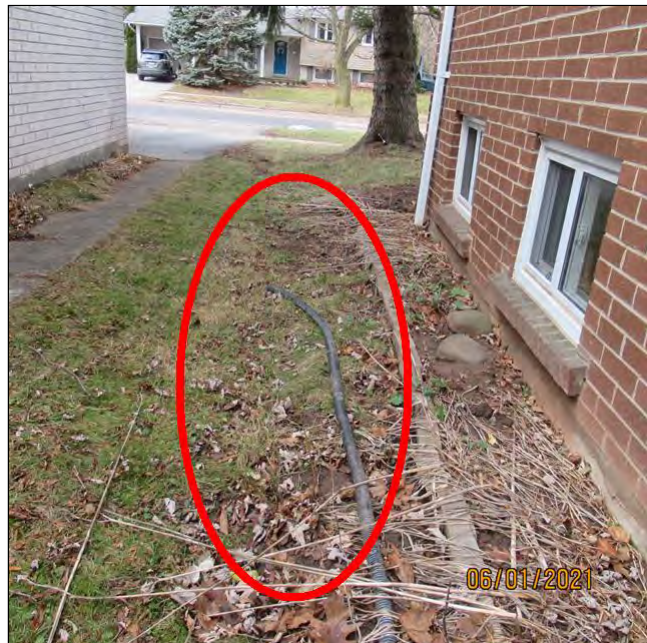
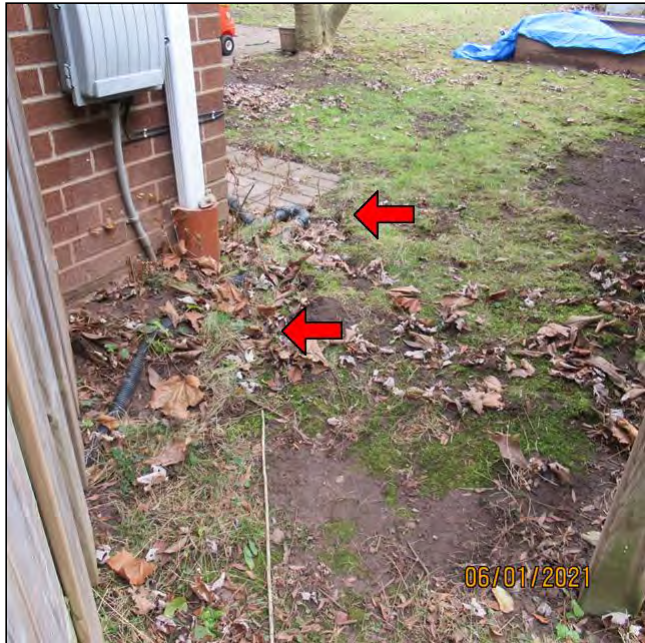
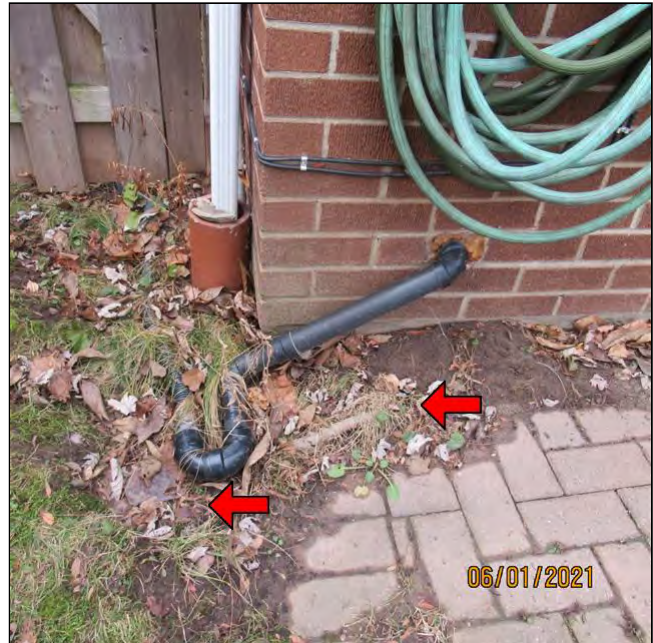
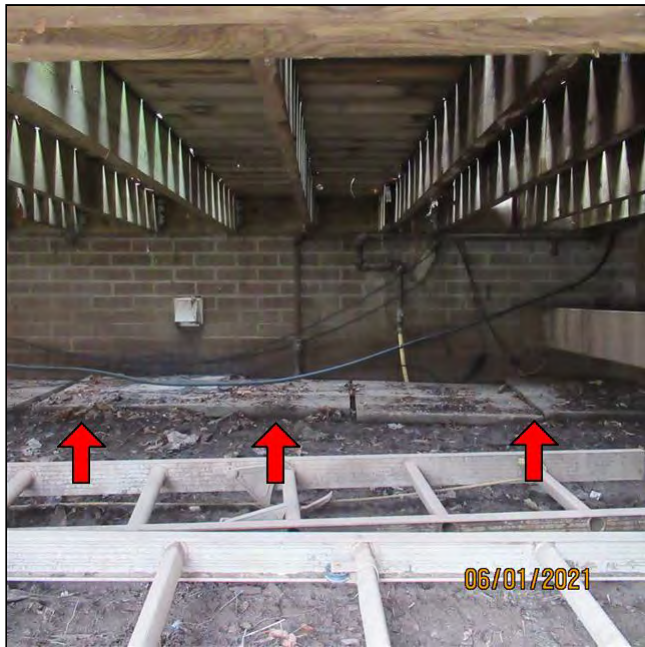
The grade at the foundation appears to be inadequate at right side and rear. We recommend monitoring water flow patterns during heavy rainfall and snow melt events to determine how water flows around the foundation. Water should flow freely away from the foundation and off the property to limit water pressure on the foundation. We recommend changing the grading around the foundation to ensure effective water drainage away from the foundation.

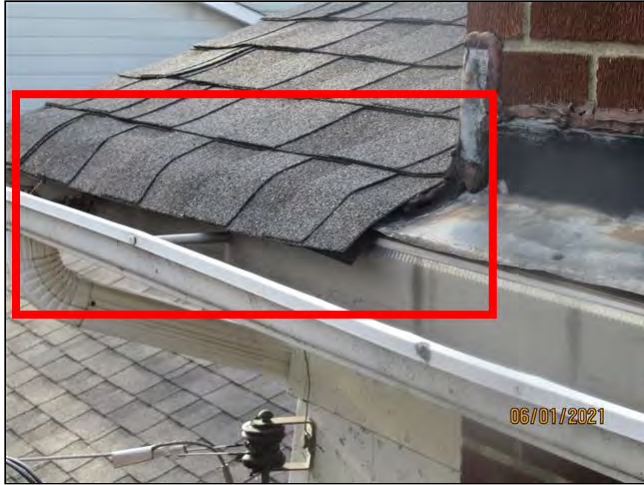
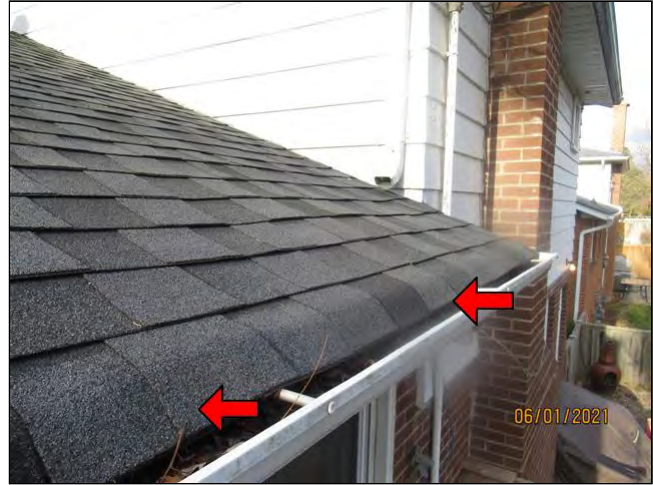
(1) Excessive shingle overhang observed. Shingles should not extend more than 3/4" (19 mm) past the drip edge. If shingles overhang the edge of the roof by more than 3/4" (19 mm), then they are not supported and may crack and break off. In addition, the wind resistance at the roof edge may be compromised. We recommend review by a qualified roofer for corrections as necessary.

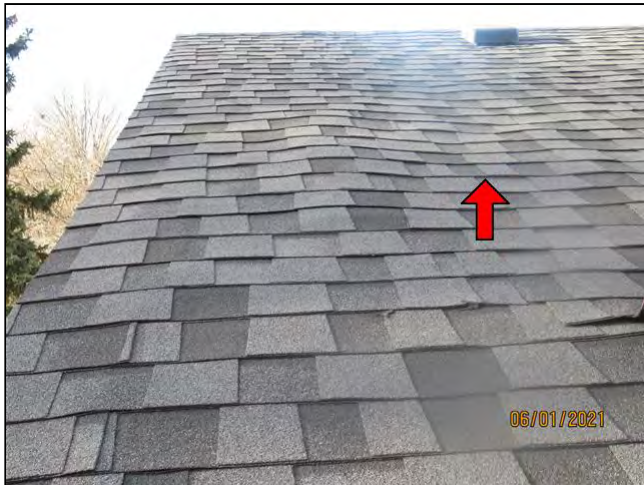
2.0 Item 3(Picture)

(2) Sagging noted in the roof decking. We are unable to determine the cause of the sag; may be associated with deterioration of the roof sheathing observed in the attic. We recommend consulting with a licenced roofing contractor for further review and repair, as required.

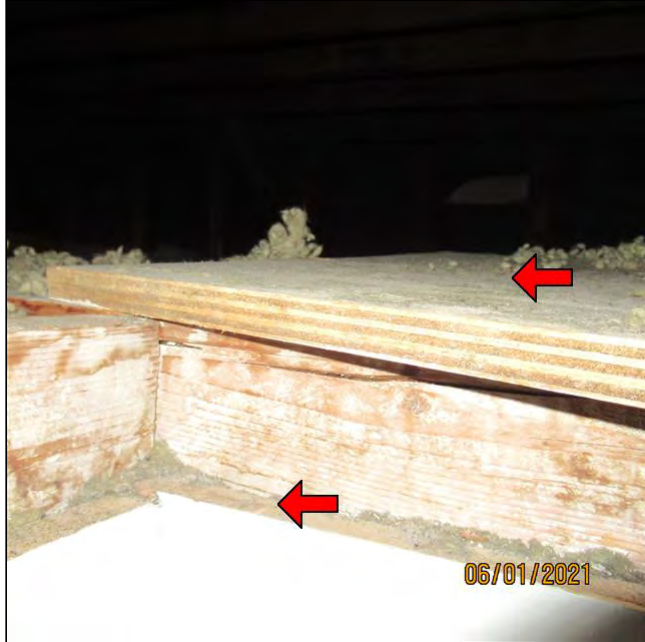
6.0.A Item 1(Picture)

(2) Missing or low levels of insulation and weather sealing on the attic hatch. We recommend properly insulating and weatherstripping the hatch for improved energy efficiency and to limit warm moist air escaping into the attic space.

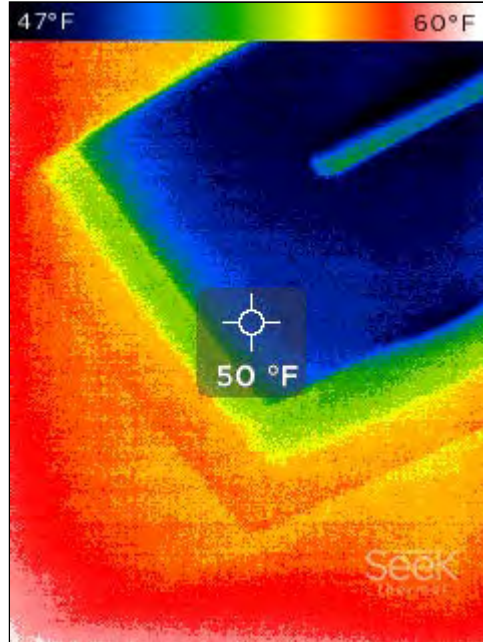
6.0.A Item 2(Picture) Attic hatch with no insulation is chilled by the attic air

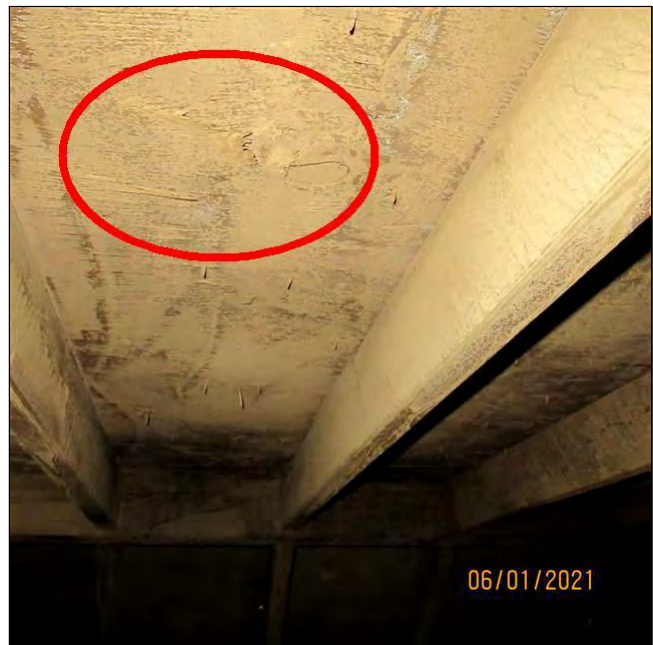
6.1.A Item 2(Picture)

(1) Cracked, warped plywood decking observed. Recommend review by qualified professional for repair or replacement as necessary.

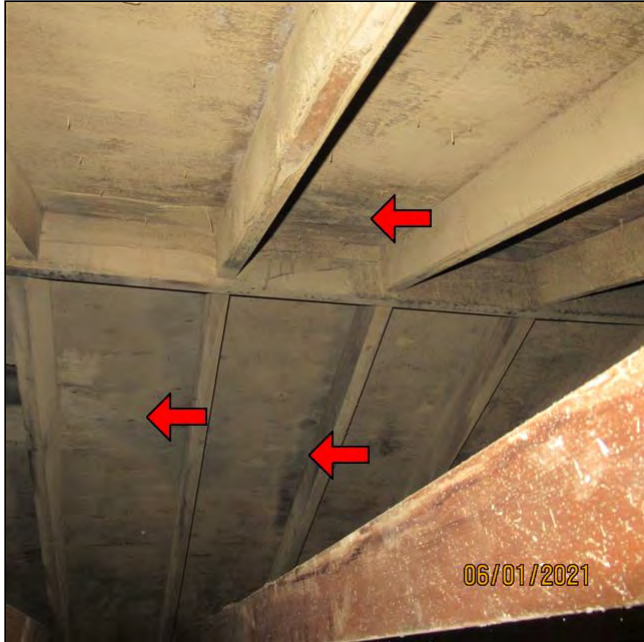
6.1.A Item 3(Picture)

(2) Black discolouration was noted on the under side of the sheathing material (under side of the roof) at the attic sheathing. This is evidence that warm moist air from the conditioned (heated) portion of the home could be leaking into the attic and unable to escape quick enough through roof vents to prevent damage to the attic materials. Black discolouration may be mould and mildew or simply aging of the sheathing material. At the time of the inspection we were unable to determine the existence, nature or extent of mould and mildew, if any. Based on the conditions observed, we recommend consulting with a qualified home air leakage control contractor to determine air leakage control measures to reduce the potential for warm moist air to enter the attic, and increase ventilation in the attic space.

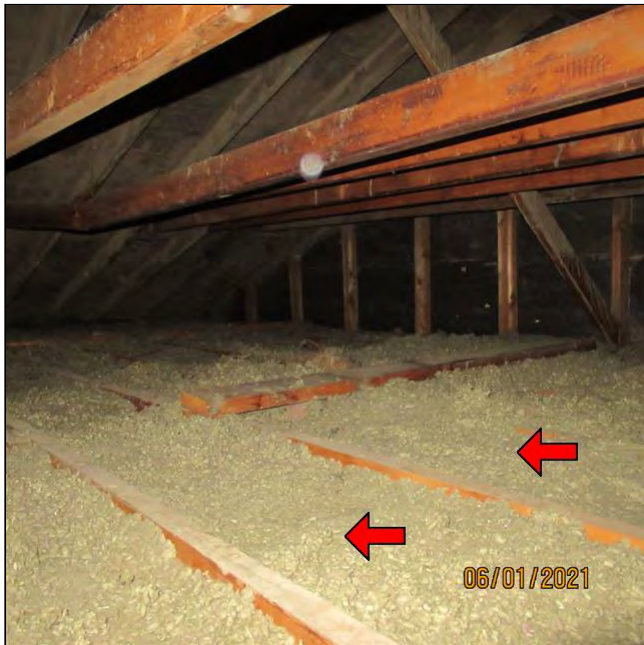
6.2.A Item 1(Picture)

3-4" of insulation present, equivalent to approximately R10 of insulation value. We recommend adding additional insulation to at least R50.

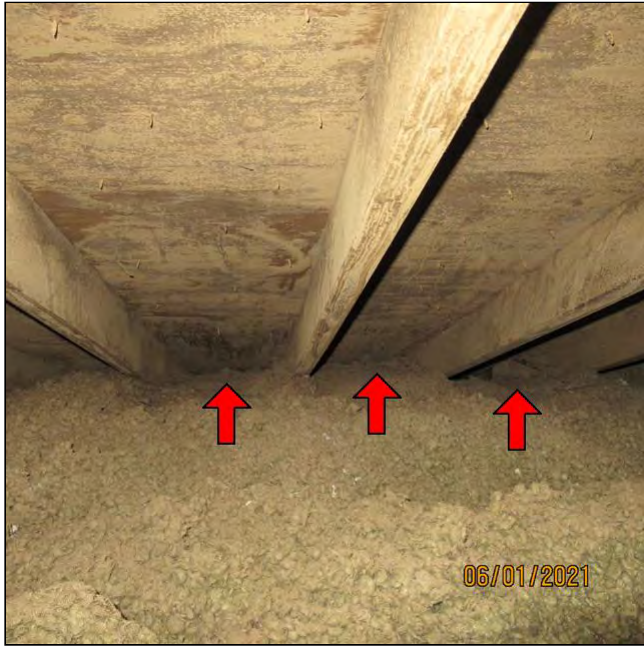
6.6.A Item 1(Picture)

No soffit venting observed in the attic. It appears the insulation was blown into the soffit space without channels being installed to allow ventilation through the soffit into the attic space. We recommend adding additional ventilation to avoid premature aging of roof and help to maintain proper humidity and temperature control.

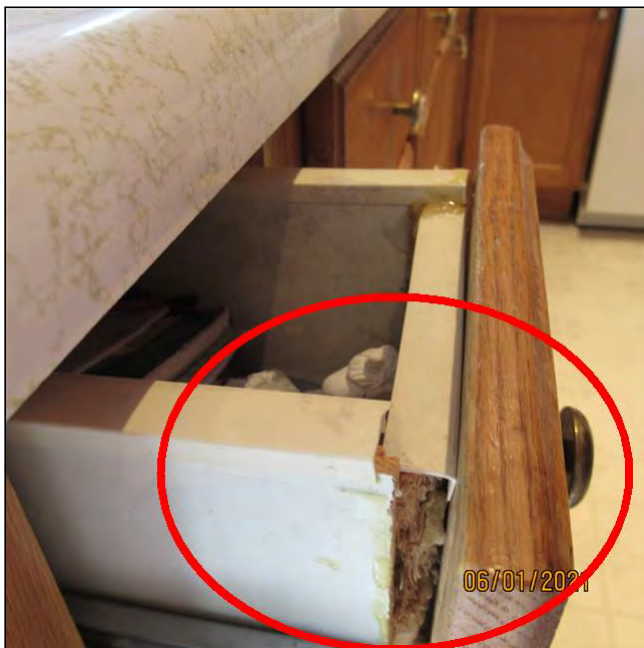
7.7 Item 1(Picture)

Drawer is pulled apart; corrections needed for proper and smooth operation.

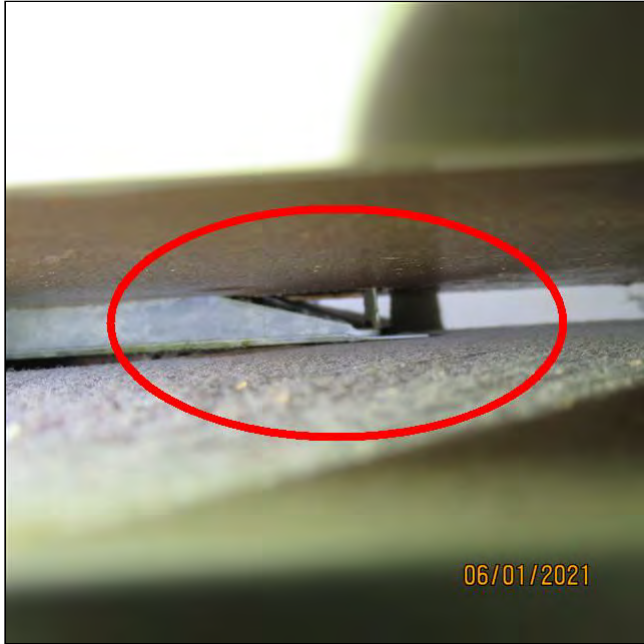
7.16 Item 1(Picture)

The range hood appears to be vented to the exterior. However, the connection to the vent pipe is poor, allowing air to recirculate to the kitchen. We recommend corrections to restore proper function.

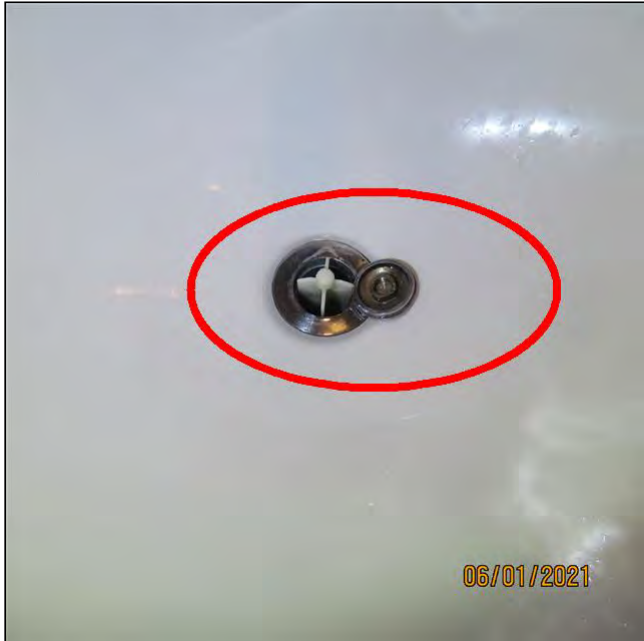
8.14.A Item 1(Picture)

Stopper is damaged; corrections are needed for proper operation.

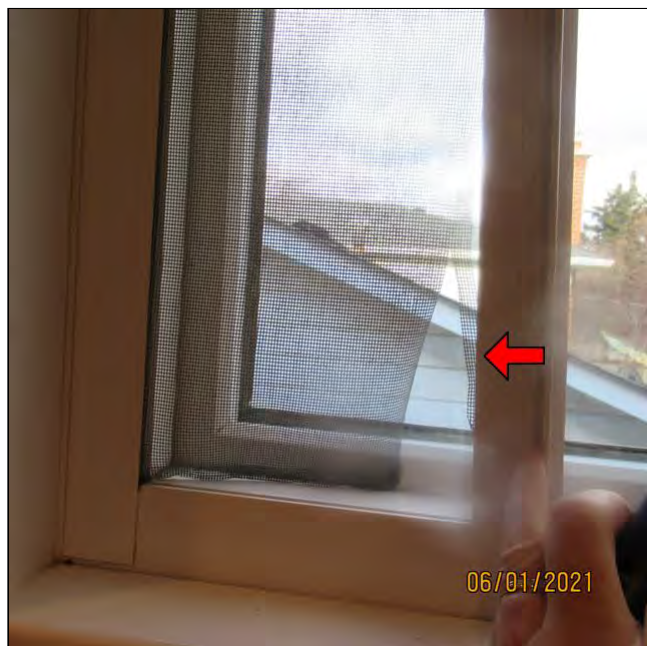
8.4.B Item 1(Picture)

Retractable screen is torn. Correct as necessary to restore proper function.

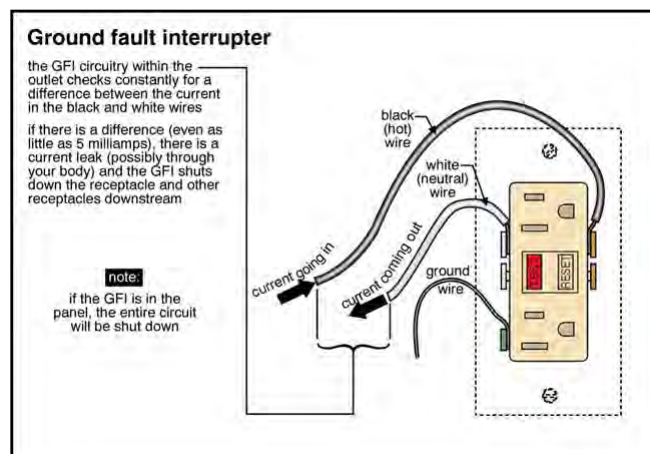
9.10 Item 1(Picture)

A Ground Fault Circuit Interrupter (GFCI) is not present at laundry room, suggest installing GFCI for safety. A qualified electrical contractor is needed for further review and to make necessary repairs/corrections

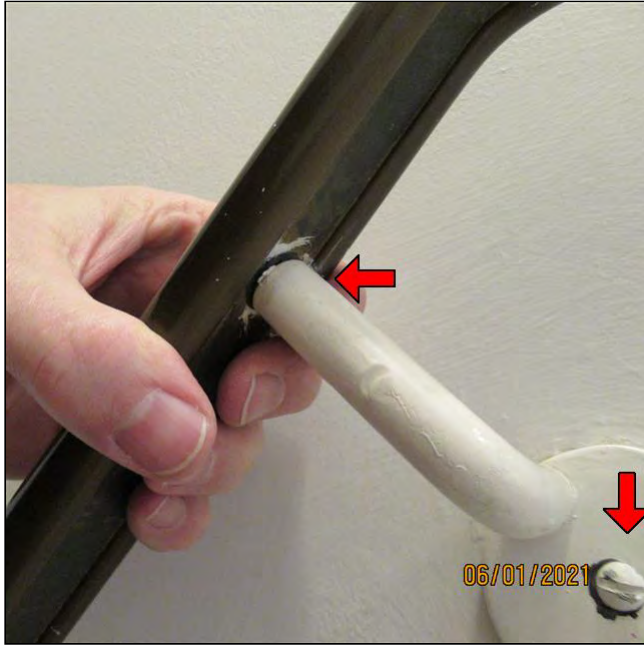
10.8 Item 1(Picture)

Handrail is loose at the top of the stairs to the upper level. We recommend review for repair as necessary for safety.

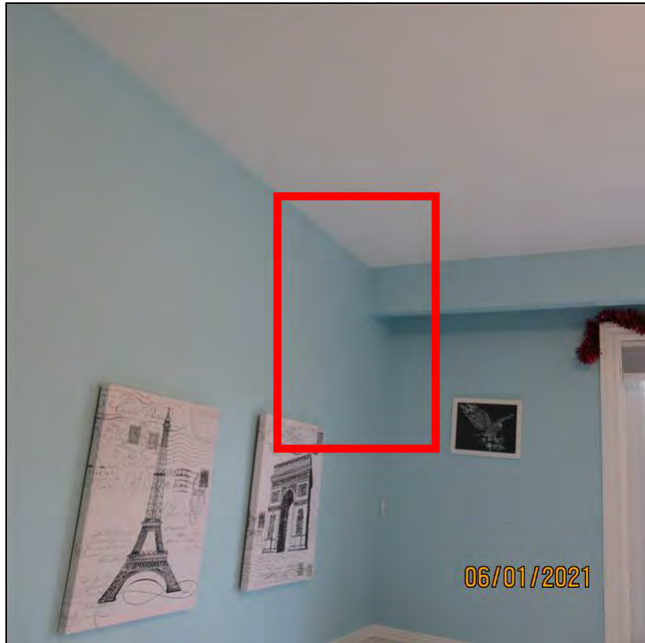
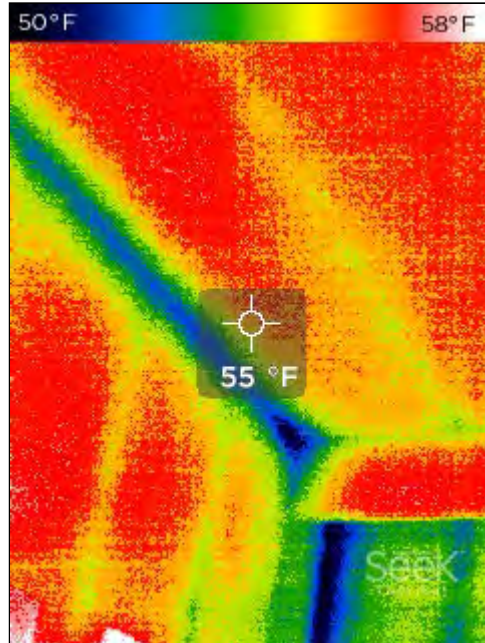
Air infiltrates into the wall assembly and chills exterior corners where sealing and insulating at the time of construction was difficult. Sealing and insulating these areas increases energy efficiency and home comfort.

11.1 Item 2(Picture) Chilled corners at exterior walls

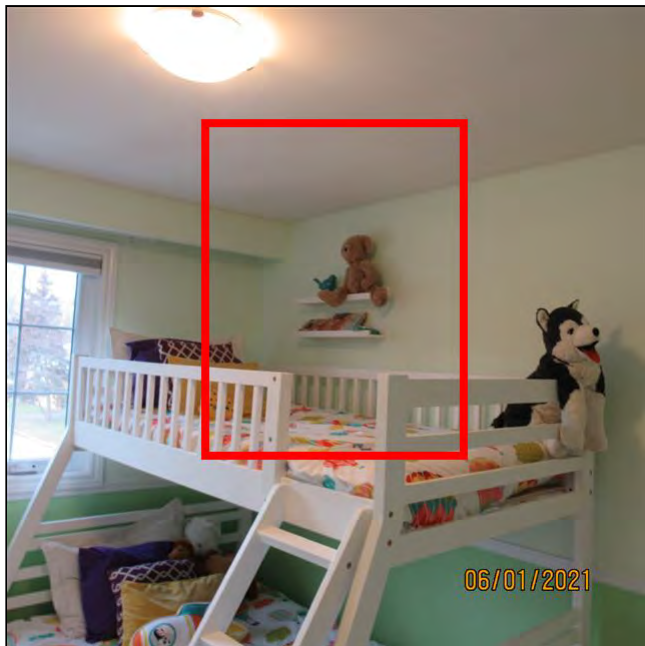
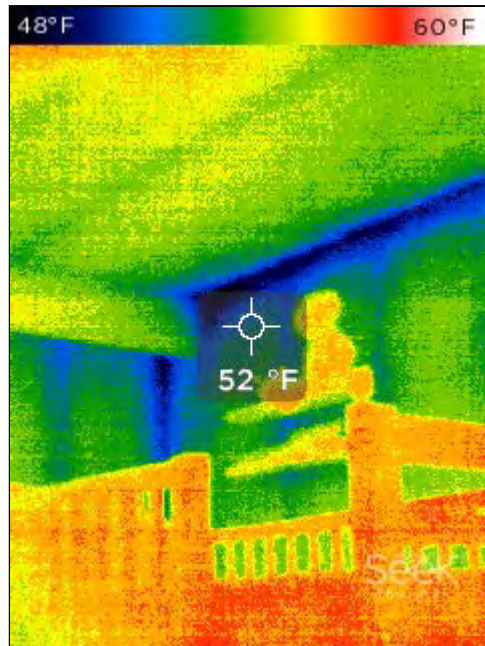
11.1 Item 4(Picture) Chilled corners at exterior walls

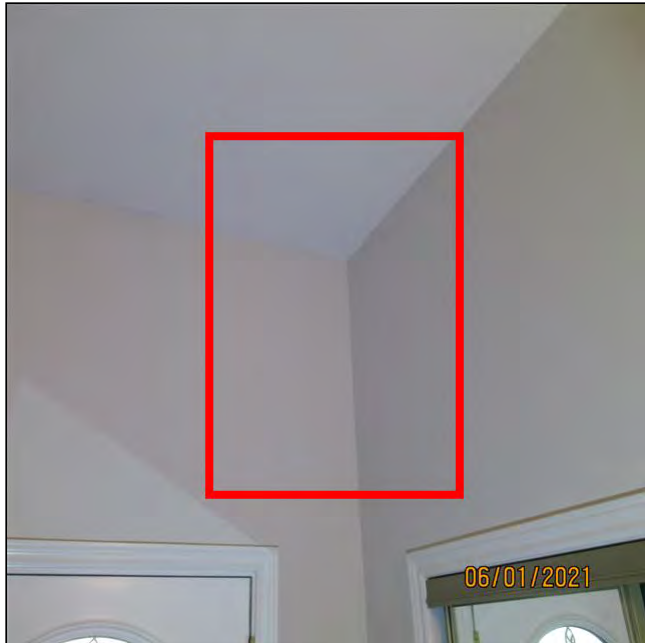
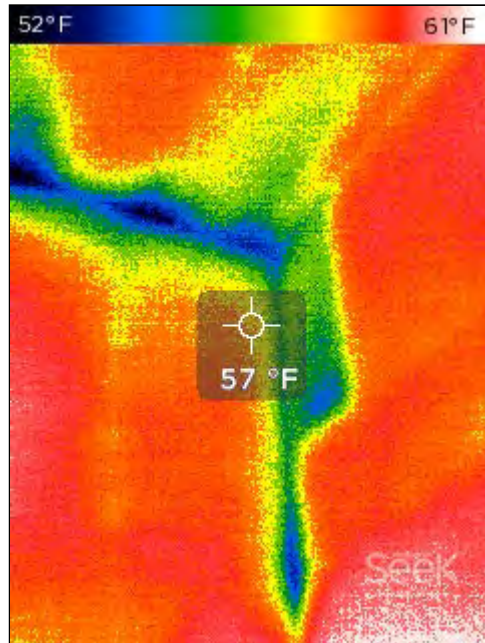
11.1 Item 6(Picture) Chilled corners and possible missing or loose insulation in the upper right corner

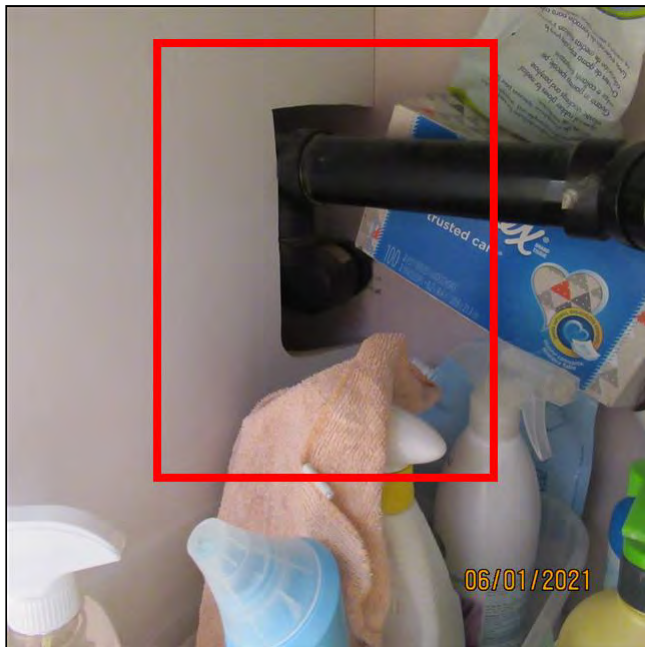
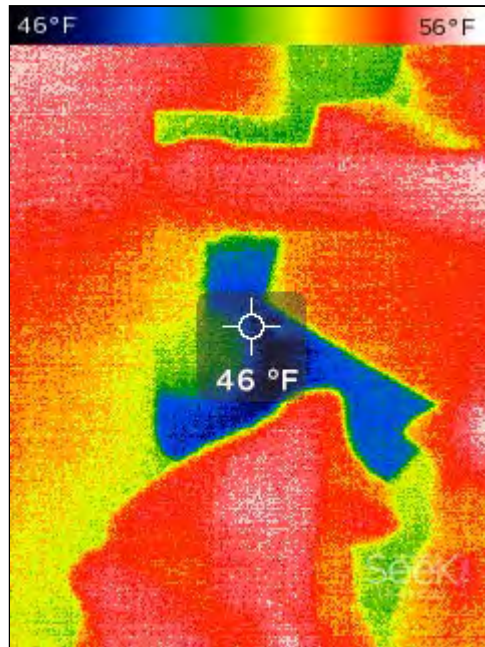
Air that infiltrates into the wall assembly can also exit into the house through holes in the wall covering (pipe passing through the wall, electrical outlets, switches and light fixtures). Sealing holes to the interior will improve energy efficiency and home comfort.

11.1 Item 8(Picture) Hole for drain pipe below the sink
