SUMMARY REPORT

AmeriSpec Inspection Services of Hamilton, Brantford and Stratford
32 Livingstone Cres
Cambridge ON N3H 5S7
226-341-9569

URGENT REVIEW SUMMARY

Doc #: 010621SH2

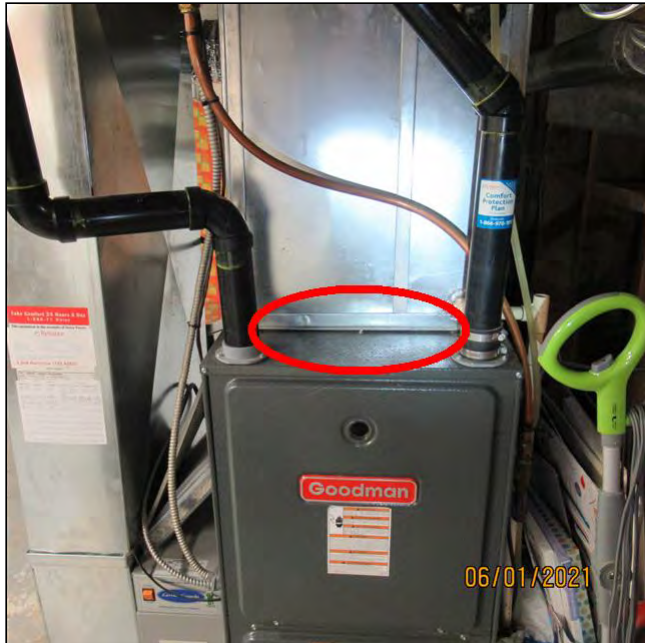
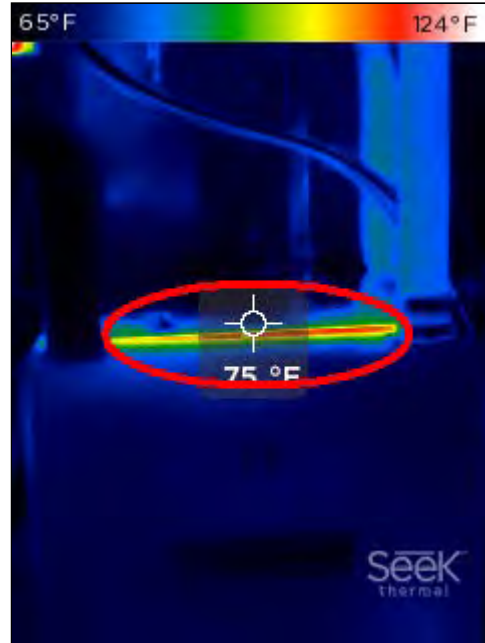
12.6 Item 2(Picture) Air escaping through gap where ductwork connects to the furnace

(2) We recommend that all exposed ductwork be sealed with foil tape to improve the efficiency of the distribution system.

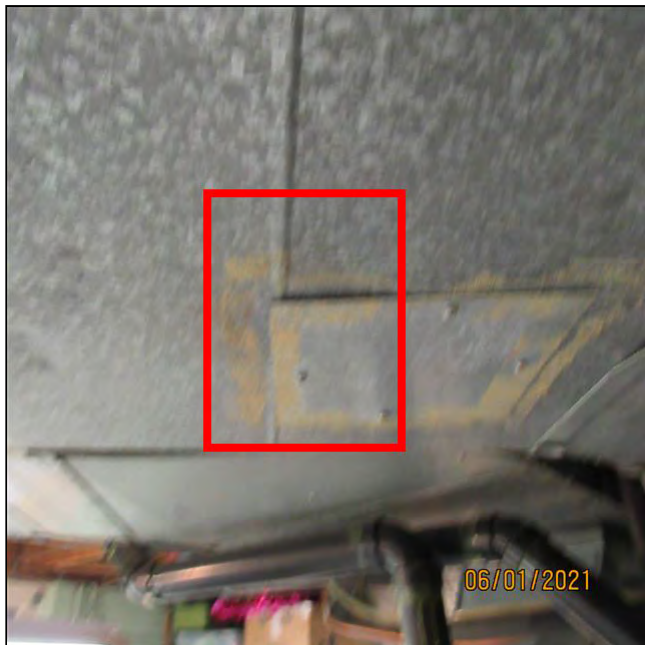
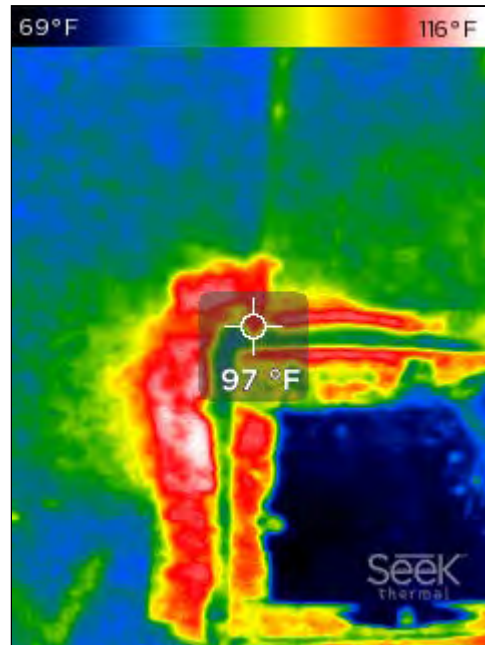
12.6 Item 4(Picture) Air escaping a plate on the ductwork

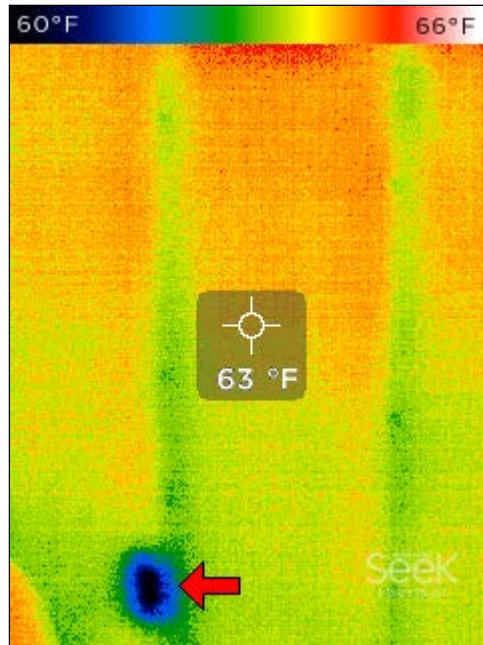
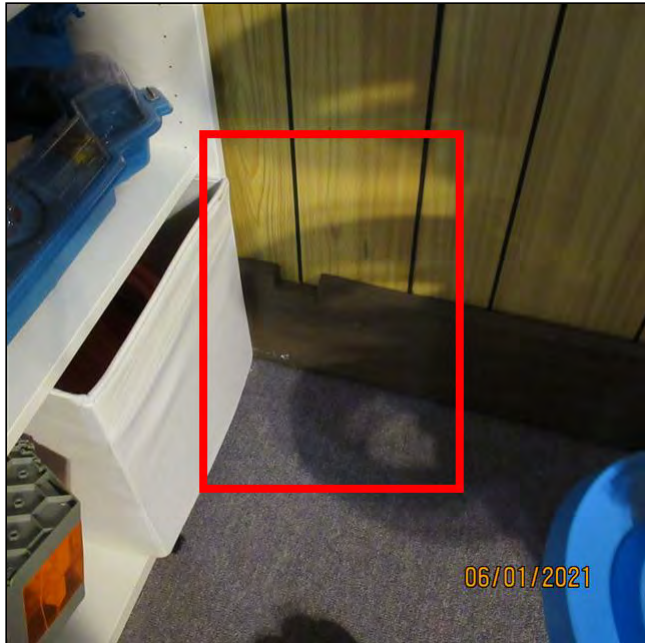
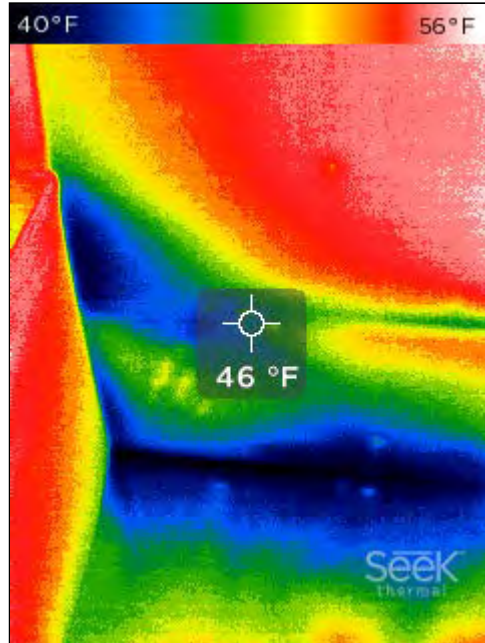
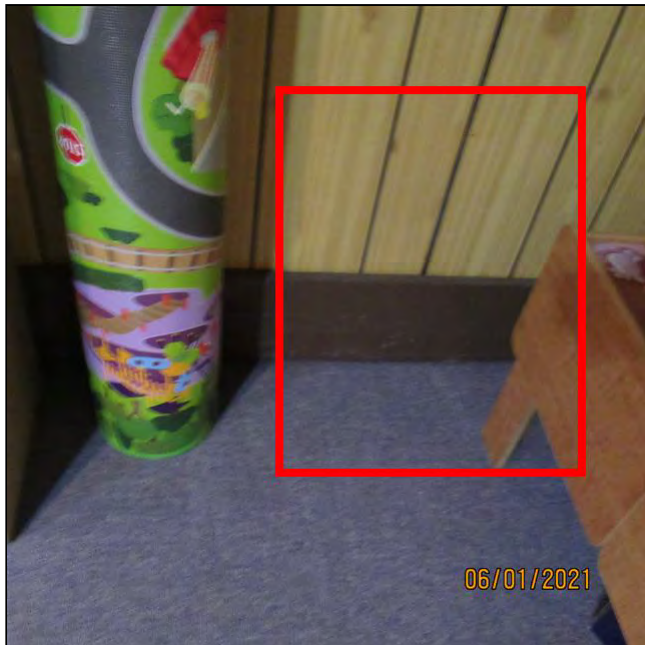
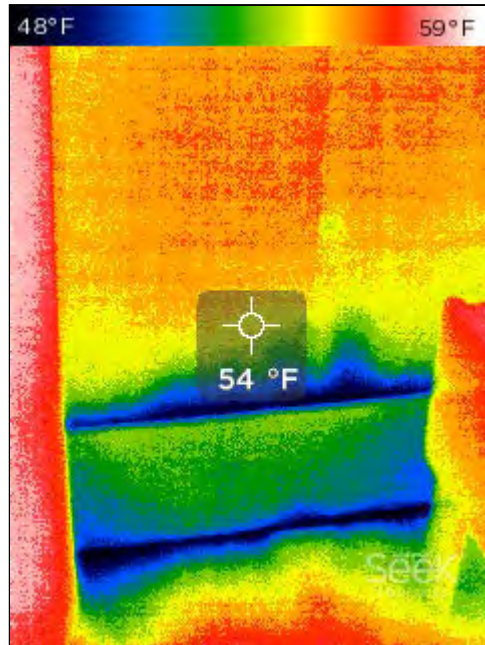
(3) Air entering the basement wall assembly from gaps at the rim plate, around windows and penetration through the wall, exit into the basement through electrical outlets, at breaks in the wall covering and along the trim. Reducing air infiltration requires sealing gaps and cracks in the building envelope.

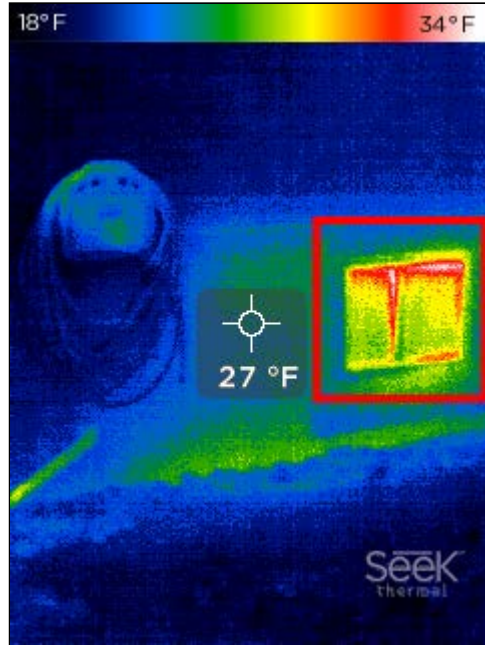
13.11 Item 2(Picture)

Heat loss observed around window frames. Improved sealing between the window frame and the rough opening will reduce some of the loss. Other loss is related to the window design and wear.

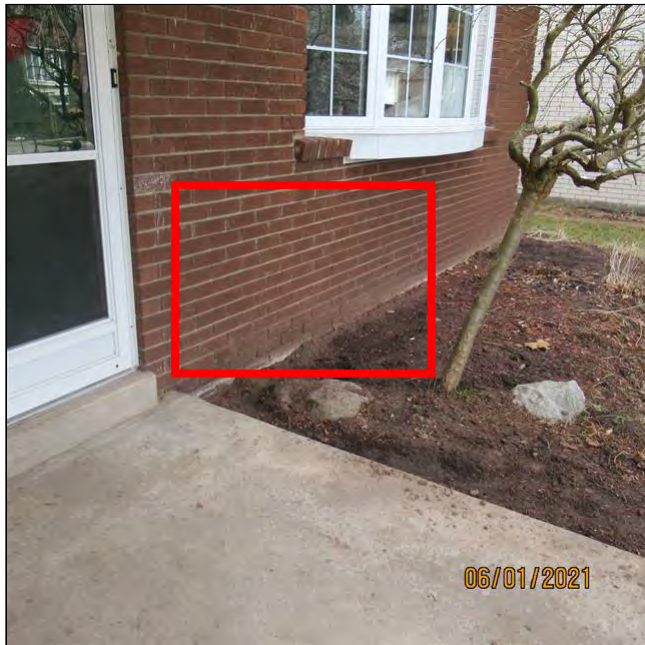
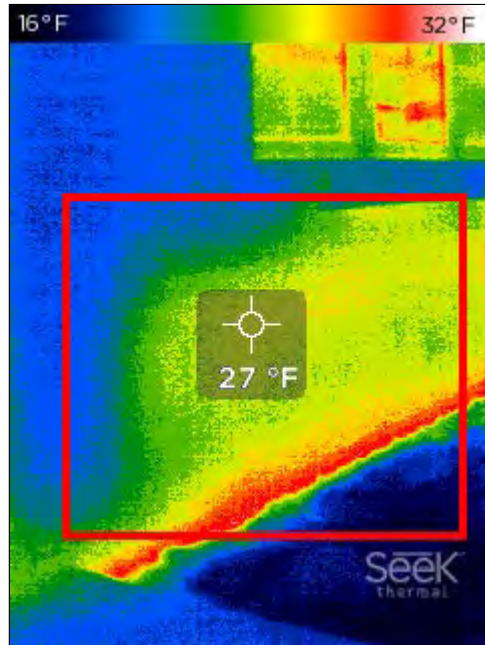
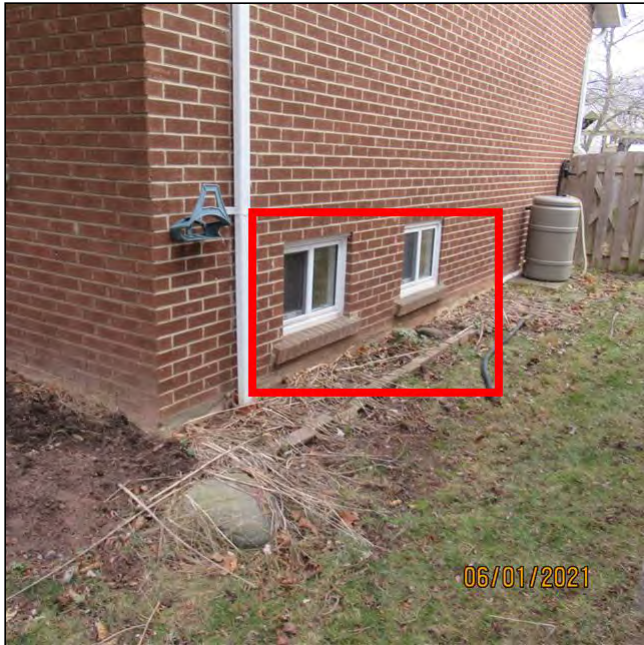
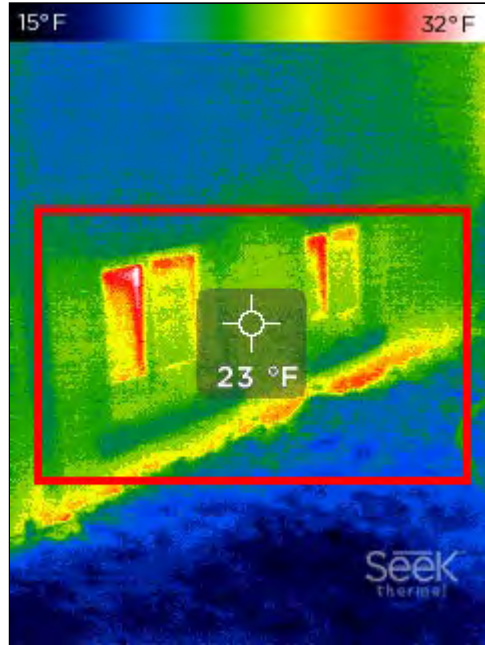
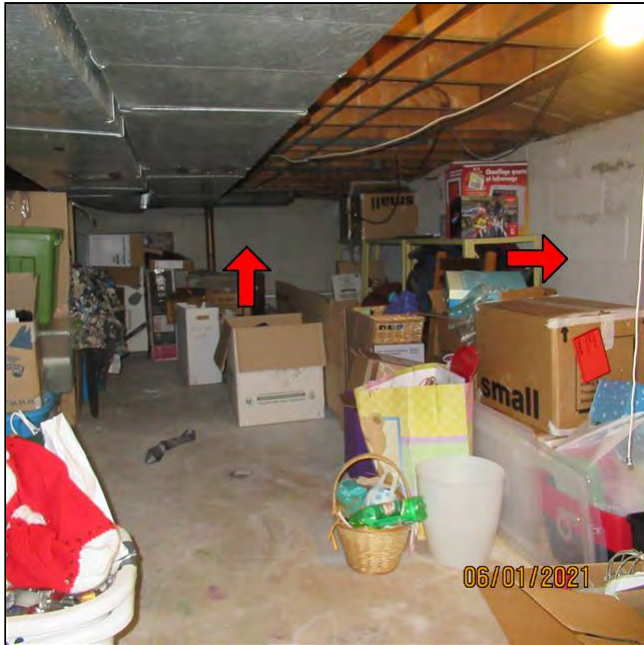
(1) Heat loss observed at the exterior walls with higher heat loss at the sill plate area. We recommend that the walls of the crawlspace be insulated.

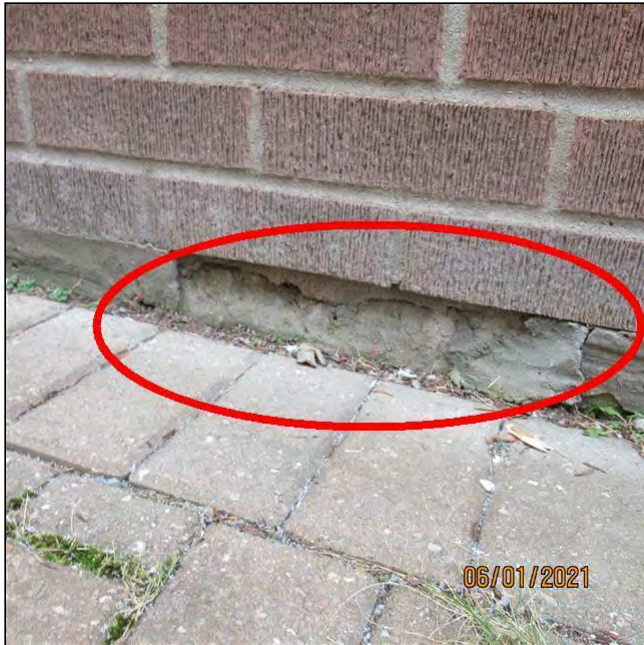
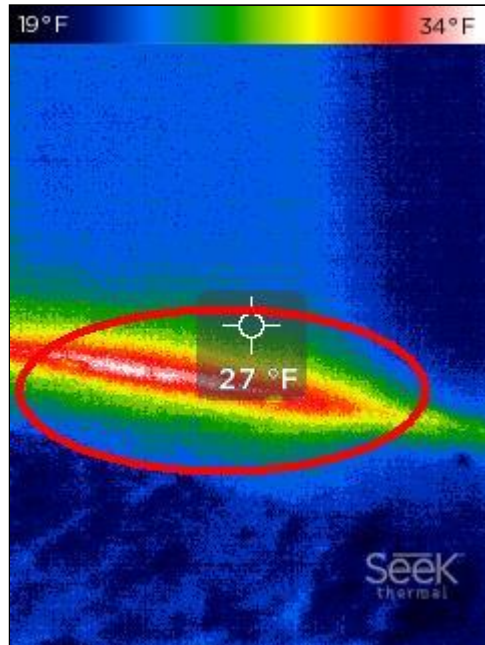
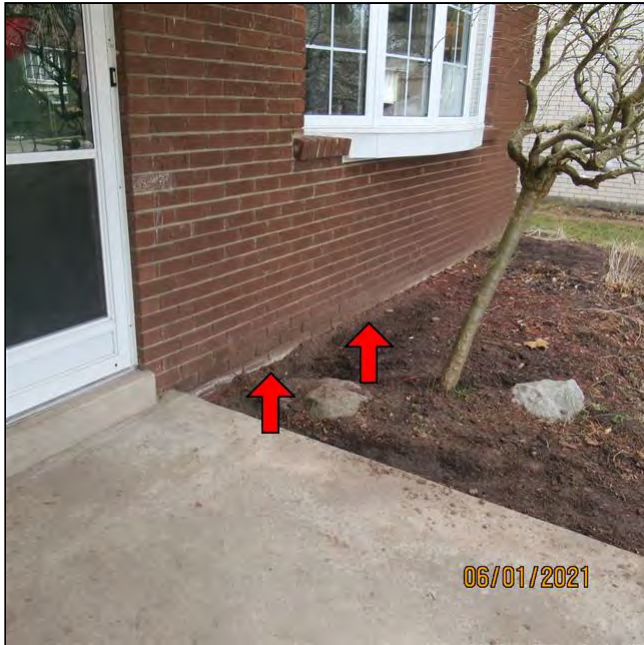
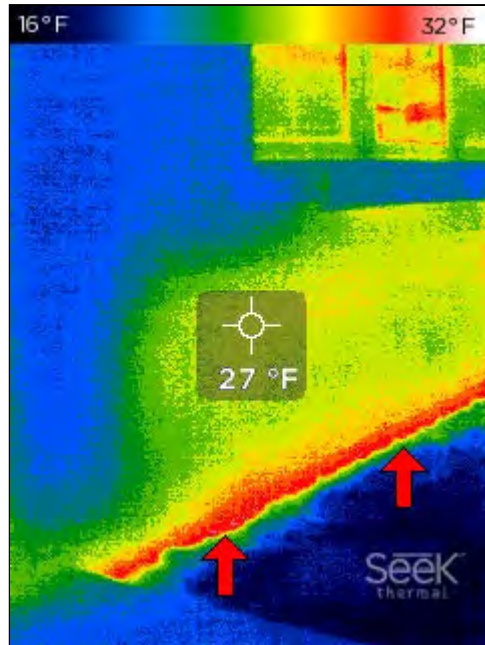
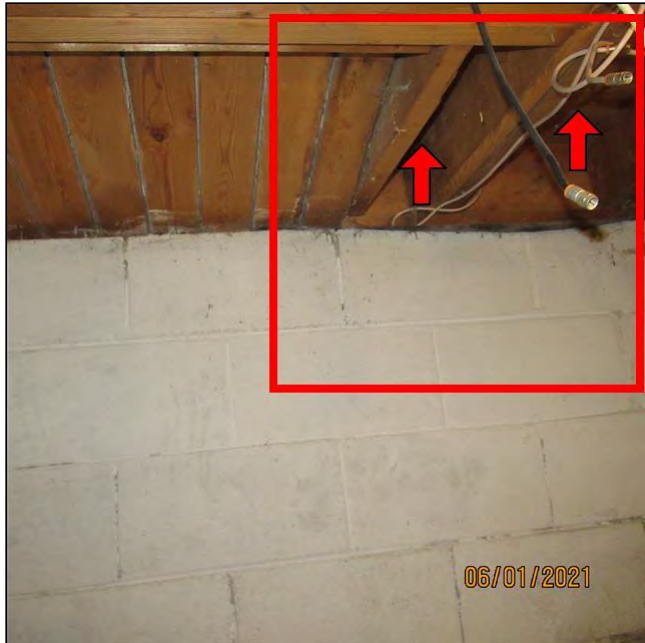
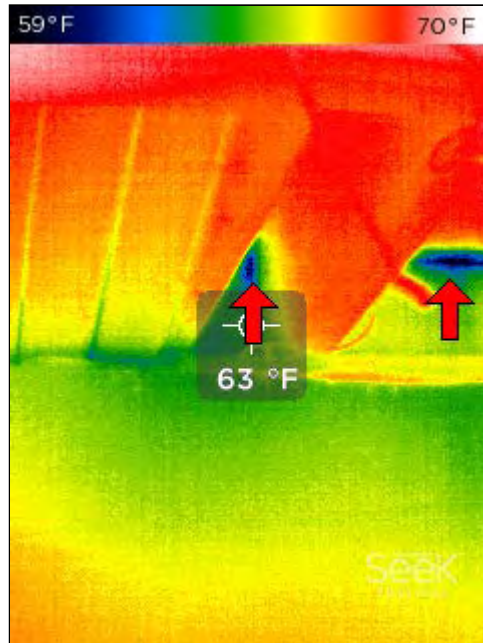
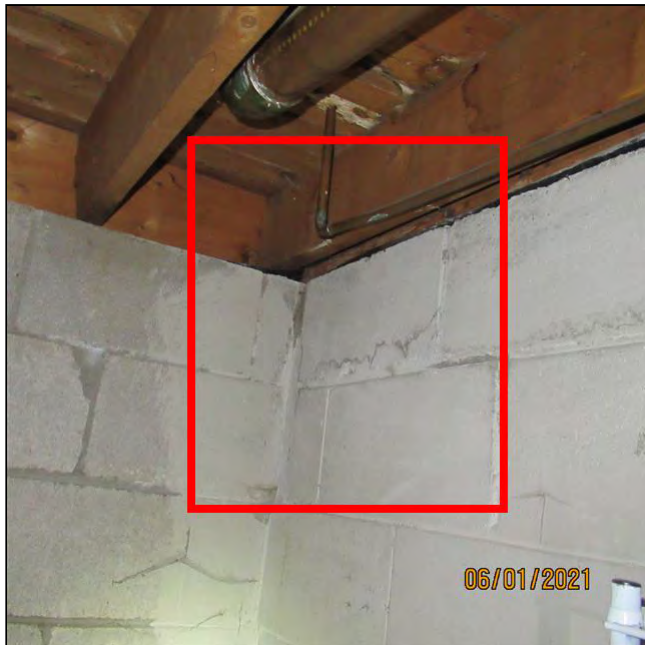
(2) Heat loss observed around sill plate area (especially where it has been exposed by parging failure). Insulating the header and rim plate areas of the basement will reduce such losses. We recommend adding insulation and a vapour barrier (or an approved spray foam insulation product) to the rim joist area to improve energy efficiency and to reduce air infiltration to the home.

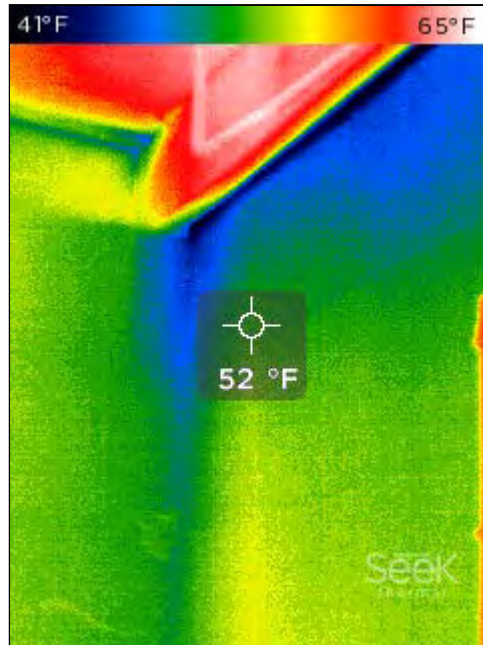
13.15 Item 13(Picture) Air leaking under the sill plate

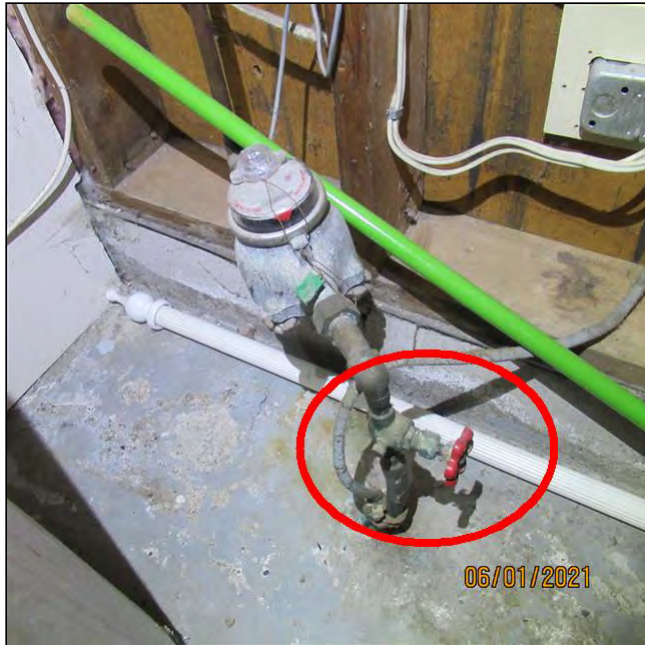
14.0 Item 1(Picture)

Gate-type valve observed. Since main shut-off valves are operated infrequently, it is not unusual for them to become frozen over time. They often leak or break when operated after a period of inactivity. For this reason main shut-off valves are not tested during a home inspection. We suggest caution when operating shut-offs that have not been turned for a long period of time. We recommend that the client consider upgrading the shut-off valve to a high quality ball-type valve which tend to be more reliable than gate valves.

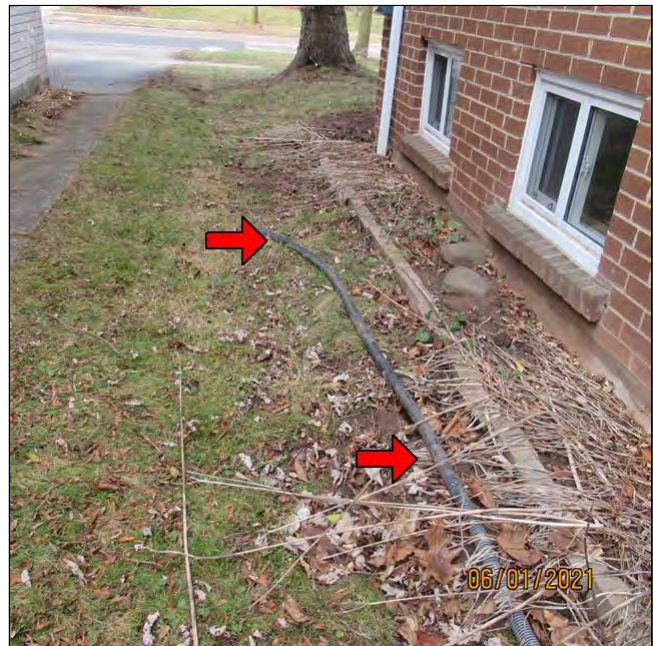
14.4 Item 2(Picture)

(1) Sump pump drains to the rear right side exterior. The drain pipe is located at the ground surface and is subject to mechanical damage. We recommend review by a qualified contractor for correction to protect the drain and ensure it drains appropriately away from the foundation.

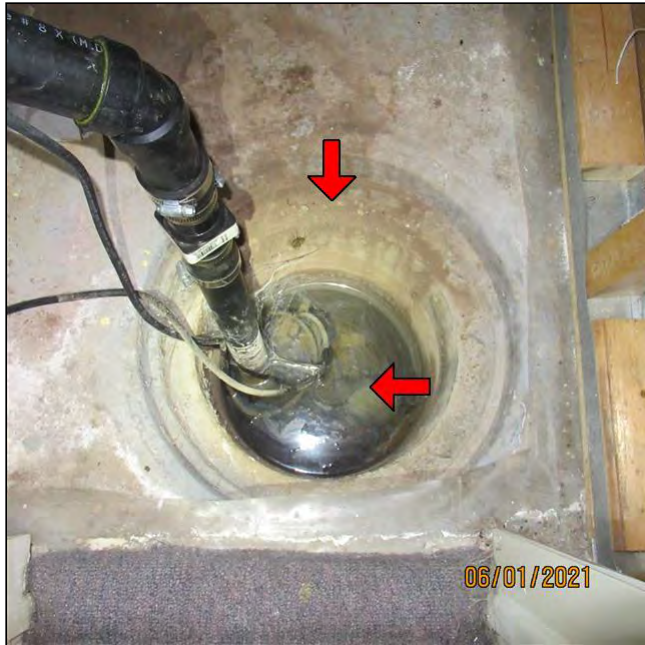
14.4 Item 3(Picture)

(2) Sump pit cover is missing. We suggest installing cover for safety and to limit moisture intrusion into the house from the exposed water surface.

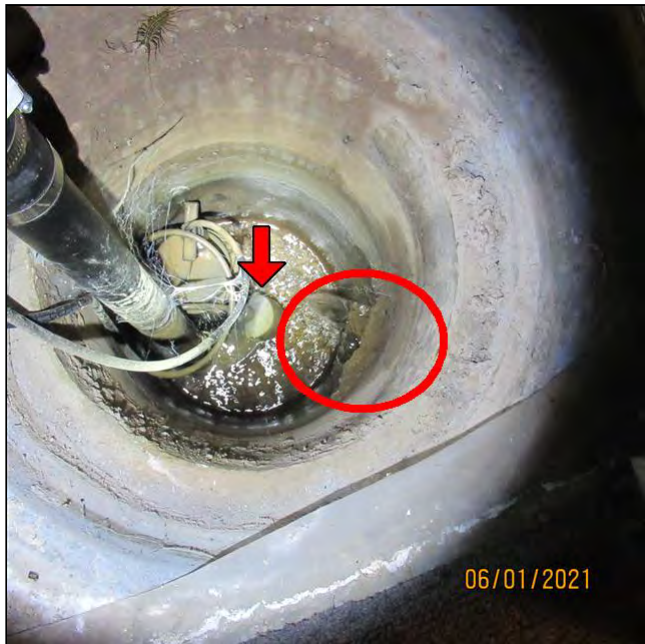
14.4 Item 4(Picture)

(3) The float switch that controls the operation of the sump pump is set to high resulting in water backing up into the weeping tile before the pump switch on to pump the water from the pit. We recommend lowering the sump float switch so that it turns on before the water backs up into the weeping tile outlet.

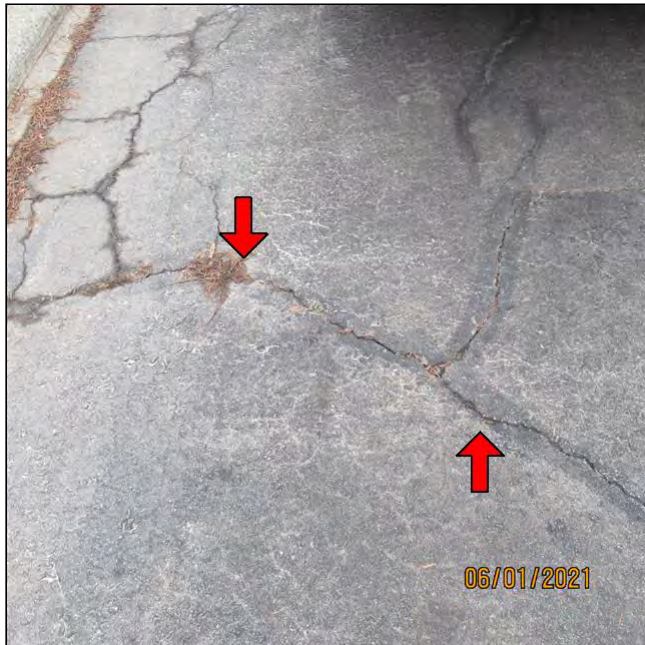
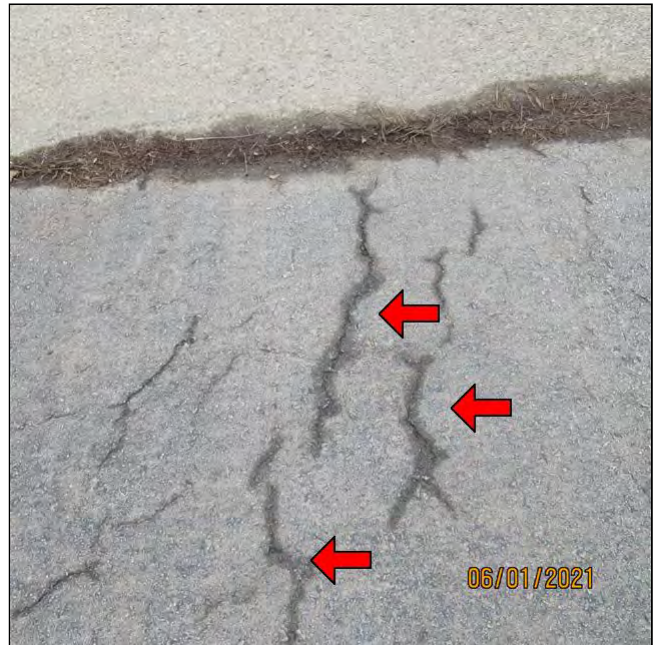
(1) Expansive cracks observed, we suggest filling cracks to prevent water infiltration and prevent further cracking.

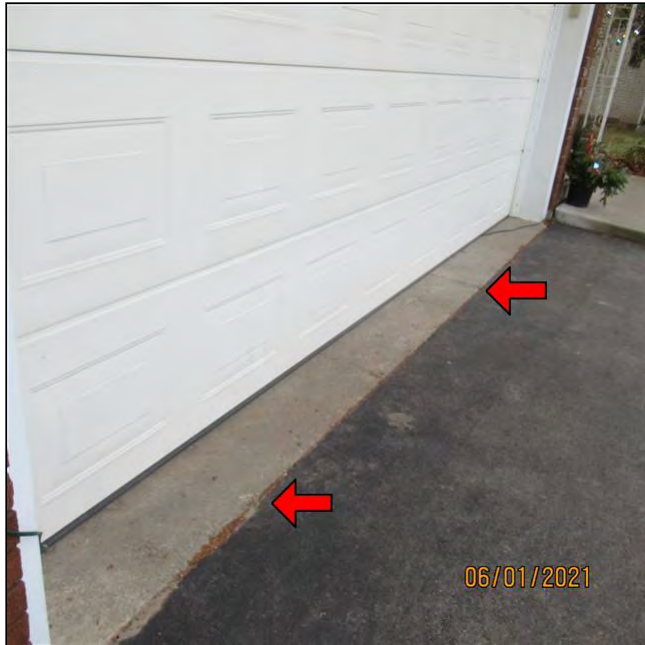
1.0 Item 3(Picture)

(2) We recommend that the client seals/caulks the opening between the foundation and the driveway with an elastic sealant and seal the driveway in accordance to manufacturer's directions for further protection.

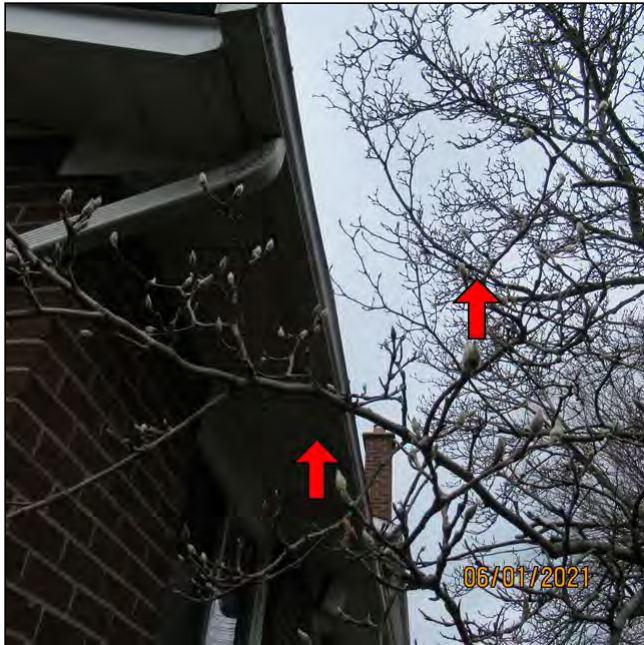
1.2 Item 5(Picture)

(5) We suggest trimming vegetation away from structure to enhance air flow, reduce moisture build-up and help prevent accelerated deterioration.

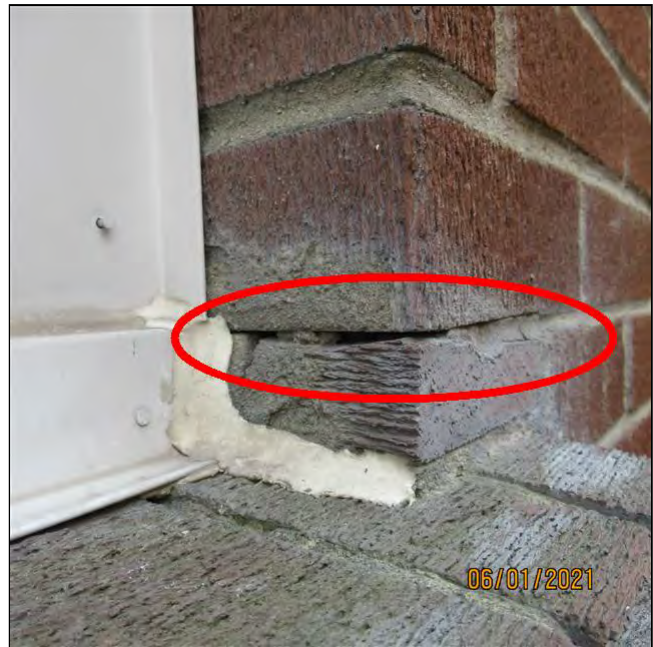
1.2 Item 7(Picture) Left side window

(6) Damaged/deteriorated mortar joints observed (left side of sliding door, front left side of garage, lower chimney, left side window). We suggest tuck pointing mortar repair as necessary to prevent further damage.

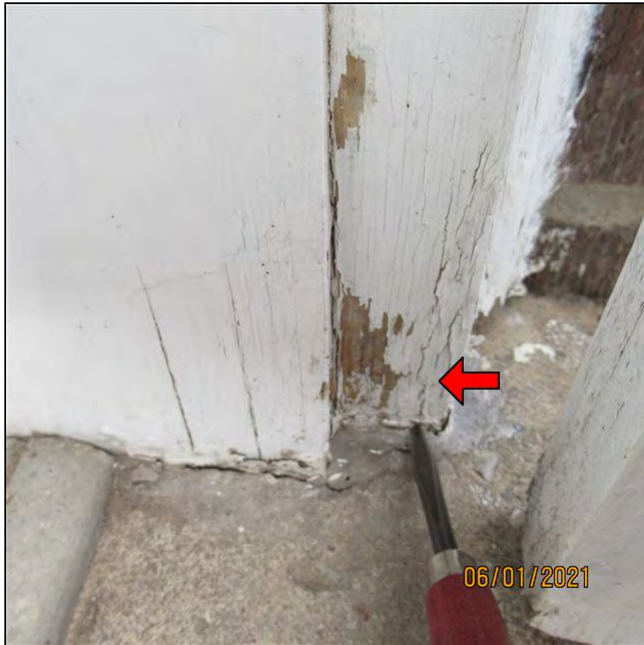
1.3 Item 1(Picture)

(1) Wood trim will require ongoing maintenance such as painting or staining to prolong its life. The client is advised to consider cladding wood surfaces in aluminum to reduce the level of exterior maintenance of the home.

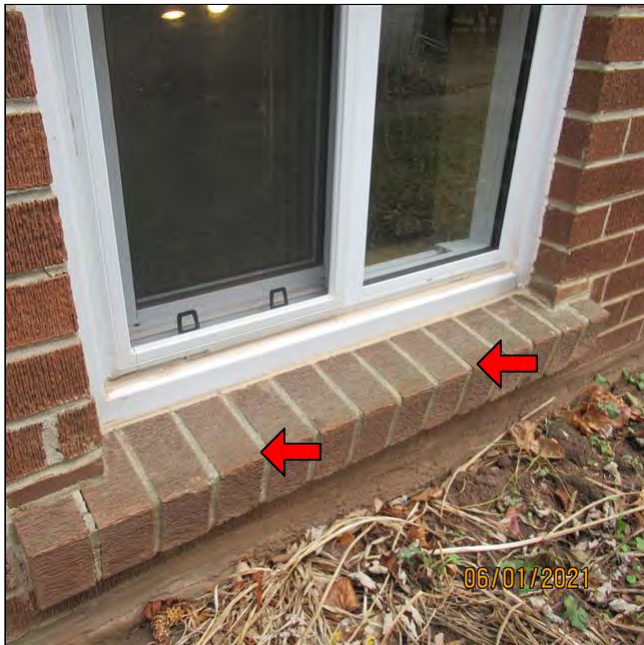
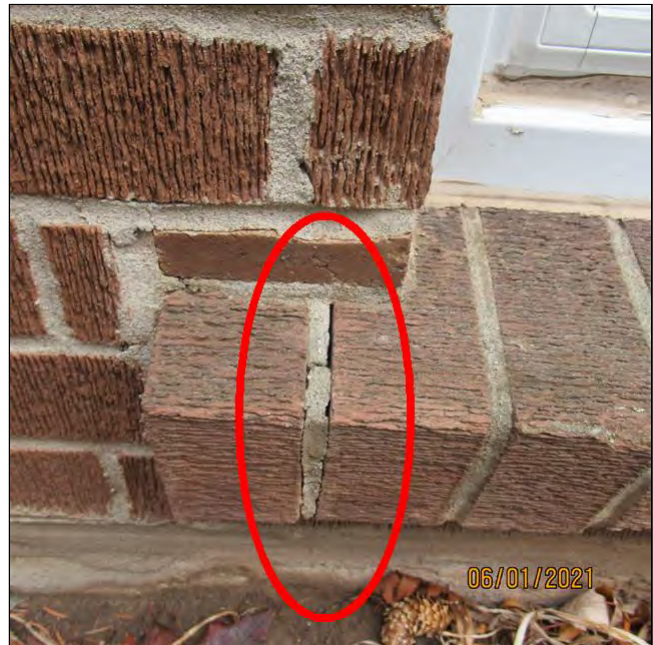
(1) Brick window sills noted. These types of sills are prone to water infiltration. We recommend maintaining the mortar joints and caulking seals in good condition or replace with precast sections.

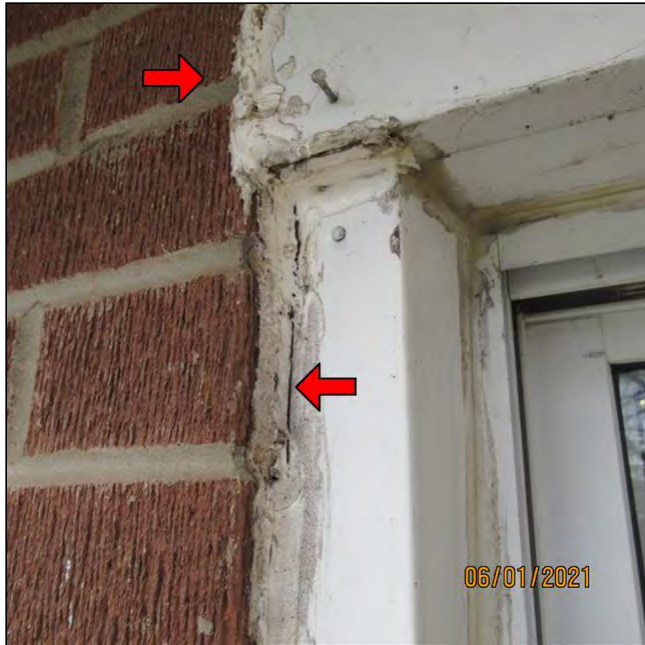
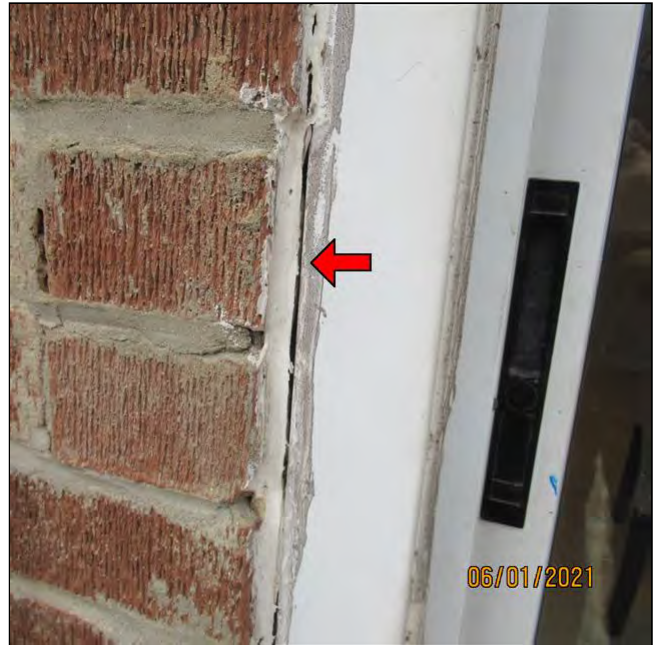
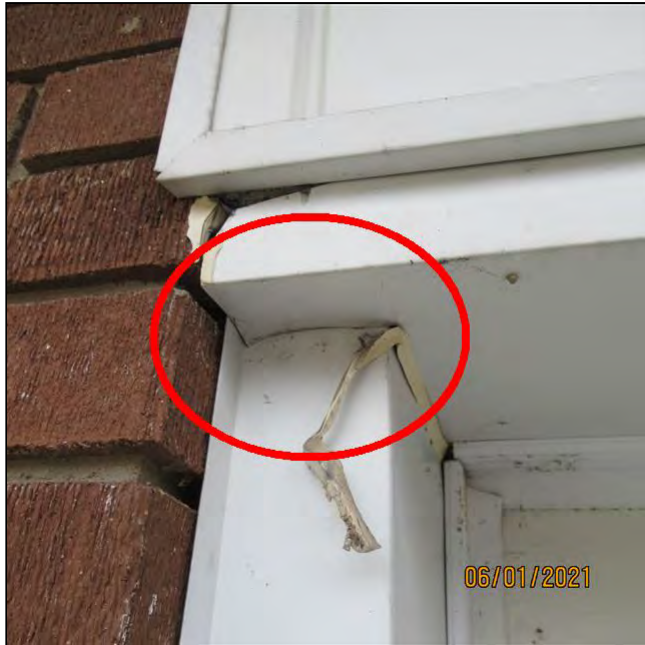
(1) Missing or damaged caulking around windows and/or doors. We suggest sealing/caulking as part of routine maintenance to prevent further deterioration.

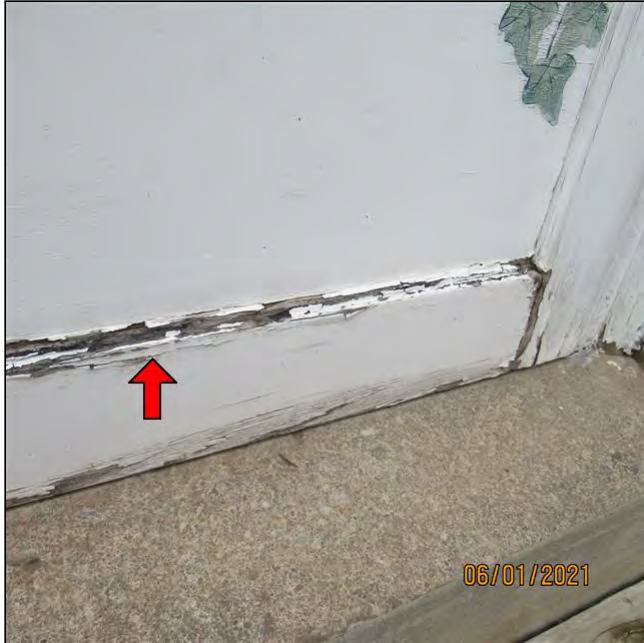
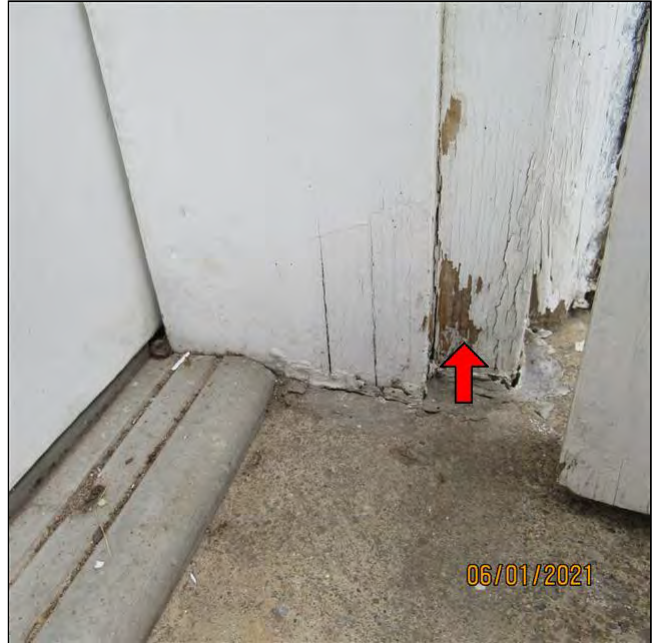
(3) Peeling paint/weathered conditions observed at rear entry and left side garage door entry. We suggest scraping and painting/staining as necessary as part of normal maintenance.

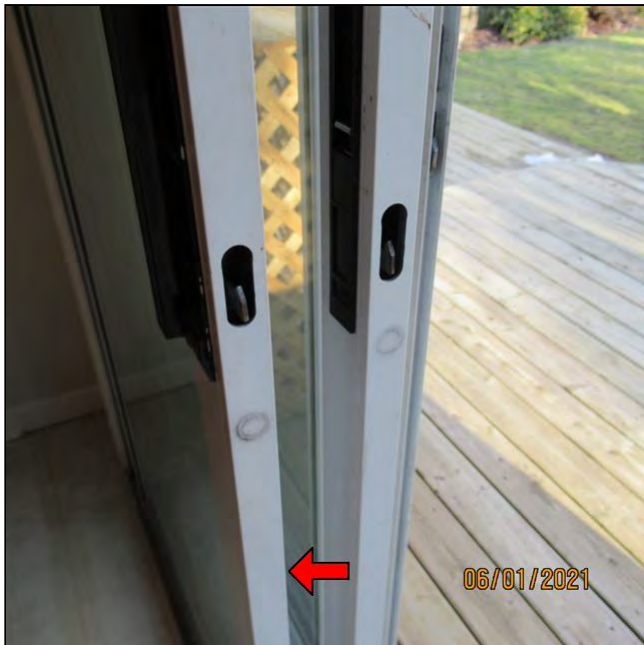
1.5 Item 7(Picture)

(4) Rear sliding glass doors do not slide easily. We recommend review and correction to restore proper operation.

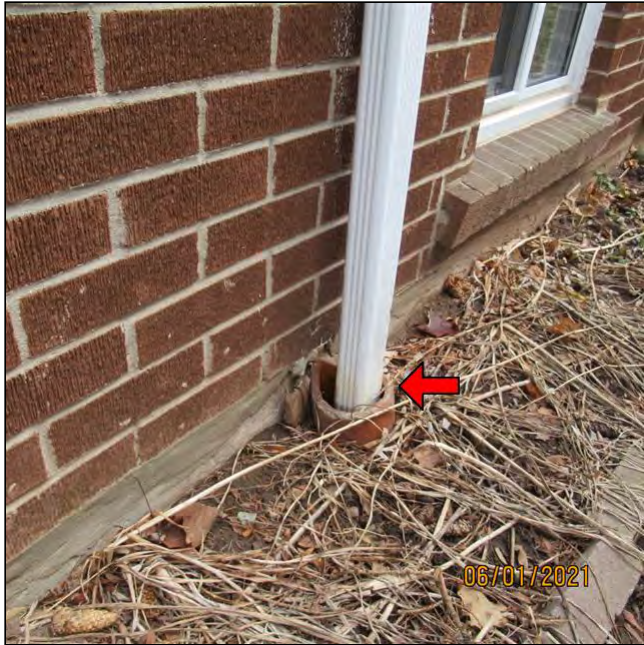
1.6 Item 1(Picture)

(1) Gutters and downspouts are an integral part of a home's water management system and should be monitored on a regular basis for proper operation. It is recommended that the gutters and downspouts be cleaned and flushed as part of routine maintenance to reduce the potential for water backup and resultant damage to roofing materials and concealed portions of the home. Downspouts should also discharge at least five feet from the foundation to limit water ponding around the home.

(2) Downspouts exit into an underground drainage system. Underground drainage systems are not within the scope of this inspection and a functional water flow test is not performed. In order to verify that this system is working properly, we recommend that downspout locations be monitored during several rainfall/snowmelt events on a regular basis. If water appears to be surcharging (backing up) we recommend contacting a qualified contractor to clear any obstructions that may be blocking the downspouts and/or subsurface components or retrofitting the downspouts so that they discharge directly to the surface soils away from the foundation. In some cases, the subsurface drainage system will be directed to a "dry well" on the property. This system may be unreliable and may result in excess water

around the foundation in turn leading to basement leaks. We recommend consulting with the current owner or builder in this regard. As a general statement, we generally prefer to have the downspouts discharge to the lawn or other permeable area, if local by-laws permit.

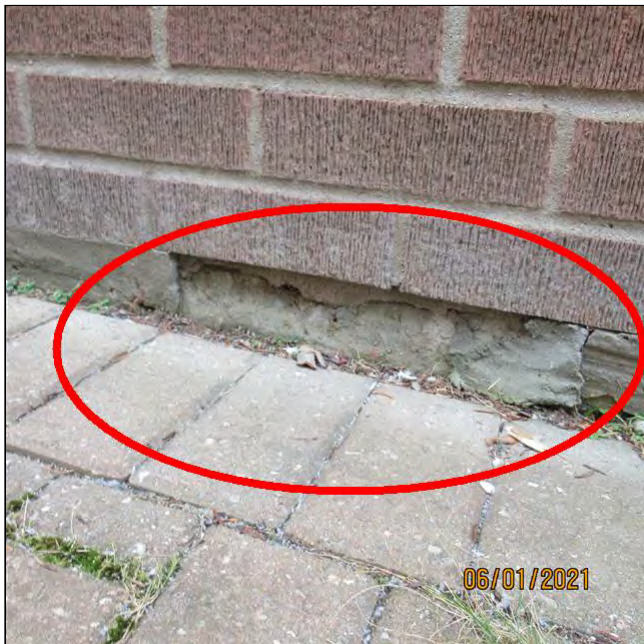
1.15 Item 1(Picture)

(2) Parged exterior noted. Parging is generally a cosmetic feature and may, over time, crack or fall off the foundation walls. At that time, the homeowner may decide to repair or replace the parging, remove it, or leave it in its condition at the time.

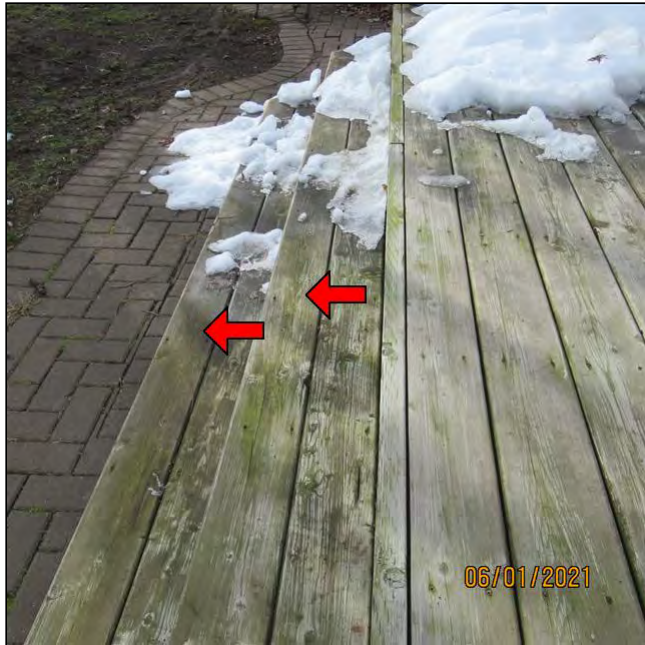
1.18 Item 1(Picture)

(1) Weathered conditions observed (algae observed). Suggest scraping and painting/staining/sealing as necessary as part of normal maintenance.

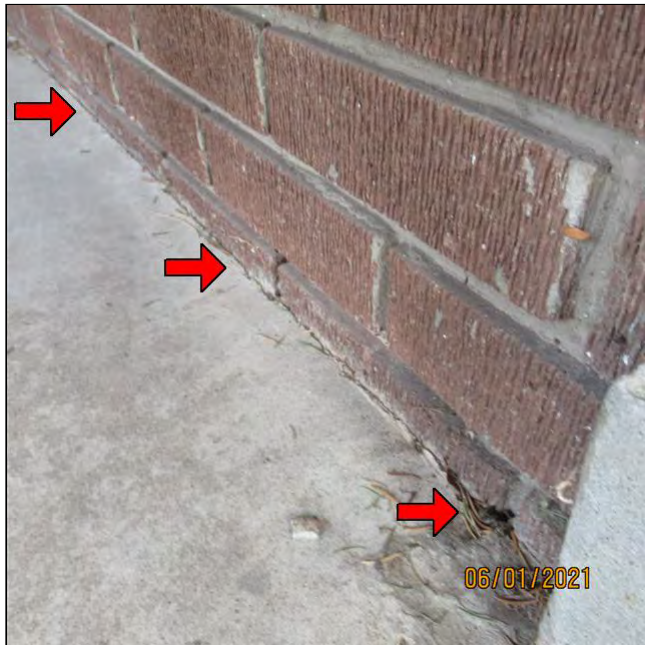
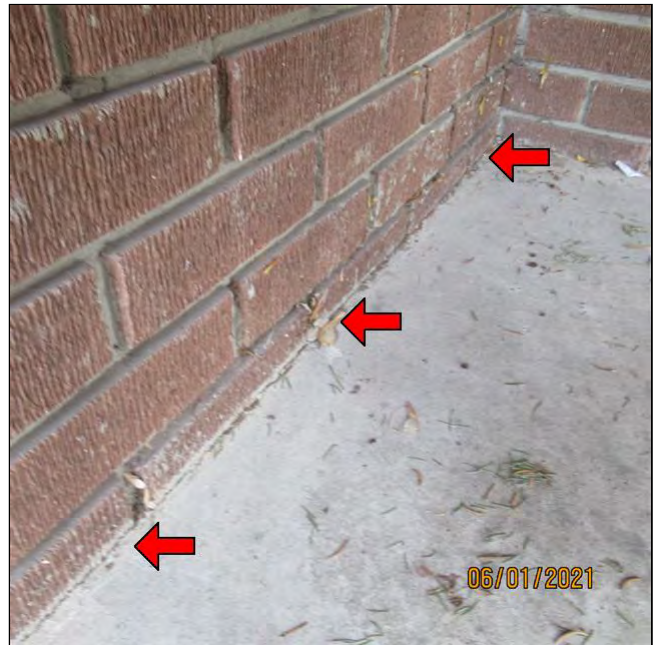
We recommend that the client seals/caulks the opening between the foundation and the porch slab with an elastic sealant.

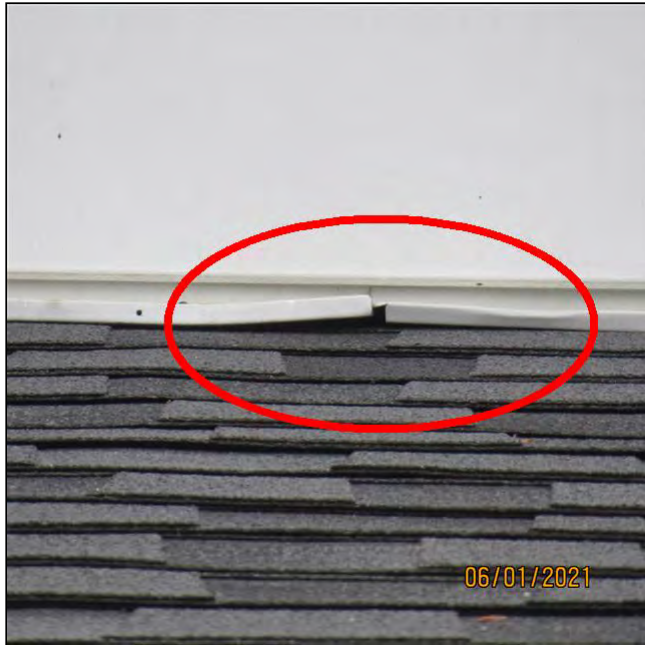
2.1 Item 1(Picture)

Flashings are damaged/deteriorated at front second level wall to roof joint. We suggest review by a licensed roofer for repairs/replacement as needed.

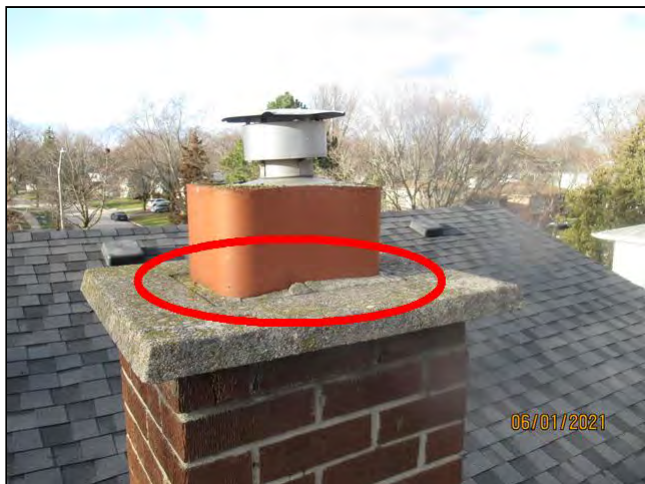
4.0.B Item 1(Picture)

We suggest sealing chimney cap (chimney crown) to reduce opportunity for water infiltration and damage. This is a common maintenance item that is often neglected by homeowners; you should make a crown inspection part of your routine seasonal maintenance checklist.

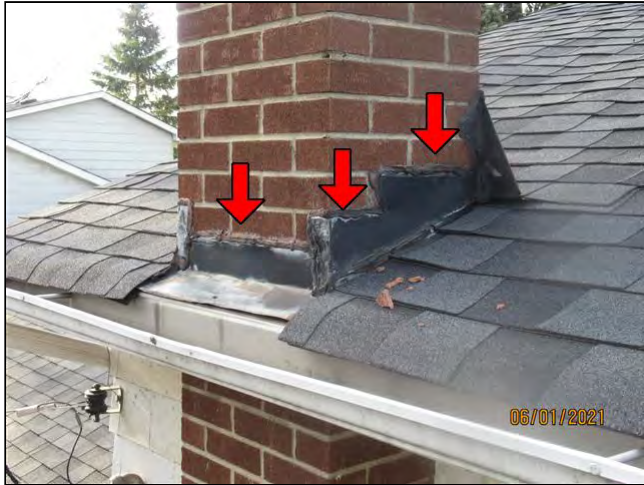
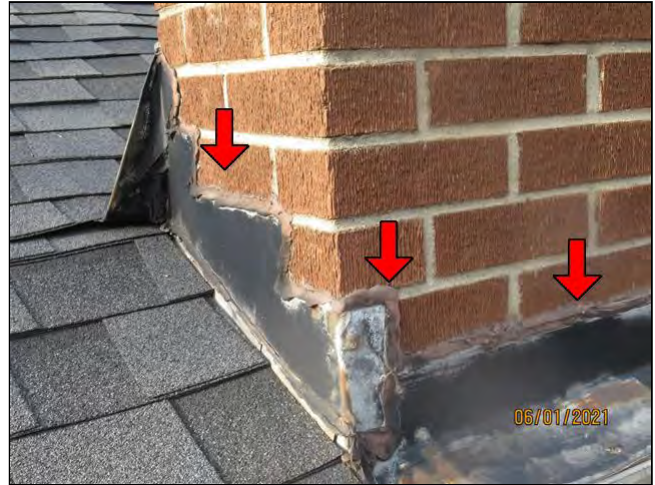
(1) We recommend re-sealing all chimney flashings as a part of routine maintenance.

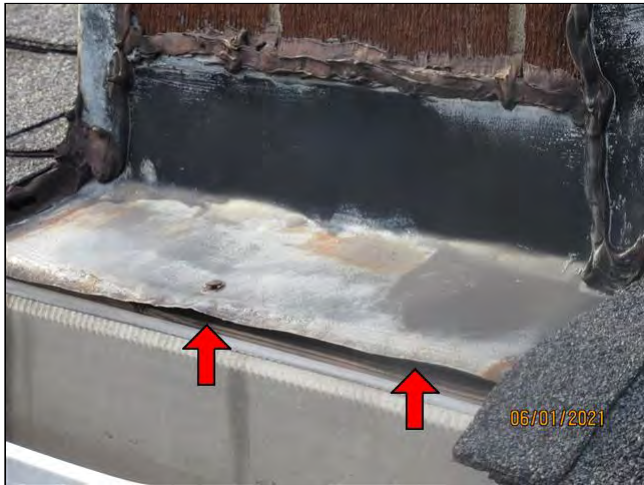
4.2.B Item 3(Picture)

(2) Lower flashing is loose. We recommend securing.

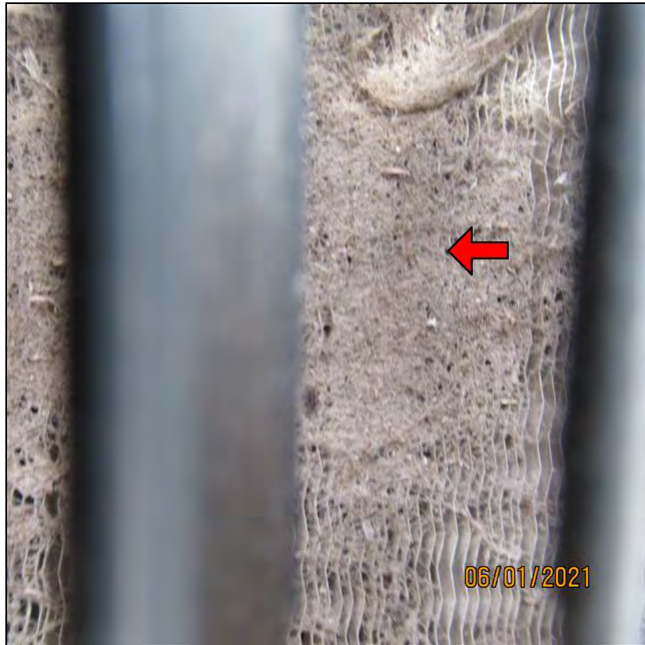
5.2 Item 1(Picture)

(2) The condenser coil fins are dirty and need to be cleaned. We recommend service by a licensed HVAC contractor to assure serviceability.

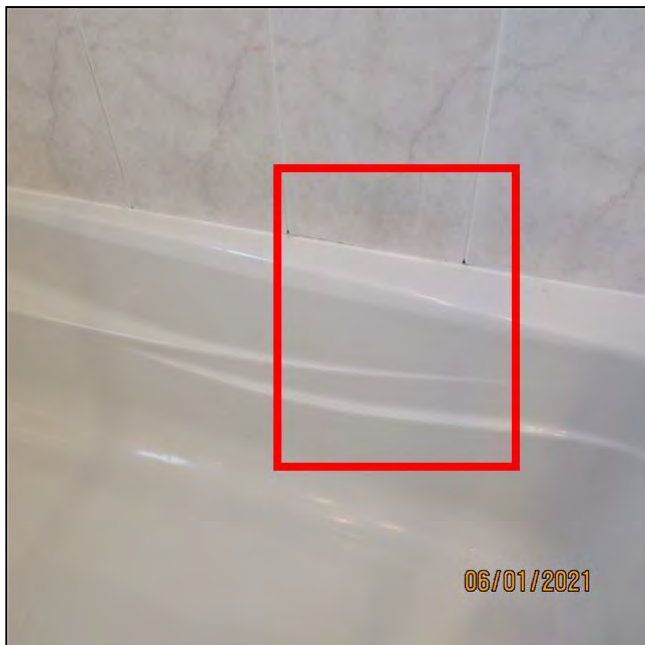
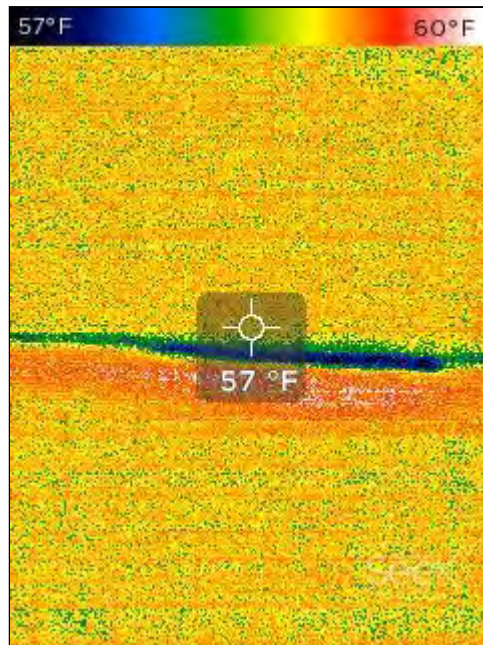
The tile edges of the tub/shower walls should be caulked and sealed to reduce the potential for water/moisture penetration behind the surround as part of routine maintenance. Failure to keep the walls sealed can cause deterioration and extensive moisture damage to the interior walls, which is not always visible to the inspector at the time of inspection. We recommend that all escutcheon plates be properly caulked and sealed as part of routine maintenance to reduce the potential for moisture infiltration behind the surround walls.
