SUMMARY REPORT

AmeriSpec Inspection Services of Hamilton, Brantford and Stratford
32 Livingstone Cres
Cambridge ON N3H 5S7
226-341-9569

URGENT REVIEW SUMMARY

Doc #: 010621SH2

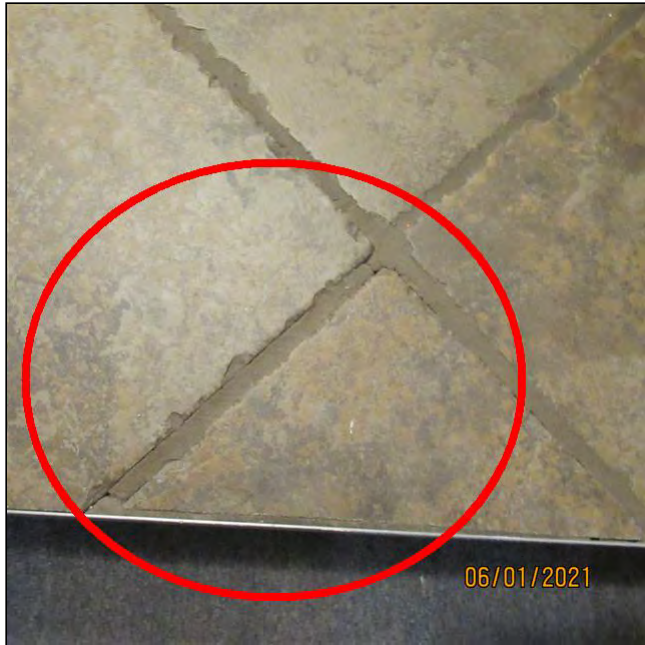
10.0 Item 1(Picture)

Loose/missing grout observed at the ground level landing at the basement stairs. We recommend re-grouting as necessary.

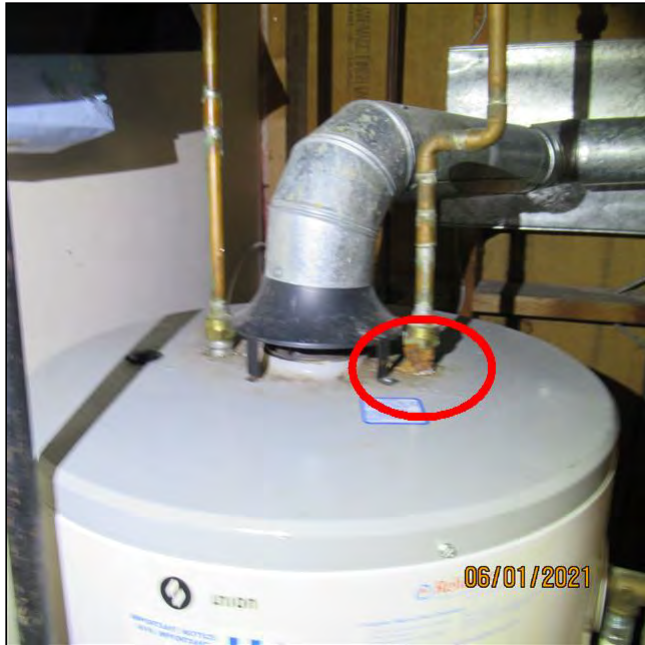
16.3 Item 1(Picture)

(1) Corrosion observed on unit. We recommend further review by a licenced technician.

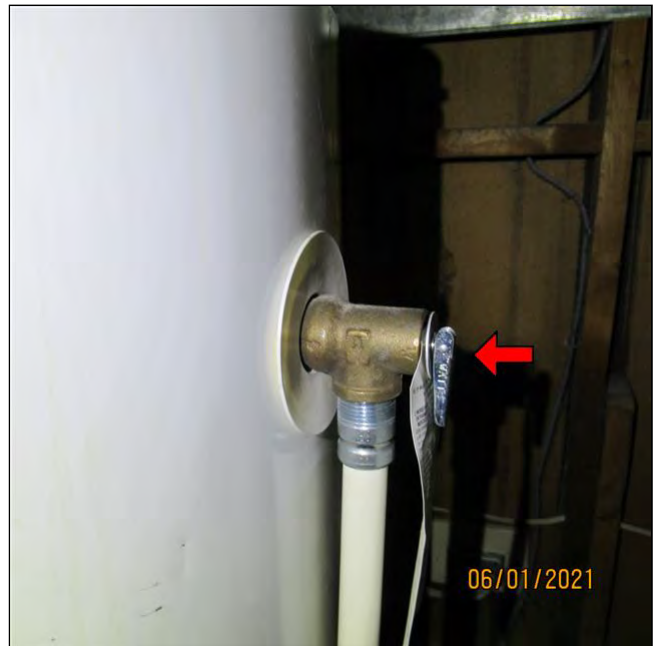
16.5 Item 2(Picture) TPR valve

Since a temperature pressure relief (TPR) valve is operated infrequently, it is not unusual for them to leak or break when operated after a period of inactivity. For this reason, the TPR valve is not tested during a home inspection. We suggest caution when operating TPR valves that have not been tested for a long period of time. When installed new the TPR valve should be tested regularly to ensure free movement in case of emergency. The client should consult with a licenced plumber for testing and operation of the TPR valve on older water heaters.

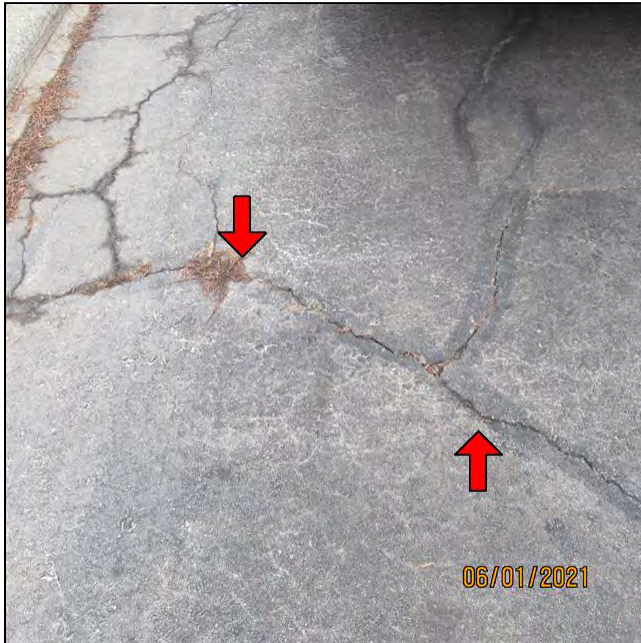
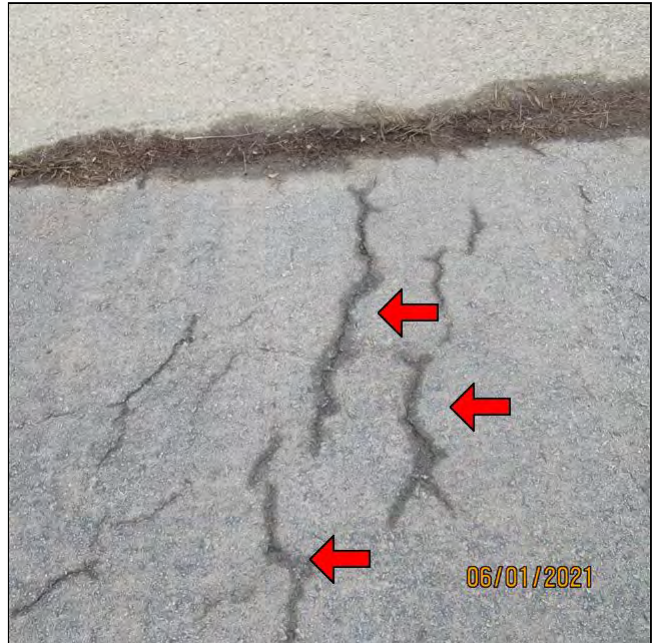
(1) Expansive cracks observed, we suggest filling cracks to prevent water infiltration and prevent further cracking.

(2) We recommend that the client seals/caulks the opening between the foundation and the driveway with an elastic sealant and seal the driveway in accordance to manufacturer's directions for further protection.

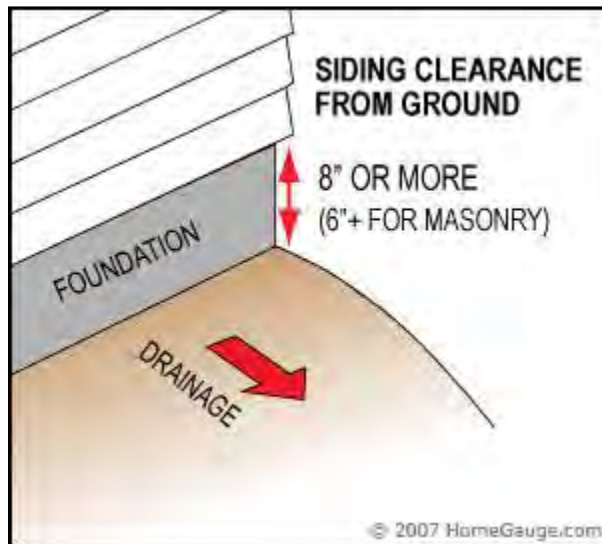
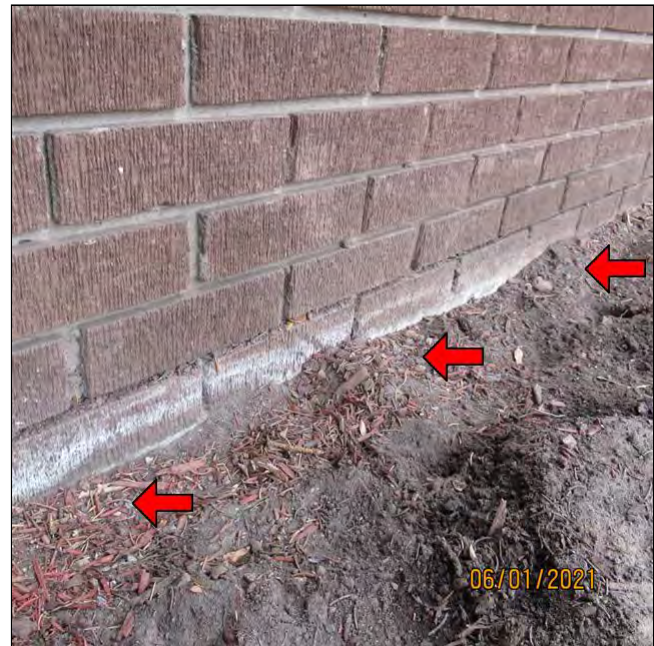
(3) Portions of the brick at front are in direct contact with the ground (front garden). This can cause accelerated deterioration of the brick, possible water intrusion at the rim plate and a higher probability of pest infestation. We recommend corrections to limit further damage/deterioration.

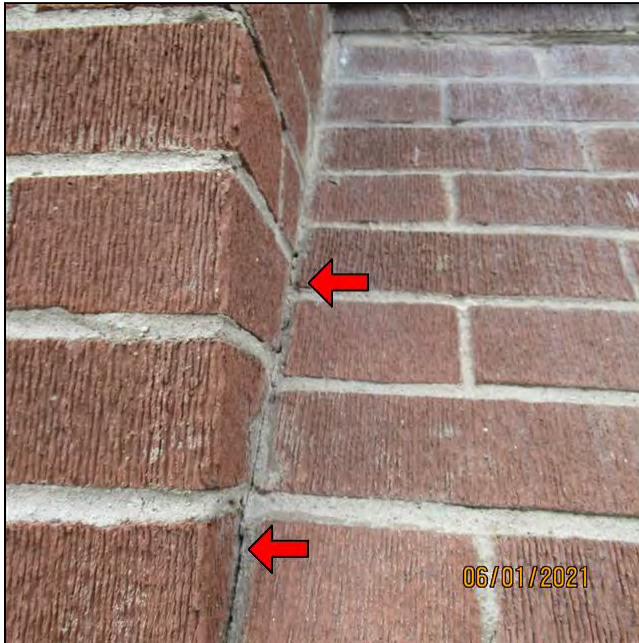
1.2 Item 6(Picture) Lower chimney

(6) Damaged/deteriorated mortar joints observed (left side of sliding door, front left side of garage, lower chimney, left side window). We suggest tuck pointing mortar repair as necessary to prevent further damage.

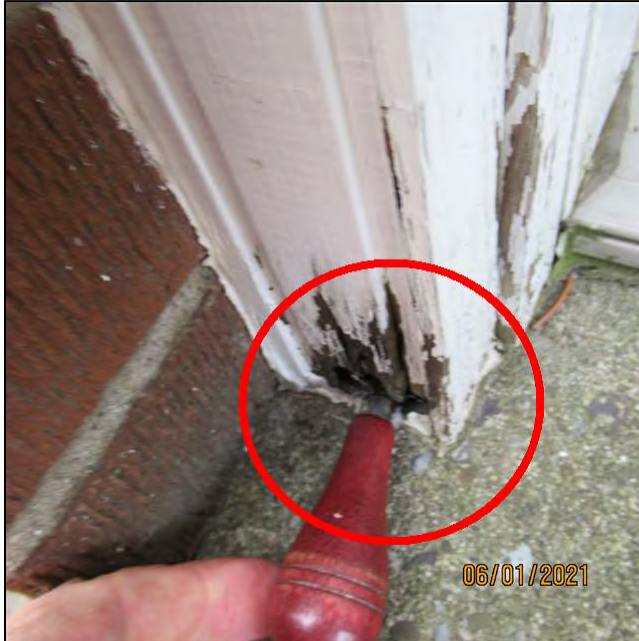
1.3 Item 3(Picture) Left side garage door

(3) Moisture damage, wood rot, observed at rear entry door and left side garage entry door (frame and trim). We recommend review for repair as necessary.

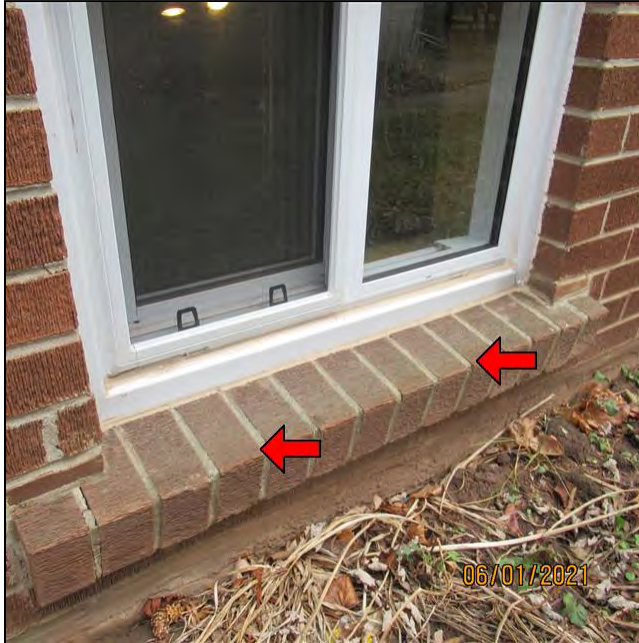
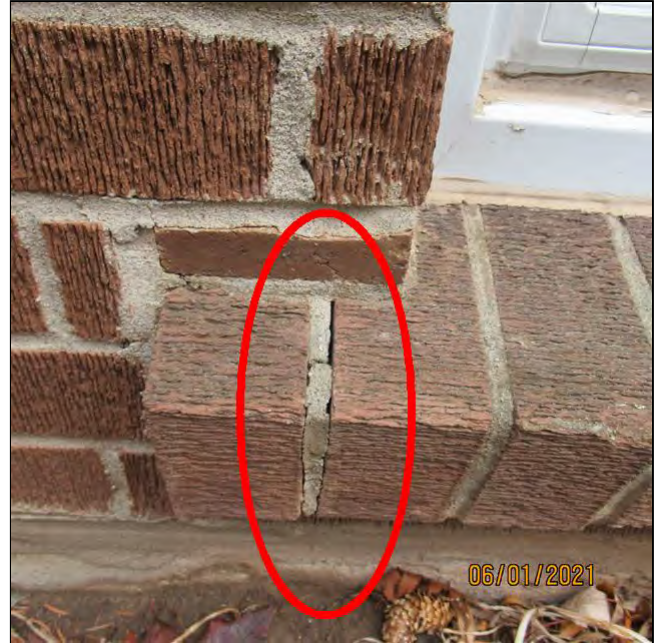
(1) Brick window sills noted. These types of sills are prone to water infiltration. We recommend maintaining the mortar joints and caulking seals in good condition or replace with precast sections.

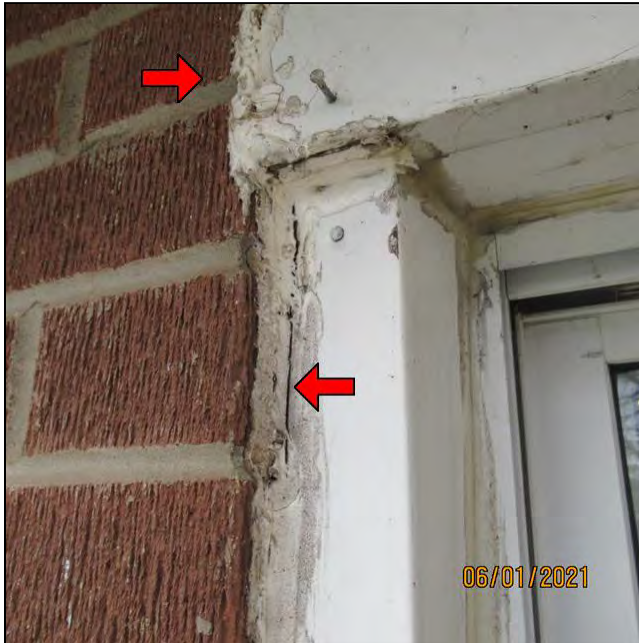
1.5 Item 1(Picture) Rear sliding door

(1) Missing or damaged caulking around windows and/or doors. We suggest sealing/caulking as part of routine maintenance to prevent further deterioration.

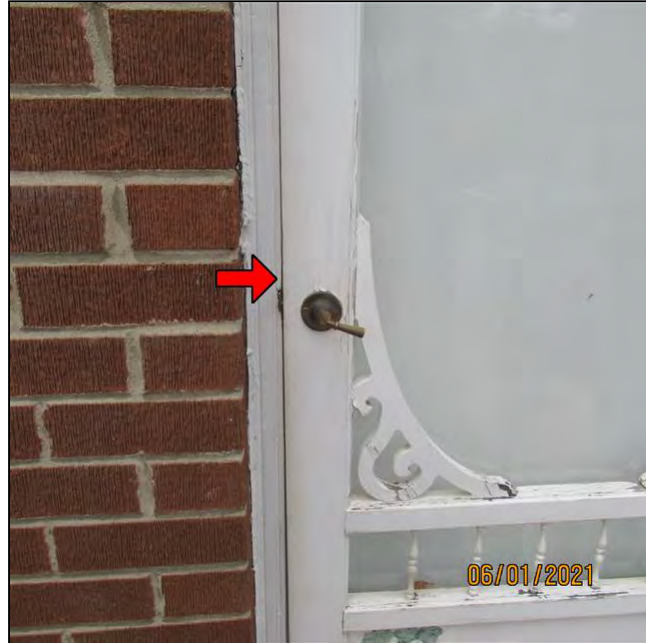
1.5 Item 4(Picture)

(2) Rear entry screen door does not close properly. Adjustments are required to restore proper operation.

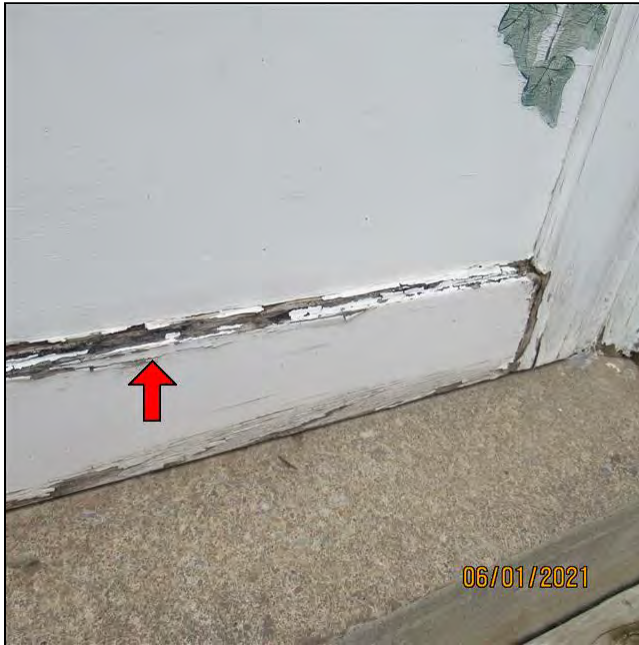
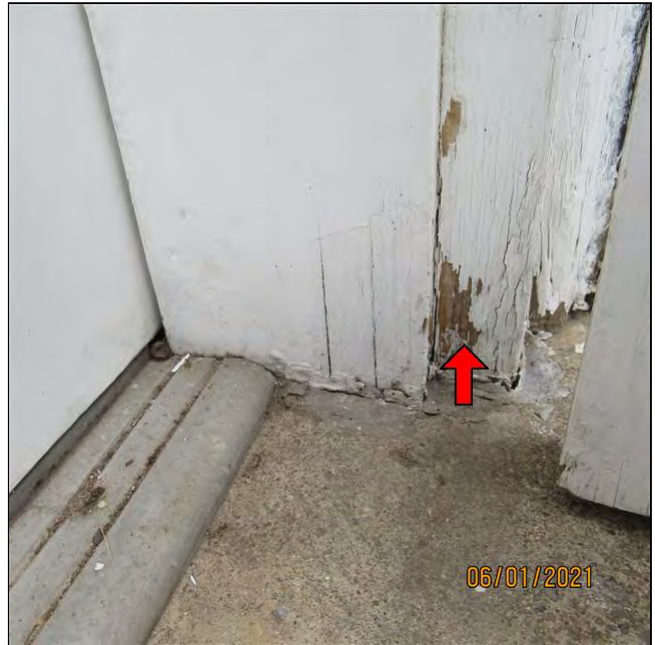
(3) Peeling paint/weathered conditions observed at rear entry and left side garage door entry. We suggest scraping and painting/staining as necessary as part of normal maintenance.

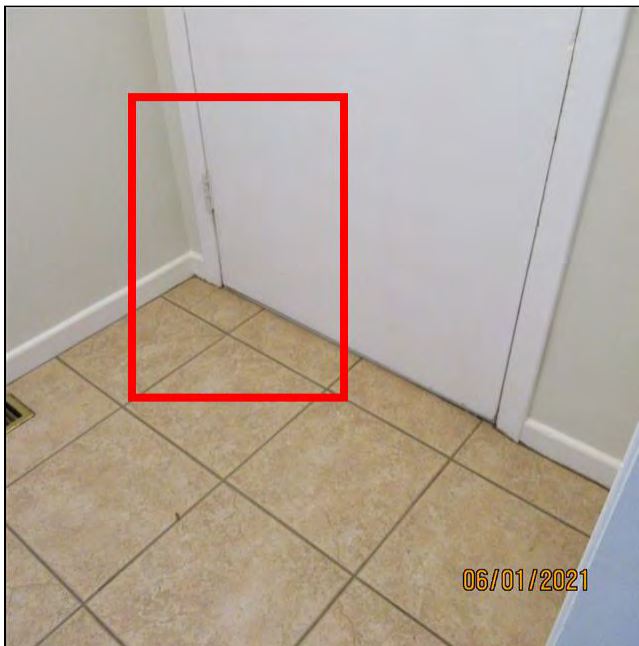
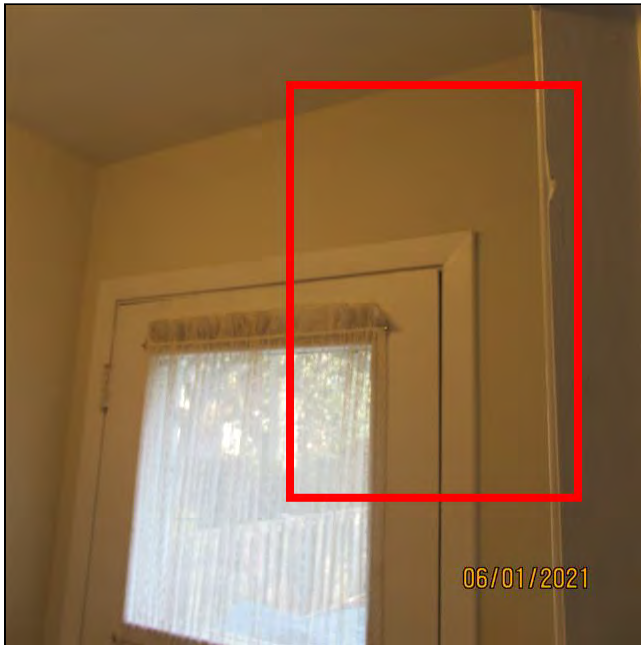
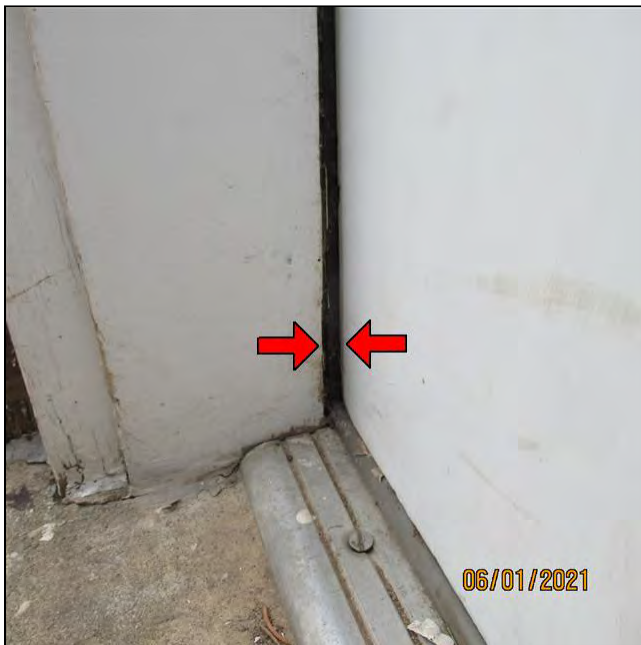
(5) Rear entry wood door is warped and does not contact the weather sealing uniformly. Air intrusion observed around the door where the weather seal is failing. We recommend review by a qualified contractor for replacement to restore energy efficiency and home comfort.

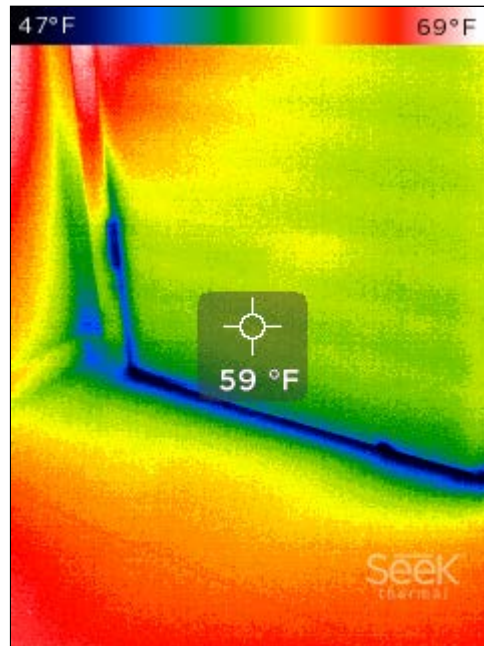
1.5 Item 9(Picture) Air infiltrating under the rear entry door

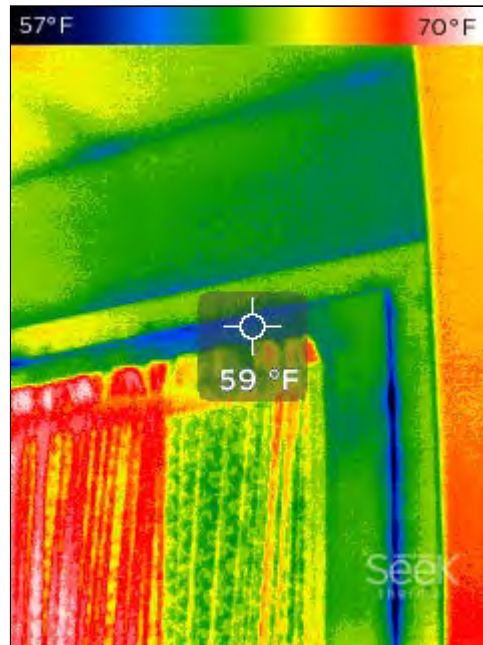
1.5 Item 11(Picture) Air infiltrating
around the rear entry door

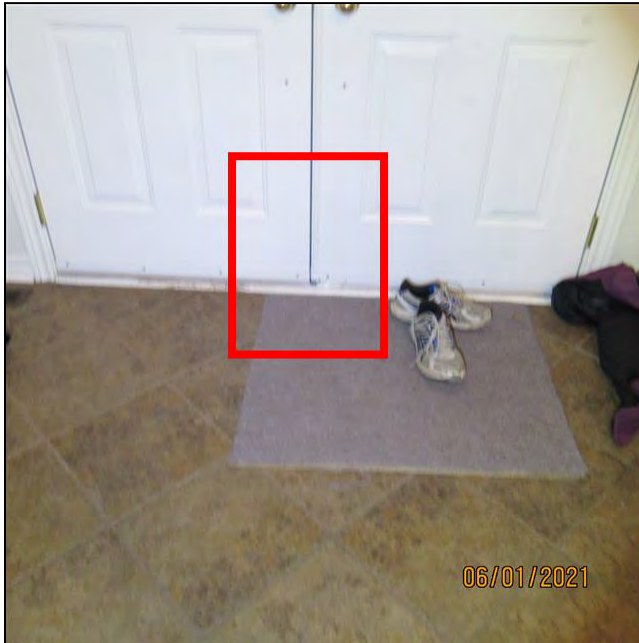
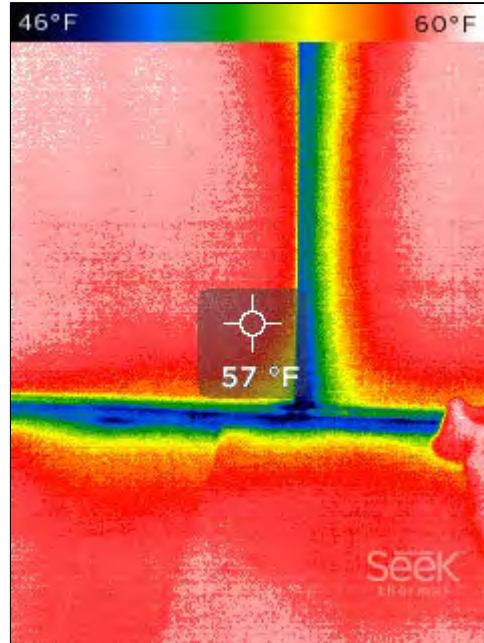
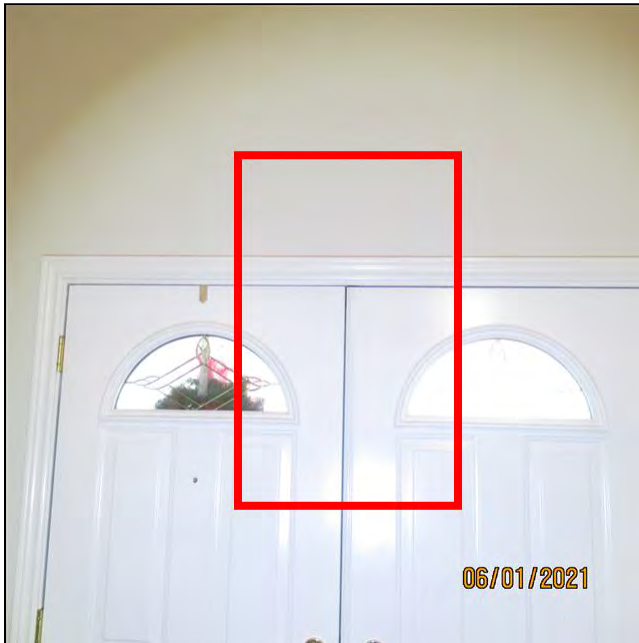
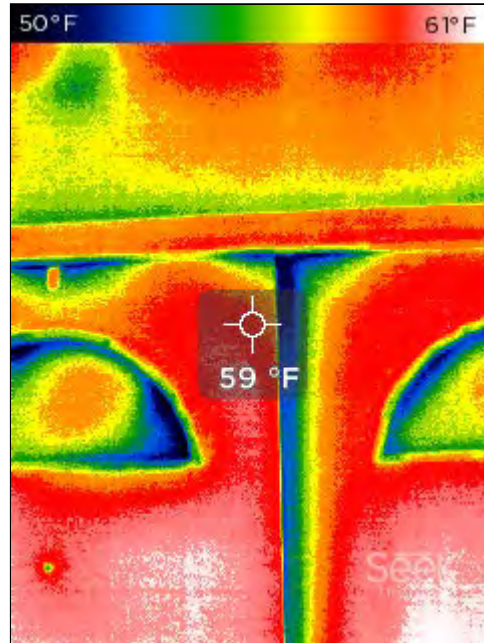
(6) French-style exterior doors are difficult to seal. Maintaining the weather seal will improve energy efficiency and home comfort.

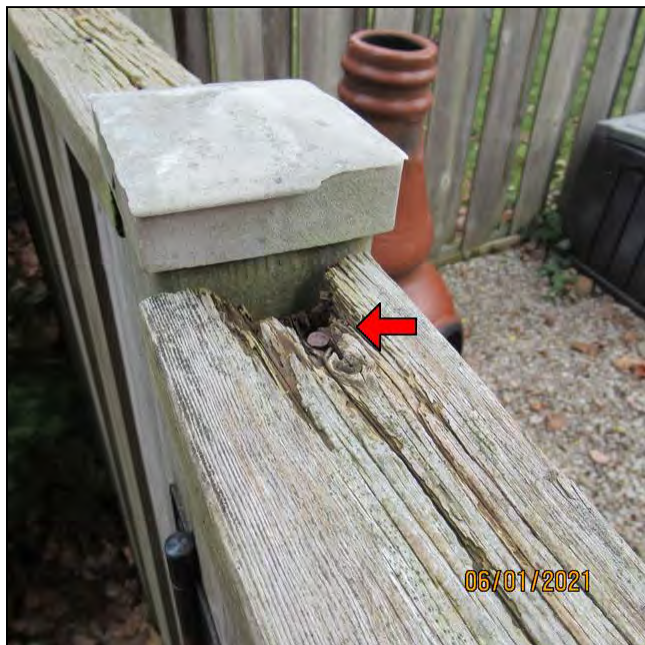
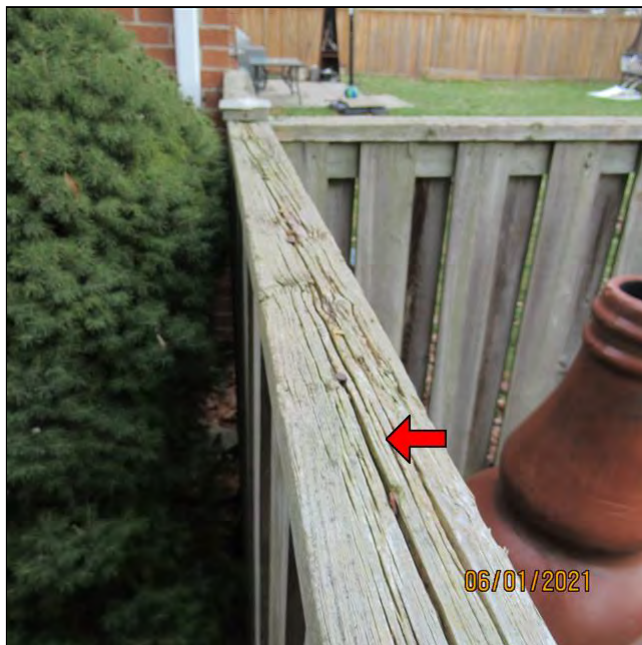
Wood deterioration observed at the left side gate and fence top rail. We suggest repairs/replacement as needed.

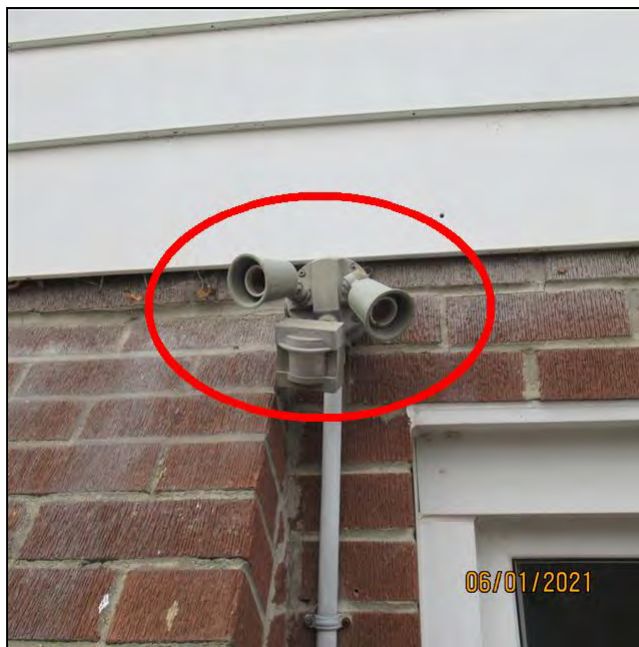
1.8 Item 1(Picture)

(1) Light fixture at rear was inoperative at time of inspection; missing bulbs. We suggest the client verify fixture for proper operation prior to closing.

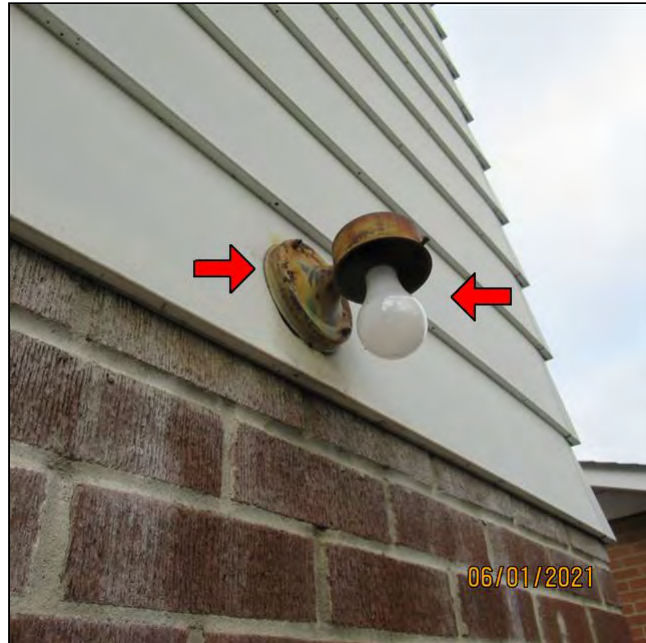
1.8 Item 2(Picture)

(2) The light fixture at the rear entry door is not properly sealed and is missing its globe. Correct as necessary.

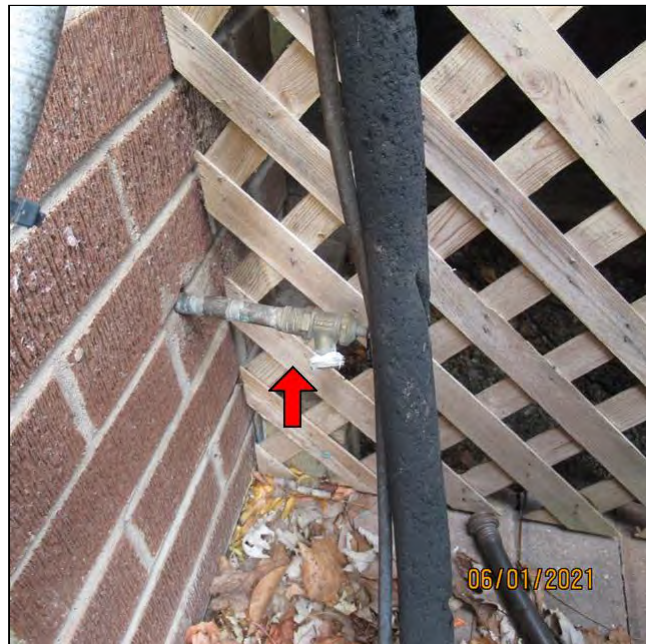
1.11 Item 1(Picture)

Winterized, unable to test. Client is advised to consult sellers as to operation.

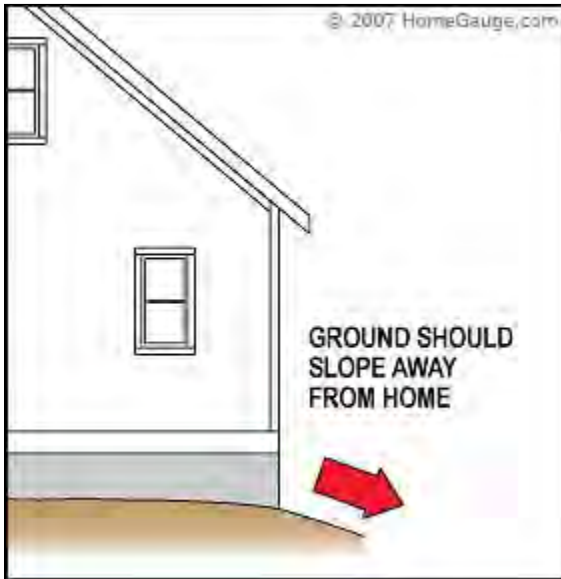
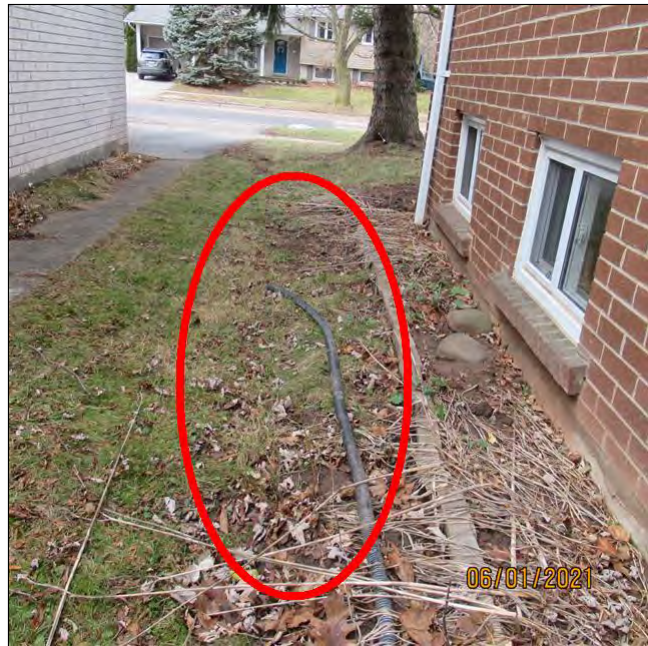
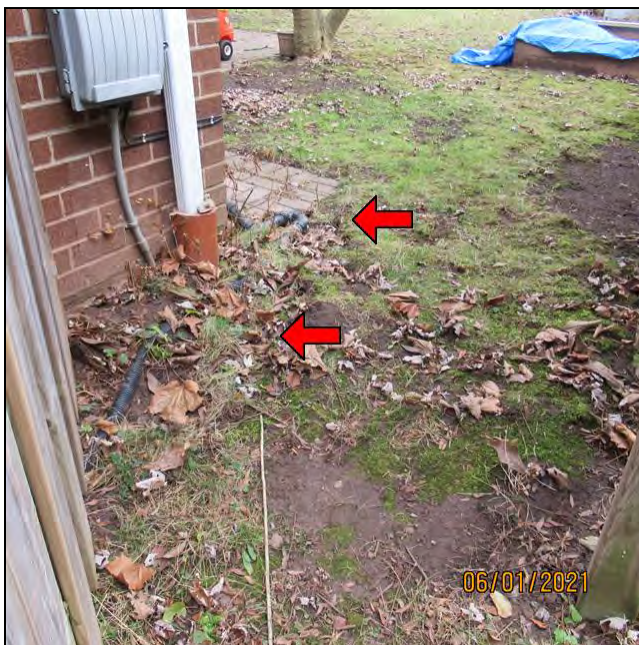
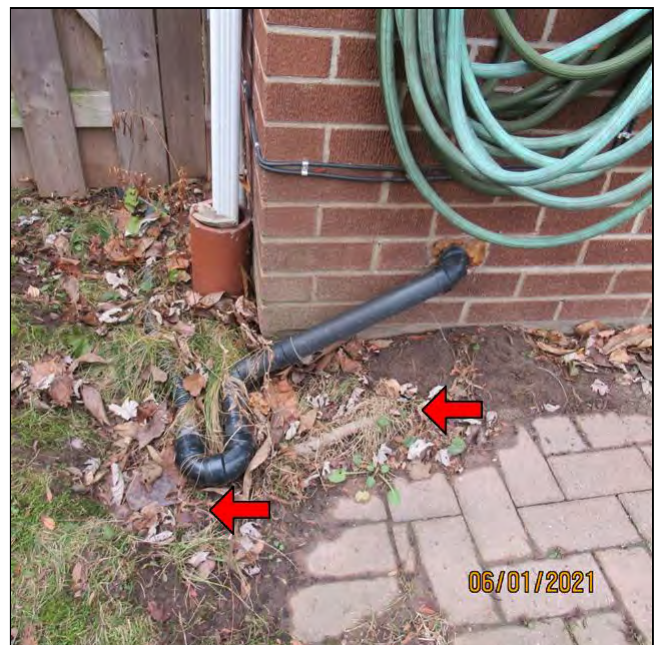
The grade at the foundation appears to be inadequate at right side and rear. We recommend monitoring water flow patterns during heavy rainfall and snow melt events to determine how water flows around the foundation. Water should flow freely away from the foundation and off the property to limit water pressure on the foundation. We recommend changing the grading around the foundation to ensure effective water drainage away from the foundation.

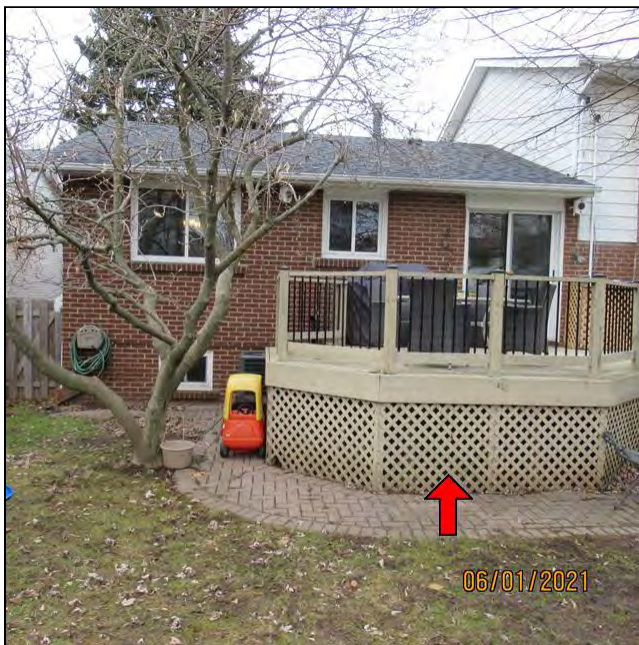
1.18 Item 2(Picture)

(2) Skirting around the deck limited the review of the structure of the deck and grade.

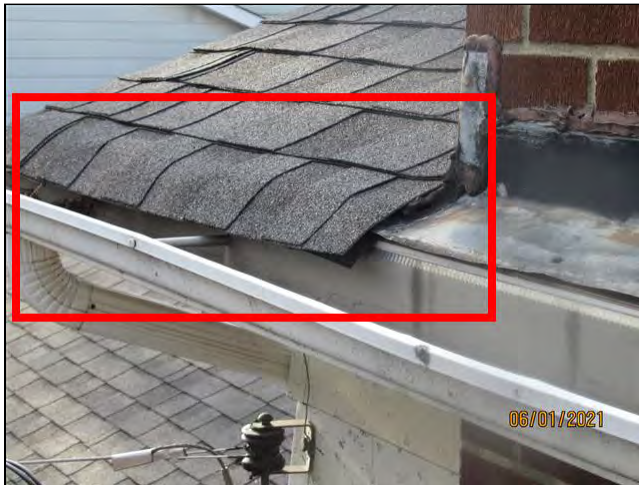
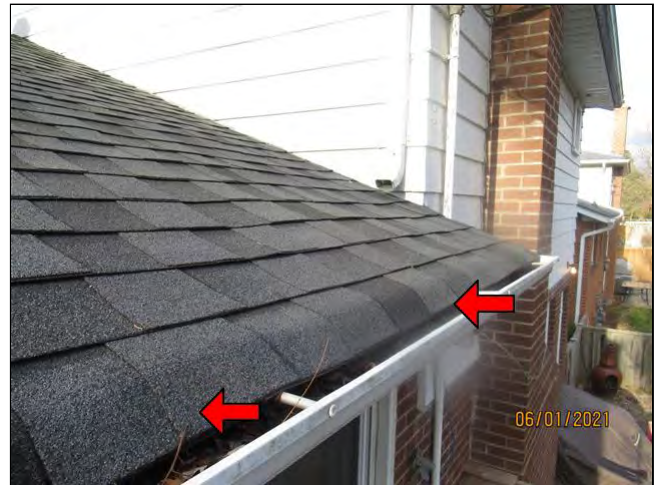
(1) Excessive shingle overhang observed. Shingles should not extend more than 3/4" (19 mm) past the drip edge. If shingles overhang the edge of the roof by more than 3/4" (19 mm), then they are not supported and may crack and break off. In addition, the wind resistance at the roof edge may be compromised. We recommend review by a qualified roofer for corrections as necessary.

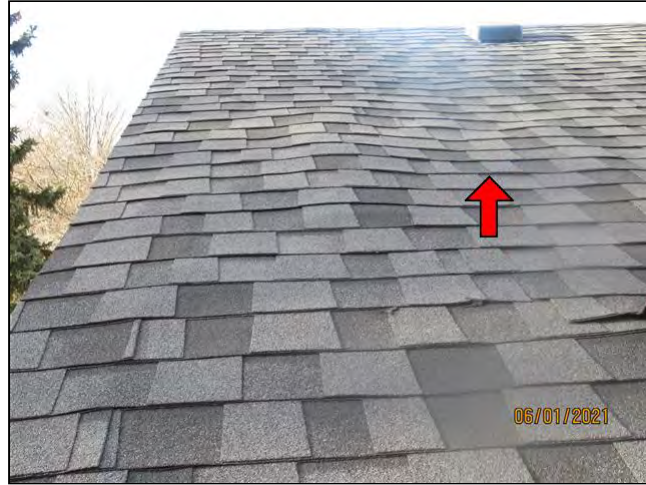
2.0 Item 3(Picture)

(2) Sagging noted in the roof decking. We are unable to determine the cause of the sag; may be associated with deterioration of the roof sheathing observed in the attic. We recommend consulting with a licenced roofing contractor for further review and repair, as required.

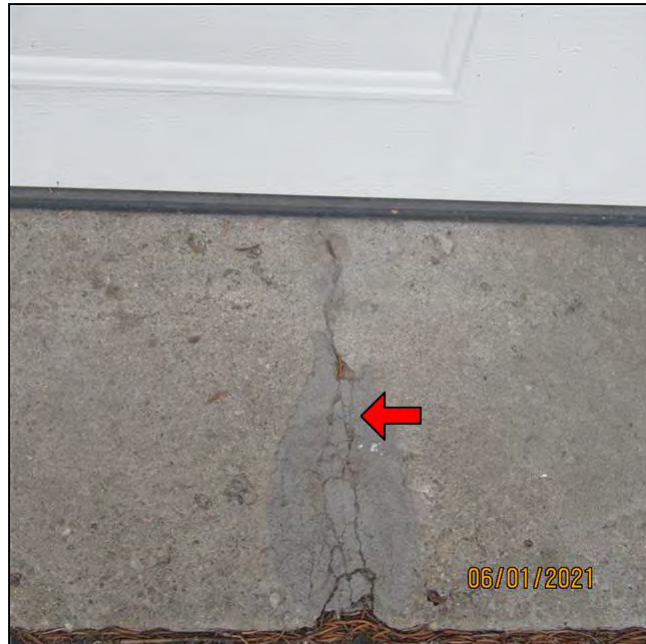
3.0 Item 1(Picture)

Common cracks observed. Generally, concrete floor slabs are not structural. Concrete floors naturally crack during the curing process due to shrinkage. Since the concrete slab does not usually carry the load of the structure, shrinkage cracks are generally considered cosmetic. However we do recommend sealing all cracks in concrete/asphalt/brick surfaces to prevent water penetration as a routine maintenance effort.

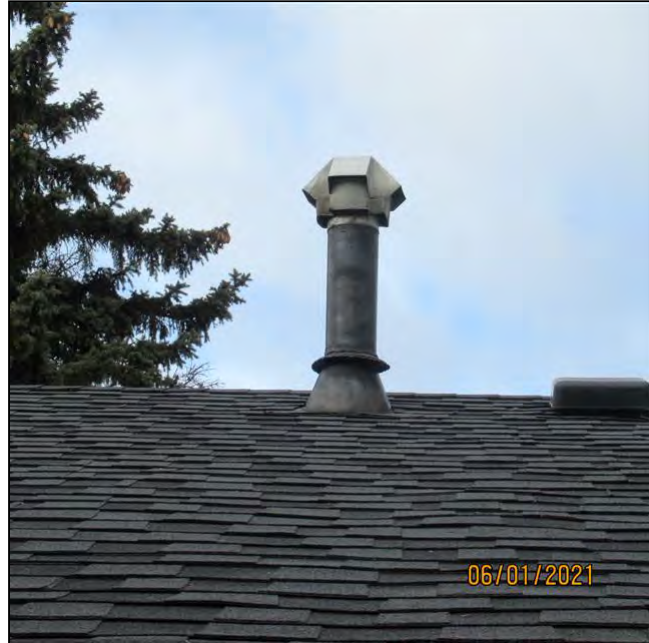
4.5.A Item 1(Picture)

Limited review, chimney was viewed from the ground and with a camera mounted on a telescopic pole. Our chimney review is limited to visible accessible components only. If further review is desired, we suggest review by a qualified professional.

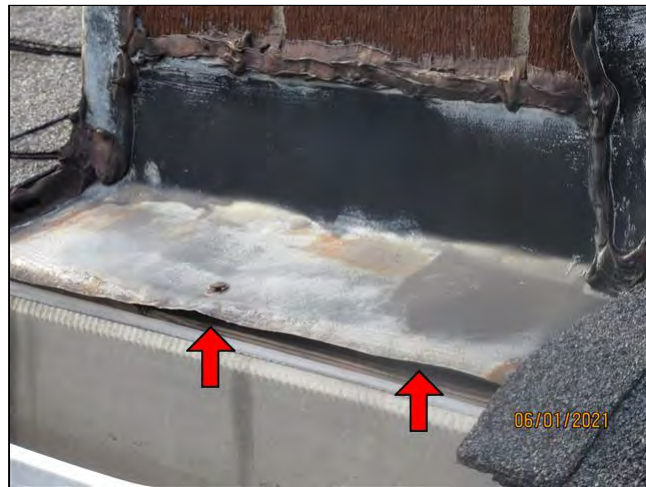
4.2.B Item 3(Picture)

(2) Lower flashing is loose. We recommend securing.

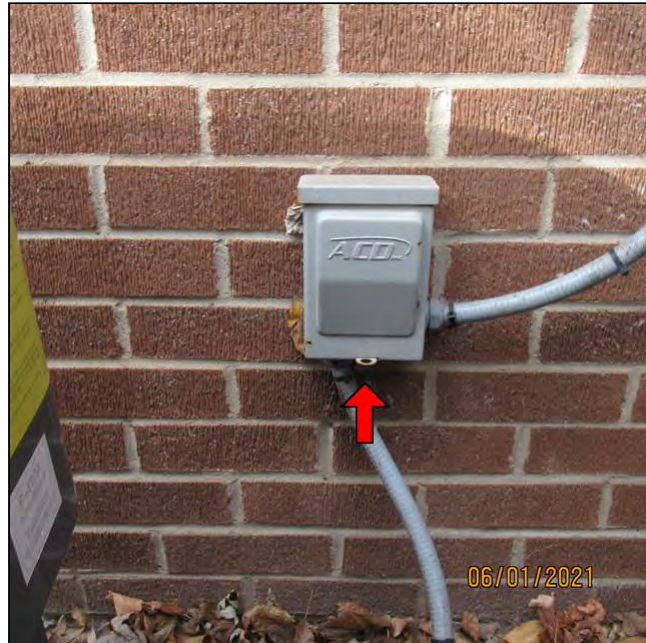
5.1 Item 1(Picture)

Electrical disconnect observed. It is recommended that the disconnect be kept locked at all times to prevent access by children.

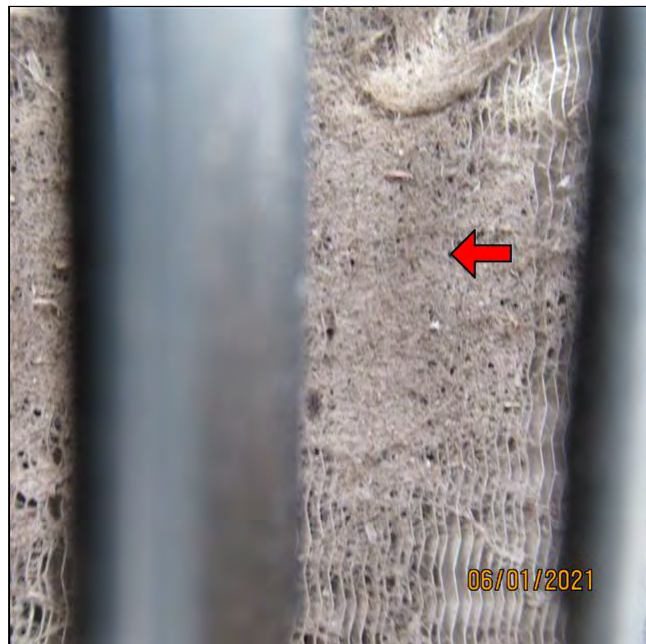
5.2 Item 1(Picture)

(2) The condenser coil fins are dirty and need to be cleaned. We recommend service by a licensed HVAC contractor to assure serviceability.

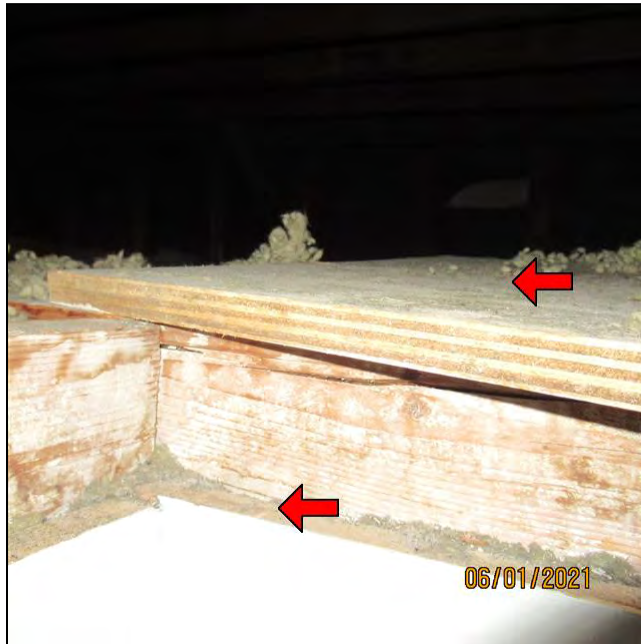
6.0.A Item 1(Picture)

(2) Missing or low levels of insulation and weather sealing on the attic hatch. We recommend properly insulating and weatherstripping the hatch for improved energy efficiency and to limit warm moist air escaping into the attic space.

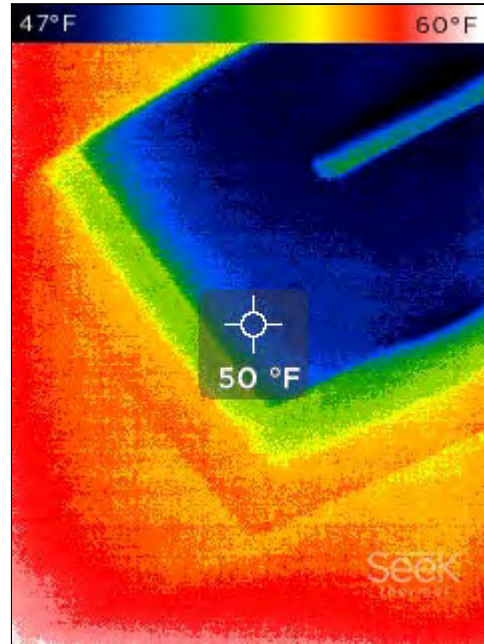
6.0.A Item 2(Picture) Attic hatch with no insulation is chilled by the attic air

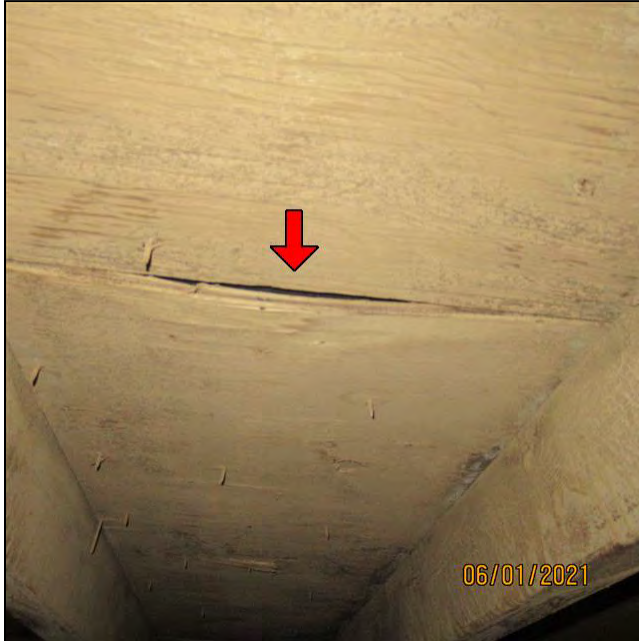
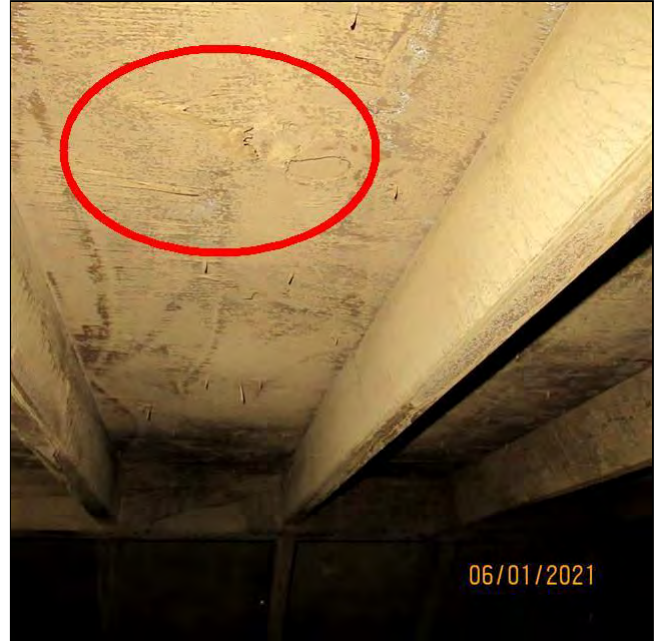
(1) Cracked, warped plywood decking observed. Recommend review by qualified professional for repair or replacement as necessary.

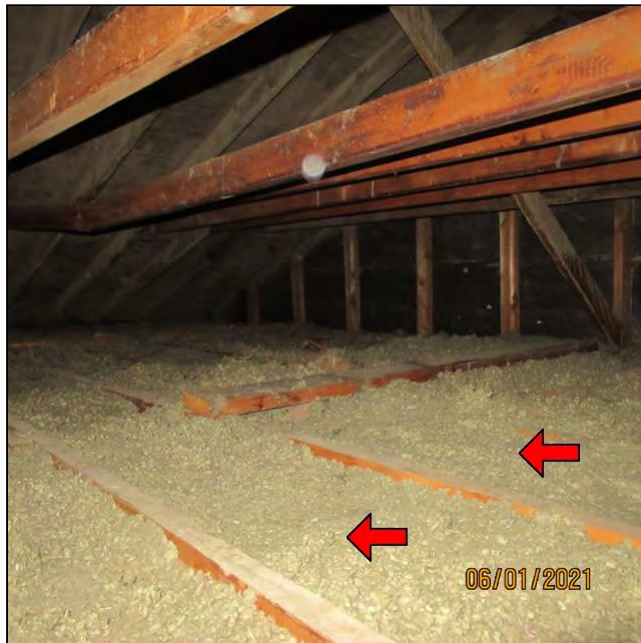
6.2.A Item 1(Picture)

3-4" of insulation present, equivalent to approximately R10 of insulation value. We recommend adding additional insulation to at least R50.

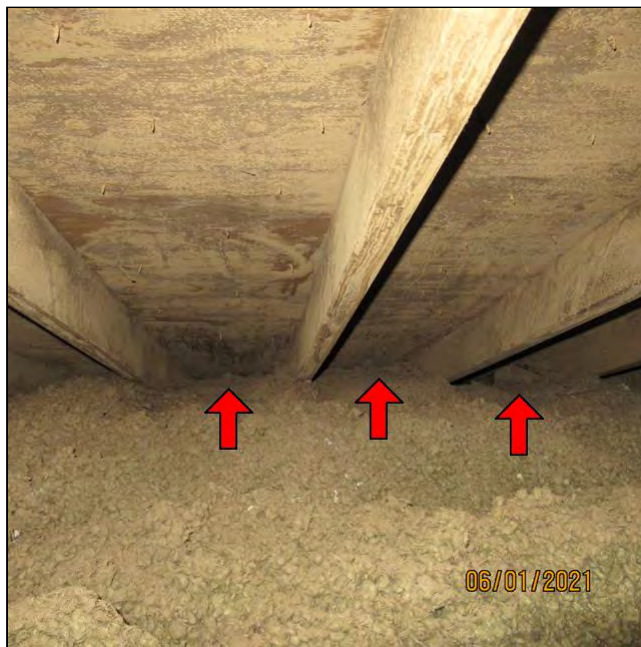
6.6.A Item 1(Picture)

No soffit venting observed in the attic. It appears the insulation was blown into the soffit space without channels being installed to allow ventilation through the soffit into the attic space. We recommend adding additional ventilation to avoid premature aging of roof and help to maintain proper humidity and temperature control.

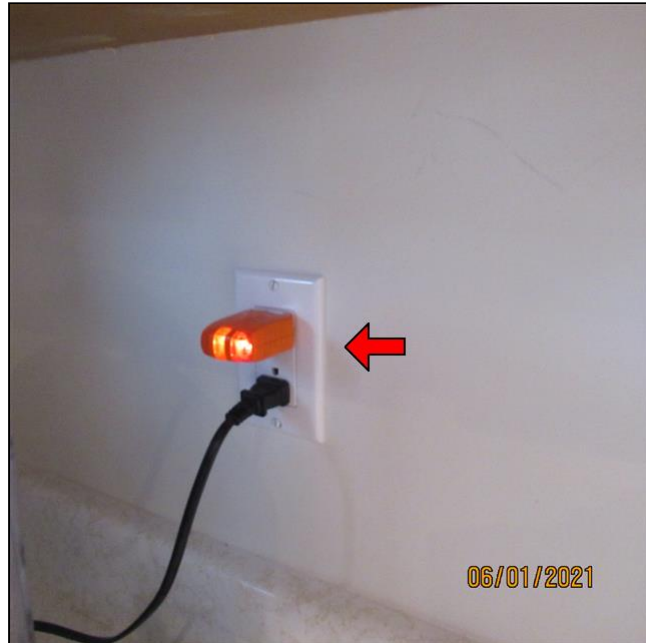
7.6 Item 1(Picture)

Reversed polarity wiring conditions was observed at the receptacle to the right of the kitchen sink. A reversed polarity condition occurs when the hot and neutral wires are connected to the opposite terminal connections of the outlet (i.e. hot wire connected to neutral terminal and neutral wire connected to hot terminal). This can be a safety hazard. This condition is usually easily corrected by minor wiring adjustments at the specific outlet(s).

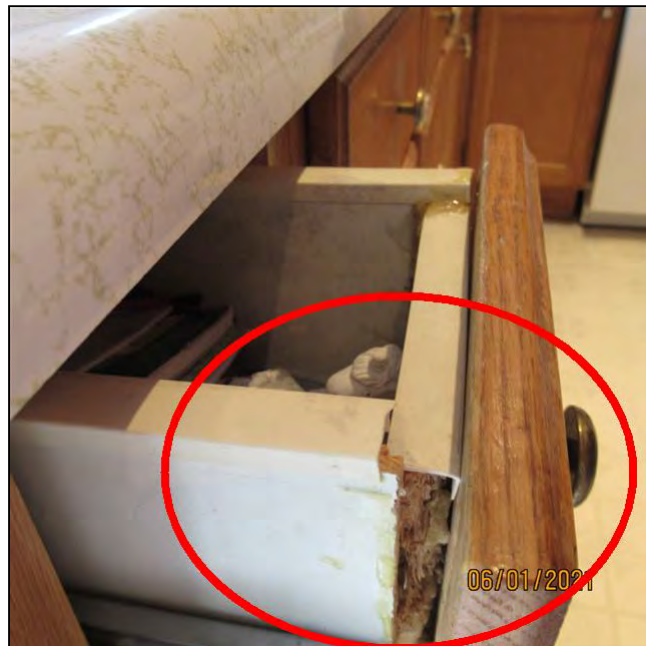
7.7 Item 1(Picture)

Drawer is pulled apart; corrections needed for proper and smooth operation.

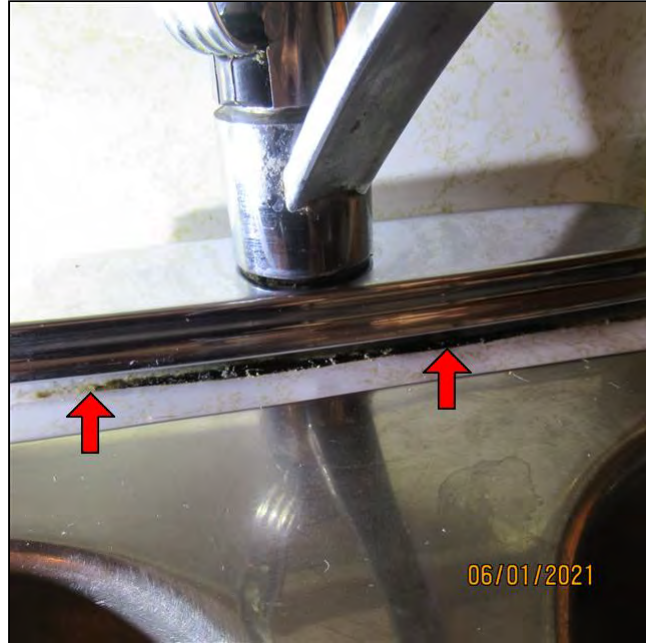
7.10 Item 1(Picture)

Faucet loose, allowing water to leak into the counter top. Recommend review by qualified professional for repair or replacement as necessary.

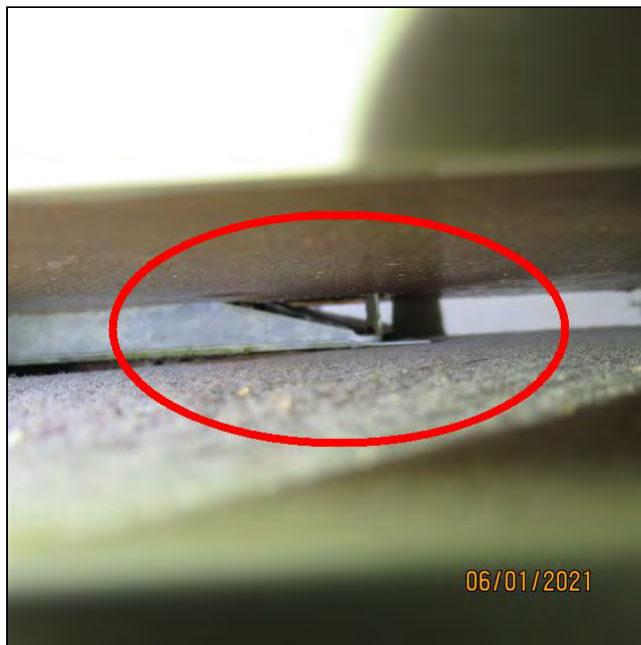
7.16 Item 1(Picture)

The range hood appears to be vented to the exterior. However, the connection to the vent pipe is poor, allowing air to recirculate to the kitchen. We recommend corrections to restore proper function.

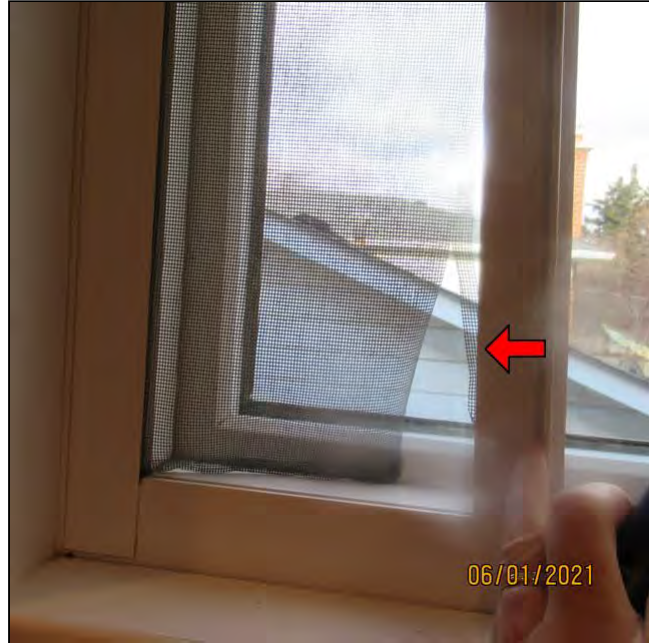
8.4.B Item 1(Picture)

Retractable screen is torn. Correct as necessary to restore proper function.
