SUMMARY REPORT

AmeriSpec Inspection Services of Hamilton, Brantford and Stratford
32 Livingstone Cres
Cambridge ON N3H 5S7
226-341-9569

URGENT REVIEW SUMMARY

Doc #: 010621SH2

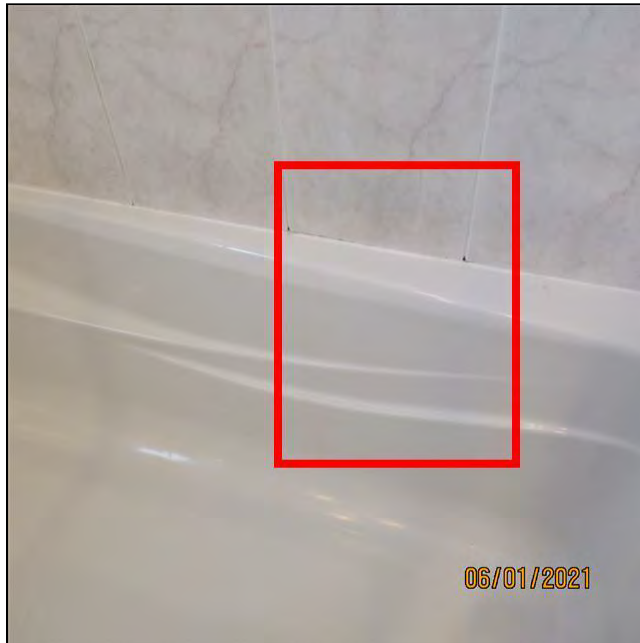
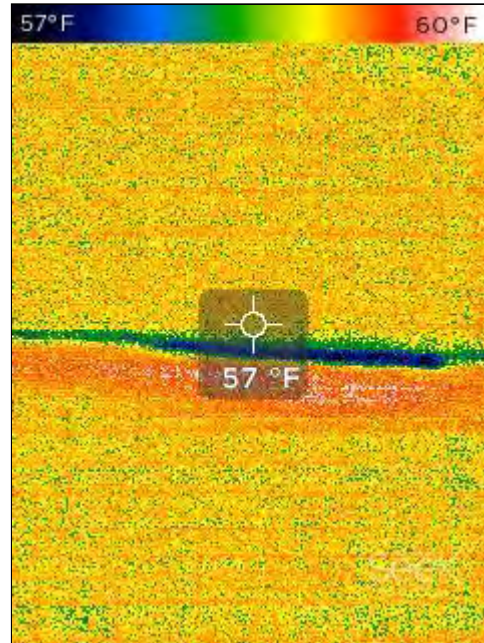
The tile edges of the tub/shower walls should be caulked and sealed to reduce the potential for water/moisture penetration behind the surround as part of routine maintenance. Failure to keep the walls sealed can cause deterioration and extensive moisture damage to the interior walls, which is not always visible to the inspector at the time of inspection. We recommend that all escutcheon plates be properly caulked and sealed as part of routine maintenance to reduce the potential for moisture infiltration behind the surround walls.

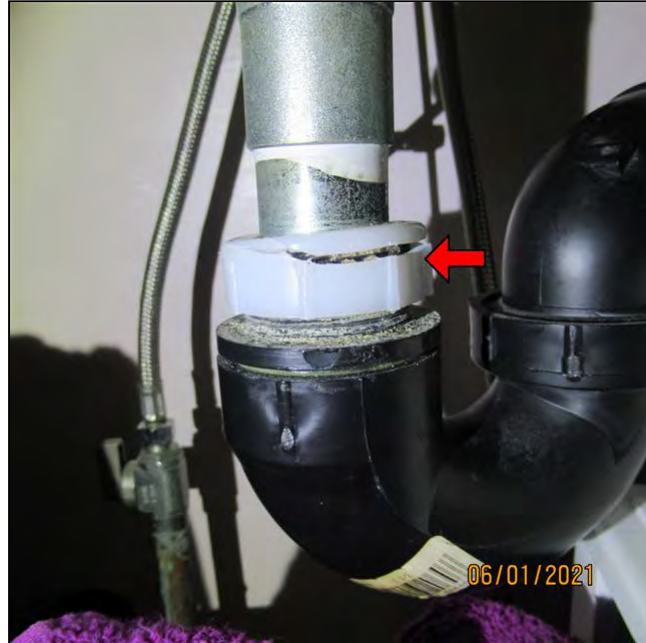
8.16.B Item 1(Picture)

Left sink drain assembly has a cracked/loose connection; no leaks observed. We recommend review by a qualified professional for repair or replacement, as necessary.

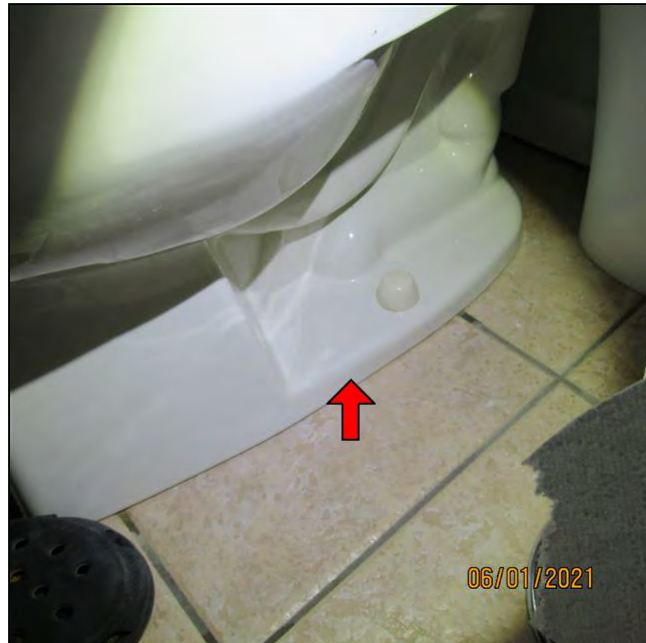
8.17.C Item 1(Picture)

The toilet bowl is loose at floor anchor bolts. The wax ring inside the unit must have a snug, secure fit in order to keep from leaking. Properly resealing and re-securing this unit is suggested to prevent water leakage and damage to the sub-floor area. This type of damage is not always visible or accessible to the inspector at time of inspection. Recommend review by a qualified plumber for repair or replacement, as necessary.

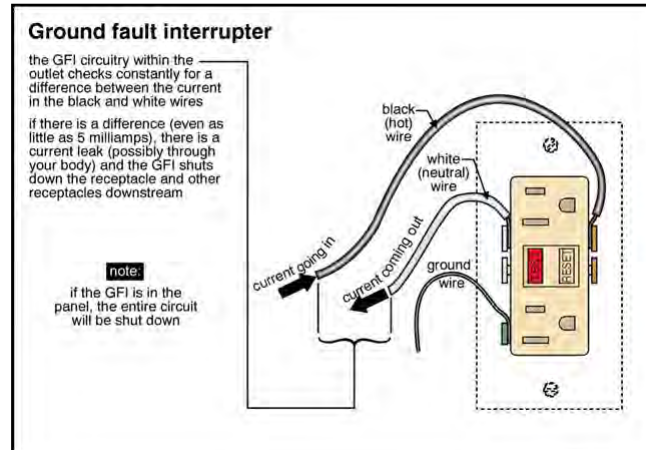
9.10 Item 1(Picture)

A Ground Fault Circuit Interrupter (GFCI) is not present at laundry room, suggest installing GFCI for safety. A qualified electrical contractor is needed for further review and to make necessary repairs/corrections

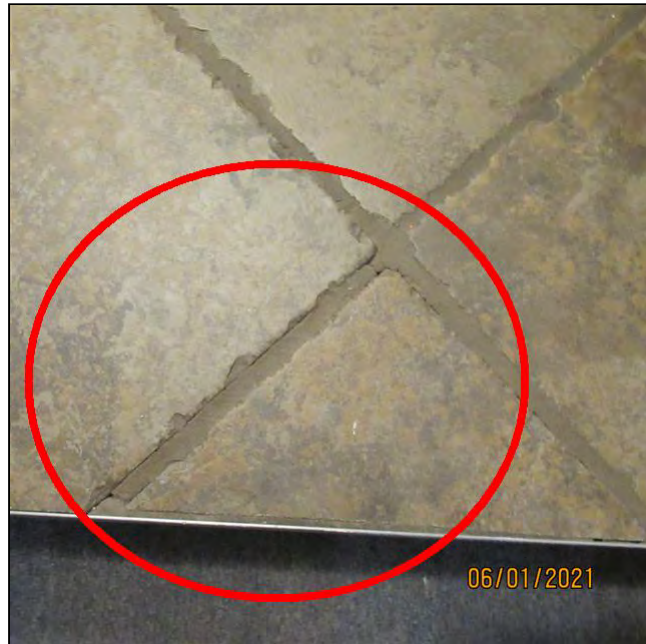
10.0 Item 1(Picture)

Loose/missing grout observed at the ground level landing at the basement stairs. We recommend re-grouting as necessary.

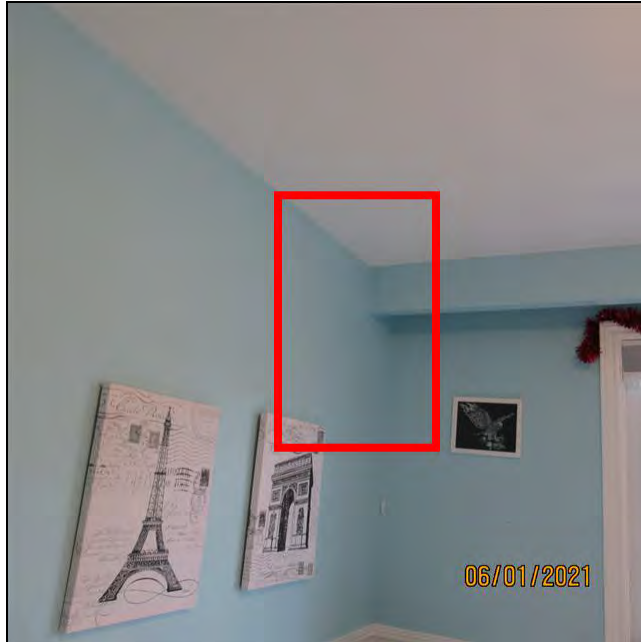
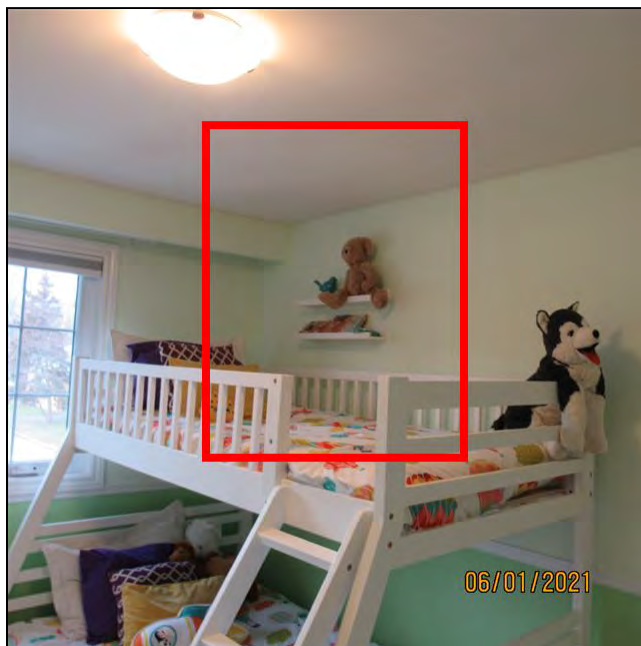
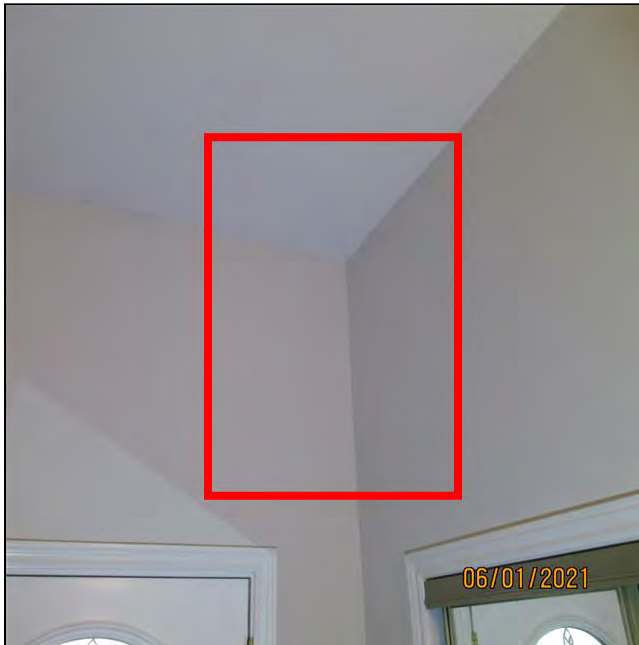
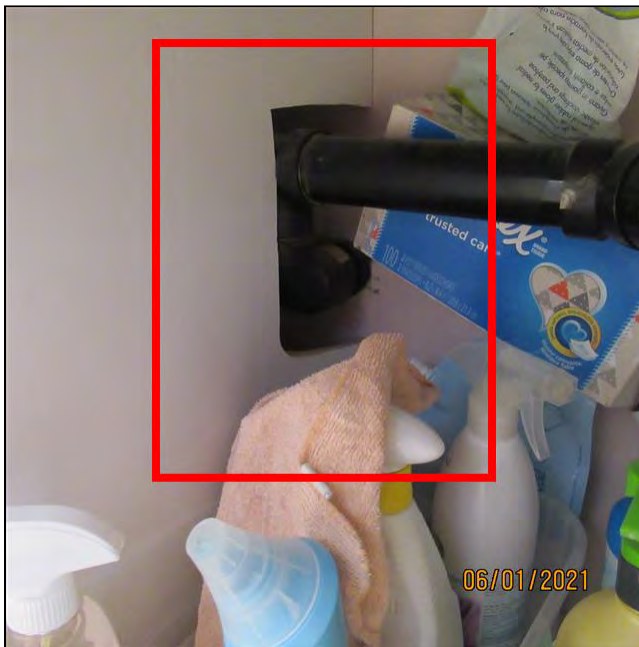
Air infiltrates into the wall assembly and chills exterior corners where sealing and insulating at the time of construction was difficult. Sealing and insulating these areas increases energy efficiency and home comfort.

Air that infiltrates into the wall assembly can also exit into the house through holes in the wall covering (pipe passing through the wall, electrical outlets, switches and light fixtures). Sealing holes to the interior will improve energy efficiency and home comfort.

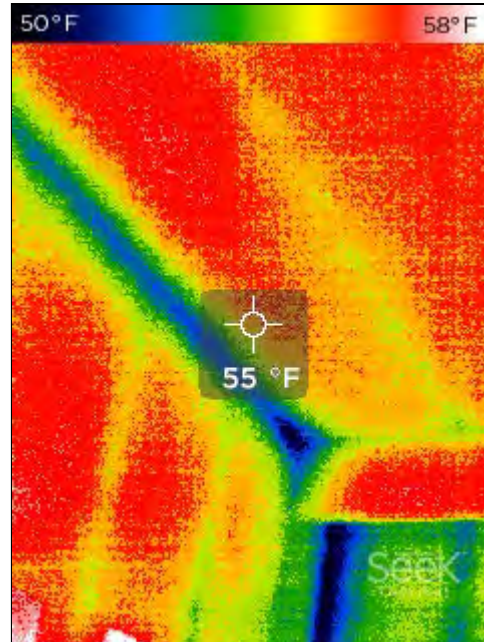
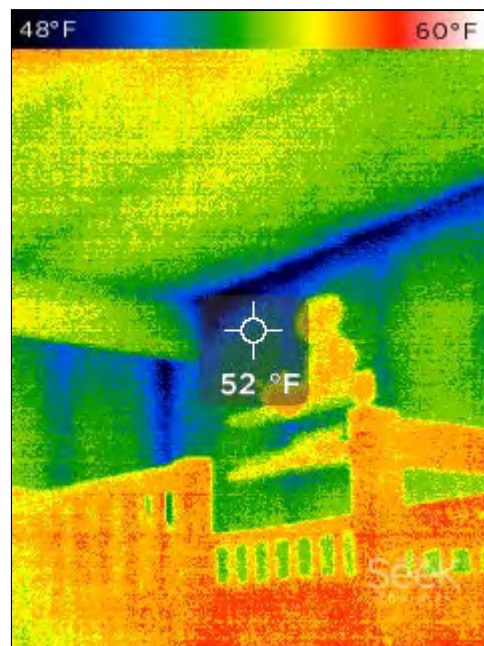
11.1 Item 2(Picture) Chilled corners at exterior walls

11.1 Item 4(Picture) Chilled corners at exterior walls

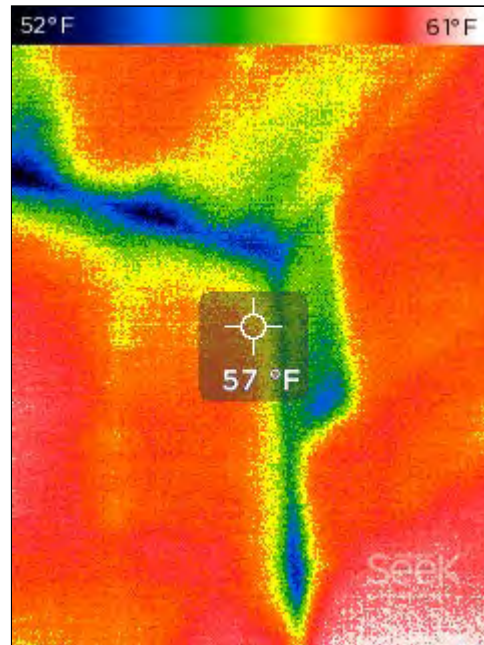
11.1 Item 6(Picture) Chilled corners and possible missing or loose insulation in the upper right corner

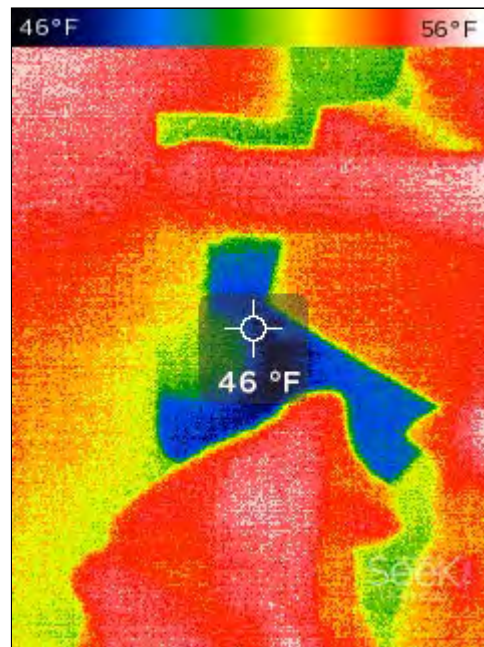
11.1 Item 8(Picture) Hole for drain pipe below the sink

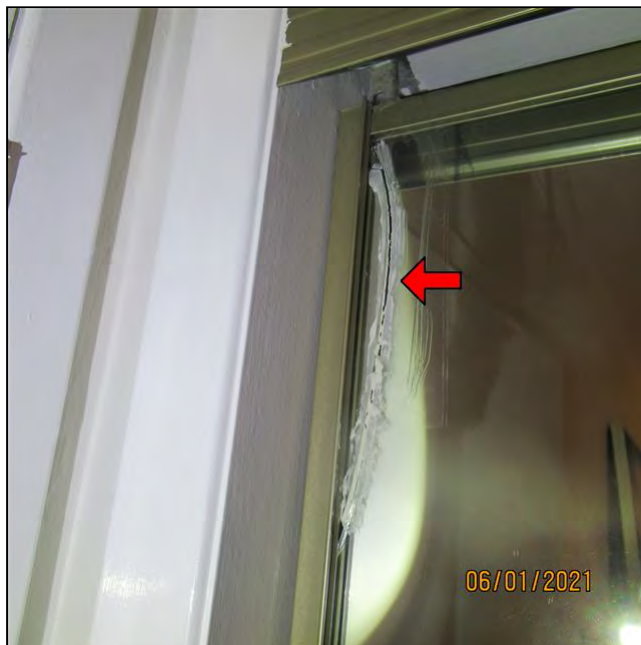
11.3 Item 1(Picture)

Cracked mirror observed at sliding closet door in the master bedroom. This is primarily a cosmetic concern. Caulking has been applied to protect against the sharp edges; may require repair.

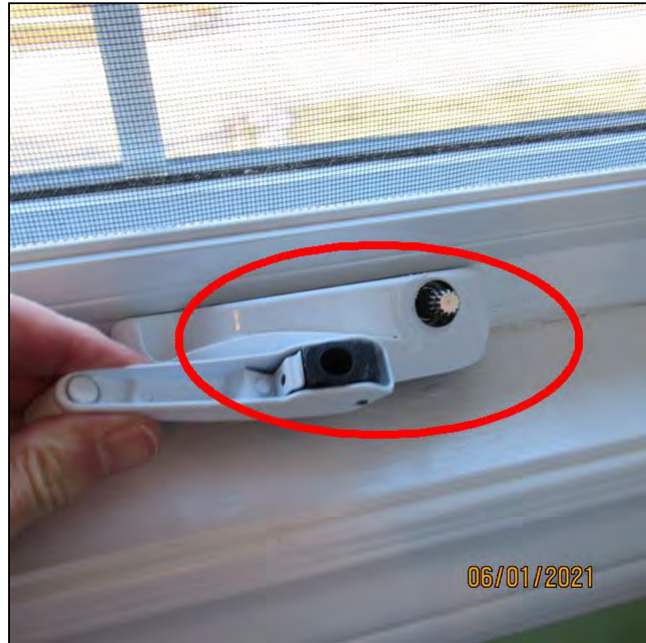
11.4 Item 2(Picture)

(2) Crank mechanism is not operational at the front left bedroom. Hardware repair/replace is needed for proper operation.

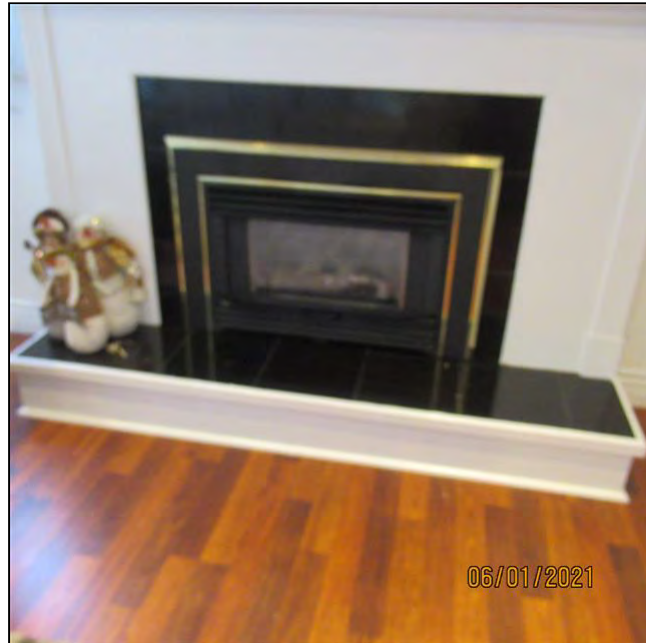
11.7 Item 1(Picture)

Inspector was not able to operate the fireplace. No pilot light operating to ignite the fireplace.

A fireplace insert was observed. We are unable to determine by a visual inspection if this system was installed according to manufacturer's specifications or local building authority requirements. Inserts, flues, and flue liners are not visible or accessible for examination unless the insert is removed. Due to safety concerns regarding dirty flues, cracks, damaged and/or deteriorating flues and chimney on fireplaces, we suggest complete review of these areas by a certified technician to ensure proper operation and fire safety.

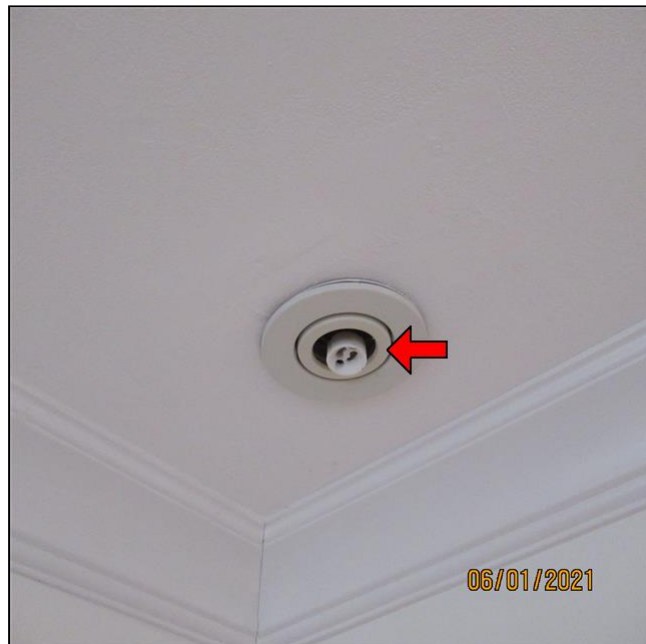
11.8 Item 1(Picture)

(1) Light fixture in the family room was inoperative at time of inspection. Missing bulb observed. We suggest the client verify fixture for proper operation prior to closing.

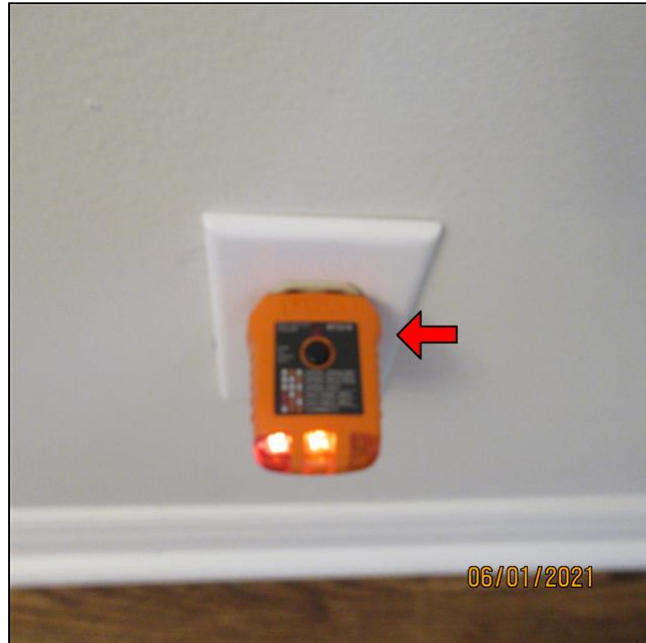
11.8 Item 2(Picture)

(2) Reversed polarity wiring conditions was observed at the receptacle in the dining room. A reversed polarity condition occurs when the hot and neutral wires are connected to the opposite terminal connections of the outlet (i.e. hot wire connected to neutral terminal and neutral wire connected to hot terminal). This can be a safety hazard. This condition is usually easily corrected by minor wiring adjustments at the specific outlet(s).

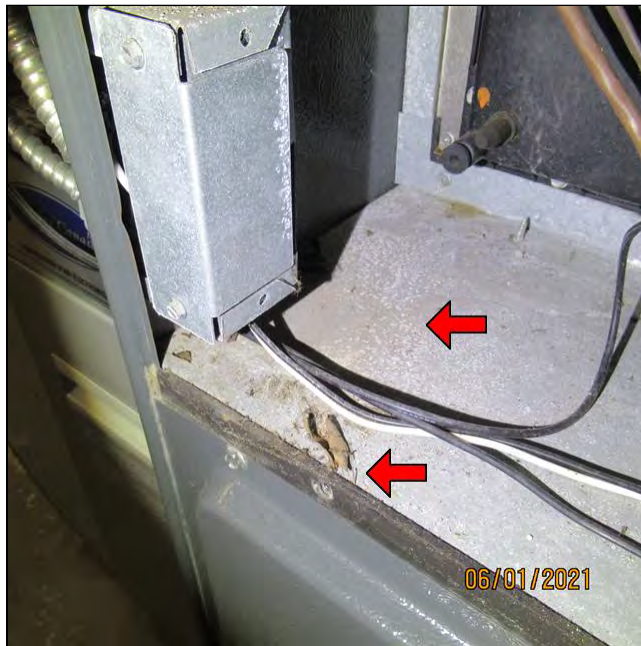
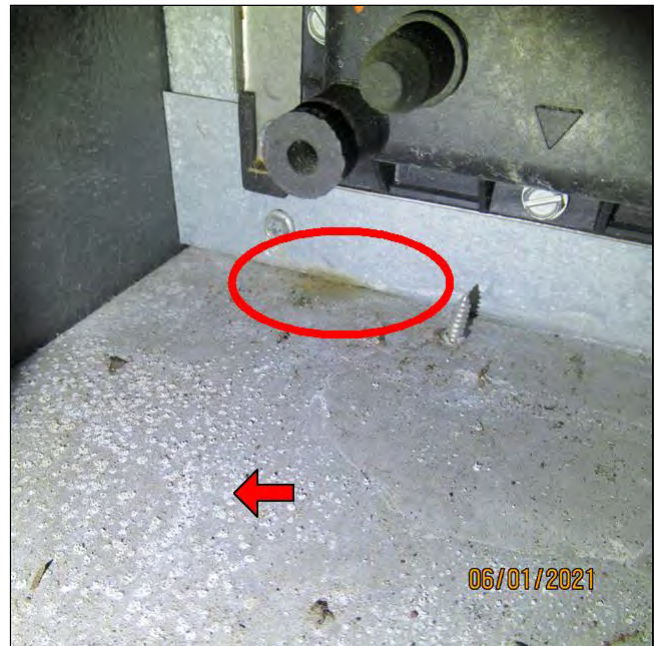
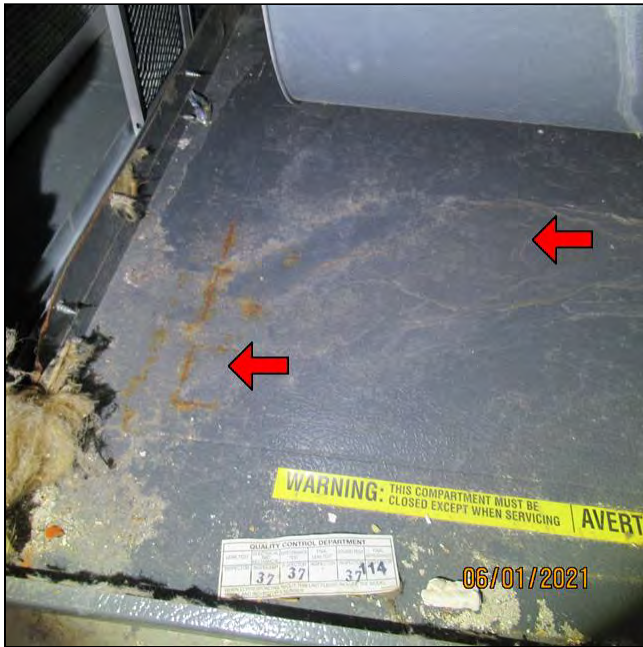
(2) Based upon the conditions observed at the time of the inspection (dust and debris in the furnace cabinet, rust staining and condensate staining in the filter cabinets, rust in the combustion and heat exchanger), we recommend review by a licensed HVAC contractor for repair or servicing, as necessary, prior to close.

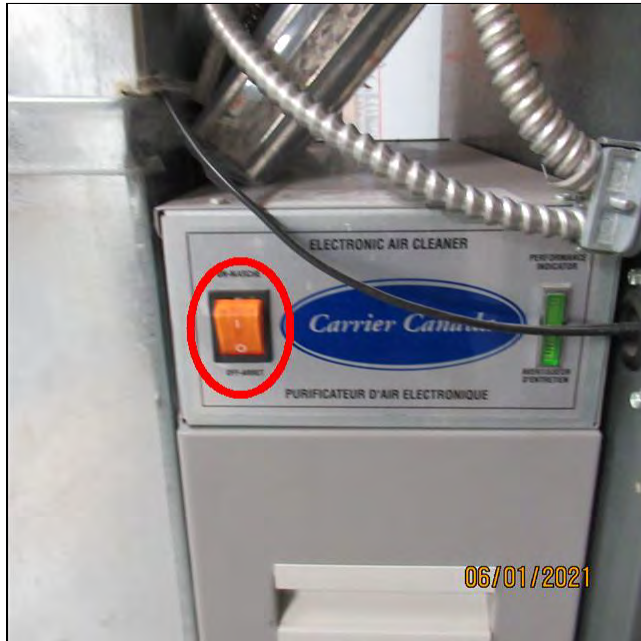
An electronic air filter was observed at this unit. This type of filter systems is not within the scope of this inspection. The unit was turned off and the filter elements were stored behind the furnace. A improperly fitted disposable filter was placed in the filter cabinet. The client is advised to consult seller's to ensure proper operation.

12.5 Item 1(Picture) Turned off

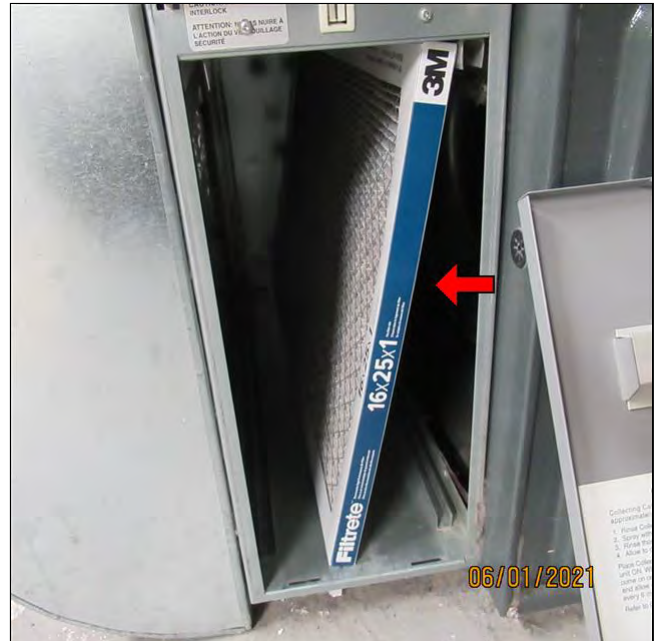
12.5 Item 2(Picture) Poorly fitting disposable filter media

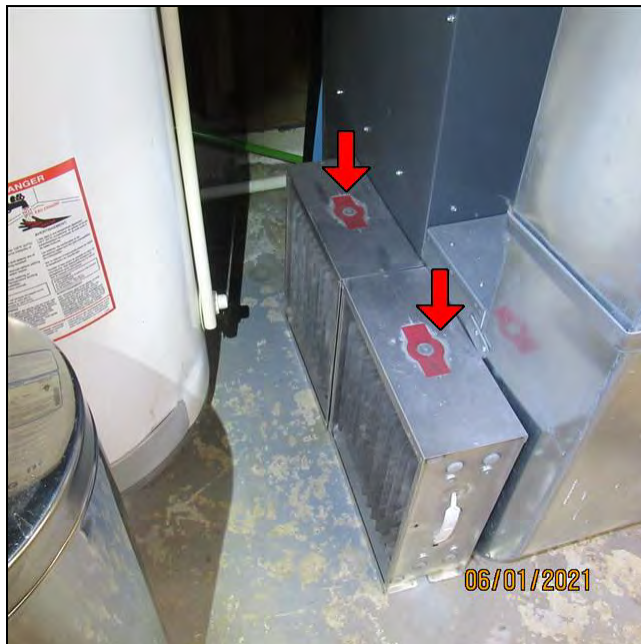
12.5 Item 3(Picture) Electric filter elements

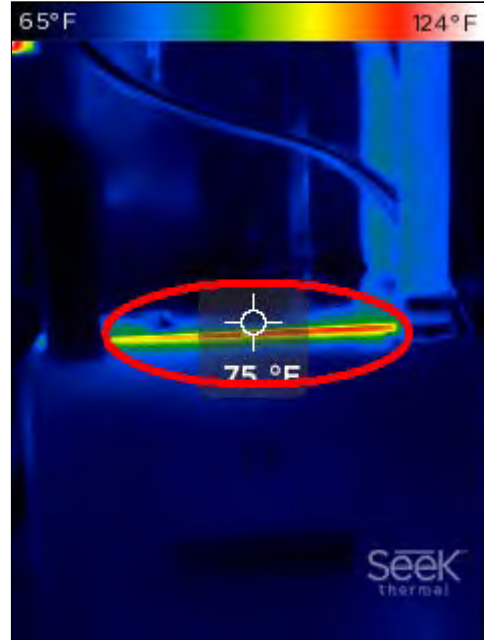
12.6 Item 2(Picture) Air escaping through gap where ductwork connects to the furnace

(2) We recommend that all exposed ductwork be sealed with foil tape to improve the efficiency of the distribution system.

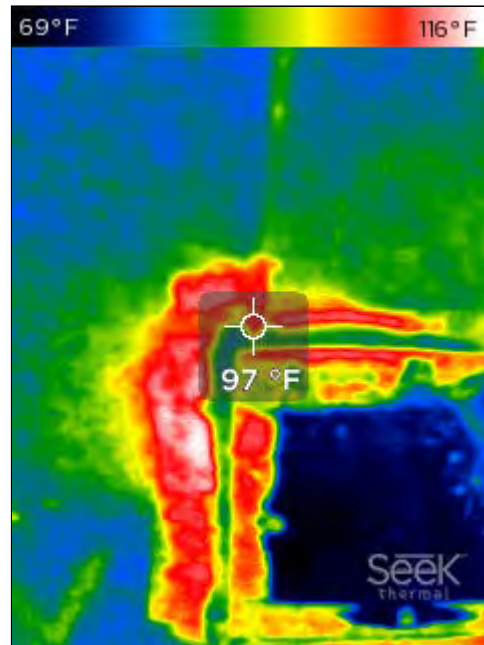
12.6 Item 4(Picture) Air escaping a plate on the ductwork

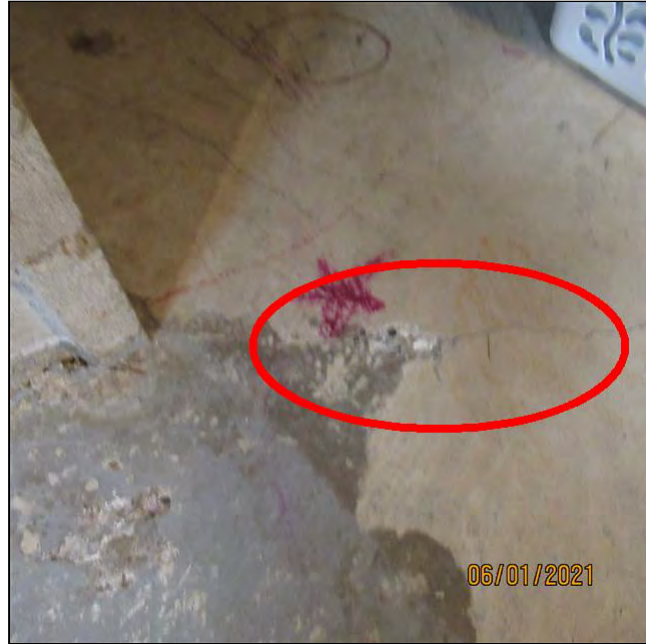
13.1 Item 1(Picture)

(2) Common cracks observed. Generally, concrete floor slabs are not structural. Concrete floors naturally crack during the curing process due to shrinkage. Since the concrete slab does not usually carry the load of the structure, shrinkage cracks are generally considered cosmetic. However, we do recommend sealing all cracks in concrete/asphalt/brick surfaces to prevent water penetration as a routine maintenance effort. The client should also monitor the floor for any heaving or displacement. Should this occur, a licenced contractor should be consulted for repair options.

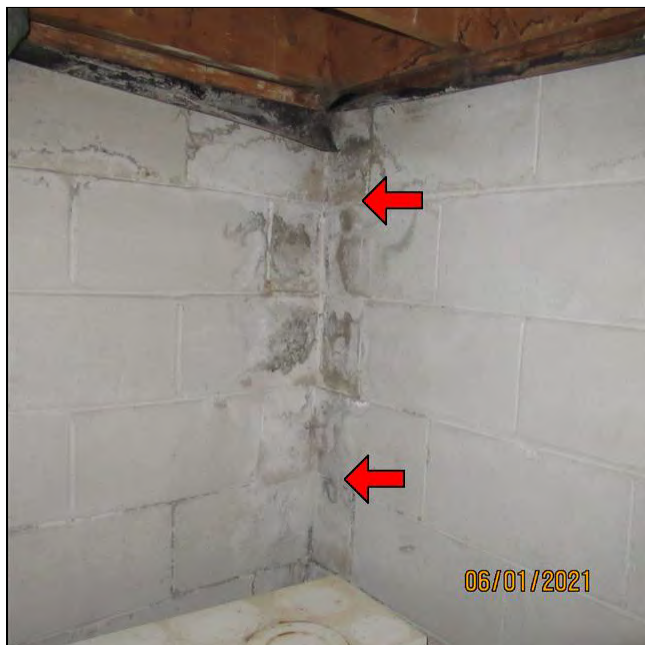
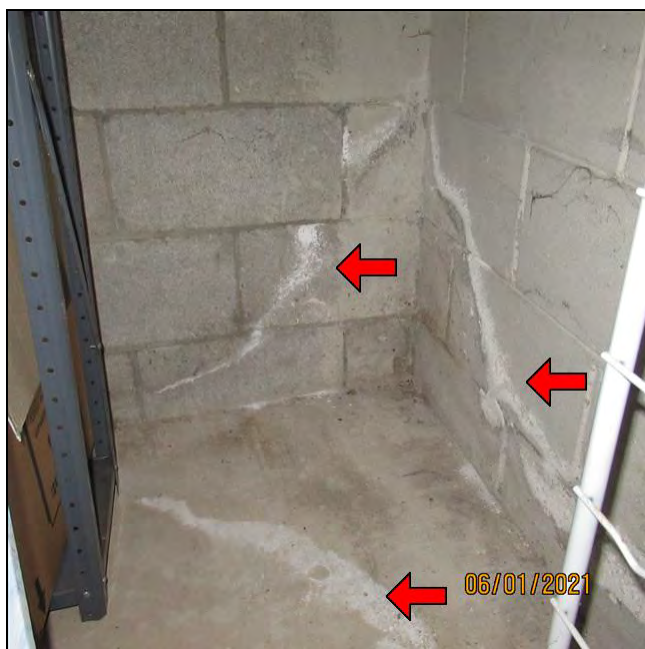
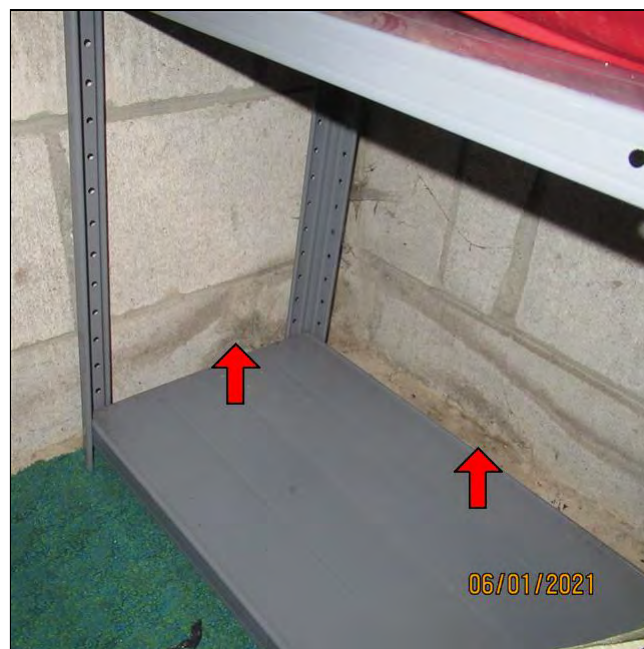
(1) Water staining and efflorescence observed at crawlspace (corners); this is a mineral deposit left behind from exterior water infiltration. We recommend consulting sellers as to moisture problems in these areas, and correct the exterior grading around the foundation in these areas to ensure effective drainage away from the foundation.

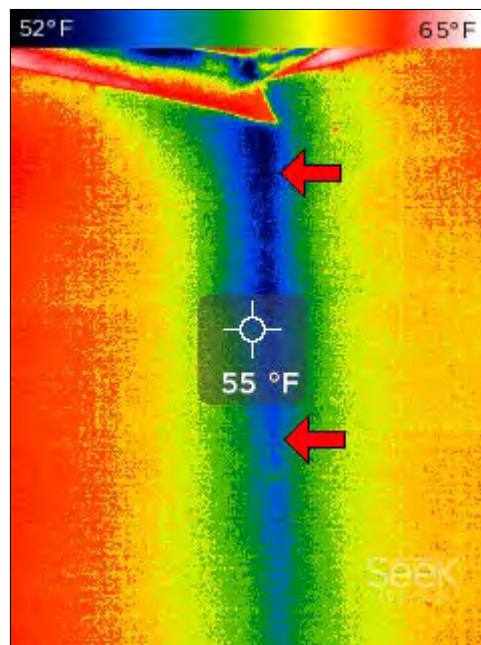
13.2 Item 2(Picture) Water infiltrating into the foundation from the exterior results in cooling of the wall

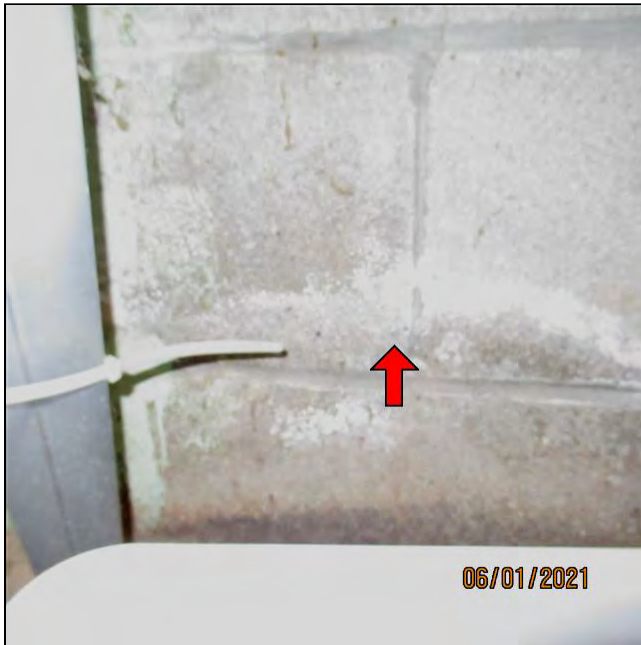
13.2 Item 5(Picture) Laundry wall

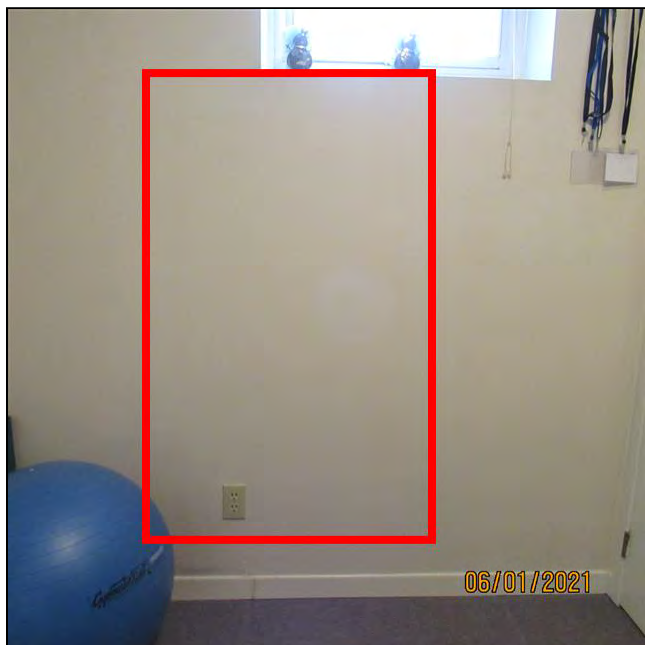
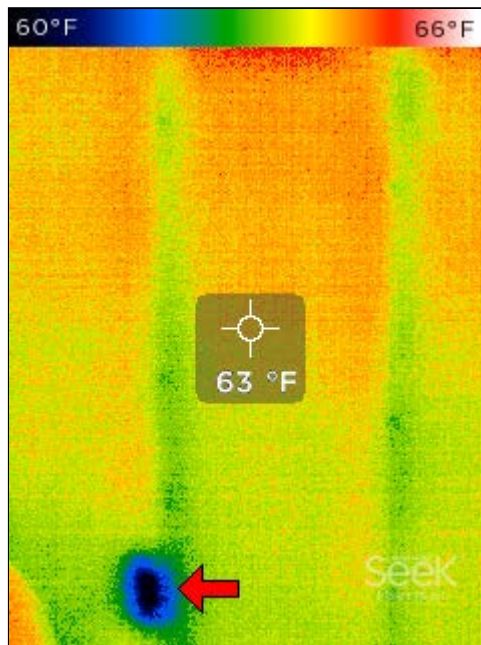
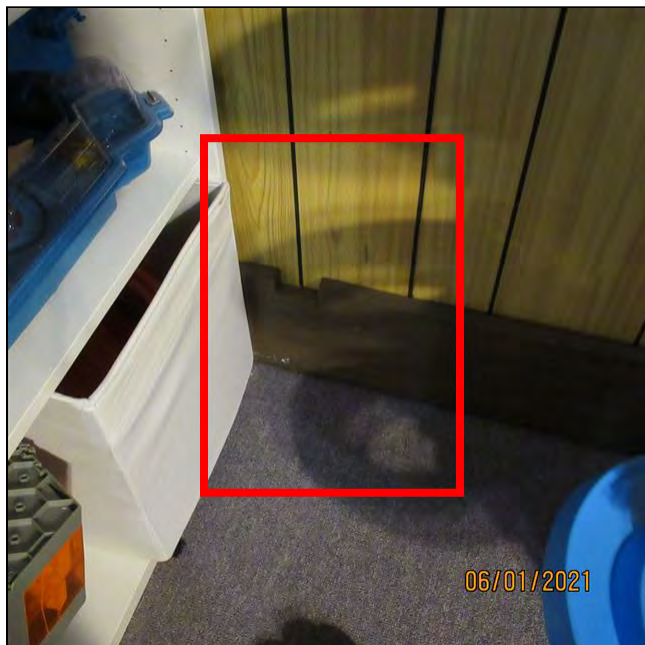
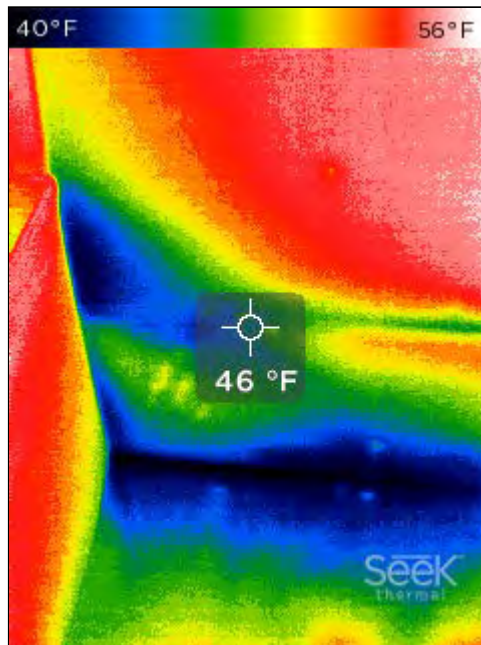
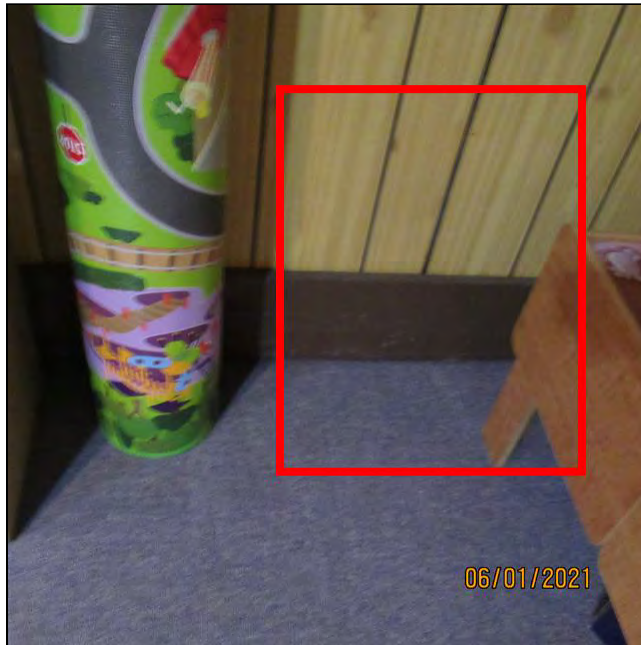
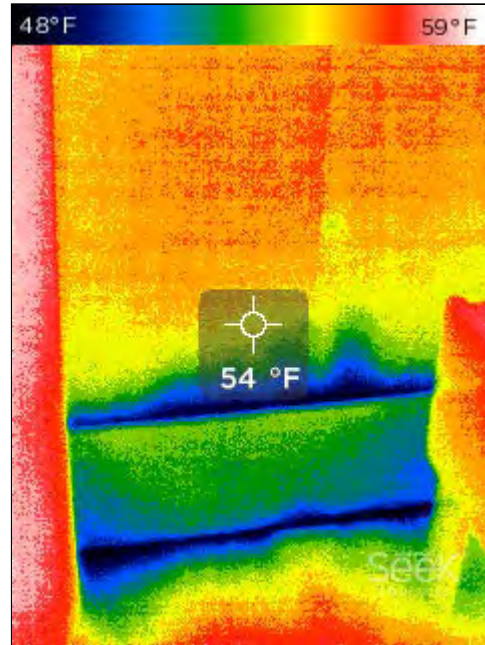
(3) Air entering the basement wall assembly from gaps at the rim plate, around windows and penetration through the wall, exit into the basement through electrical outlets, at breaks in the wall covering and along the trim. Reducing air infiltration requires sealing gaps and cracks in the building envelope.

The vertical green areas are the result of thermal bridging through the wall studs (heat travels from the warm interior to cold exterior resulting in the cooling of the wall covering in contact with the studs). Thermal bridging is reduced by installing insulation between the studs and the exterior walls.

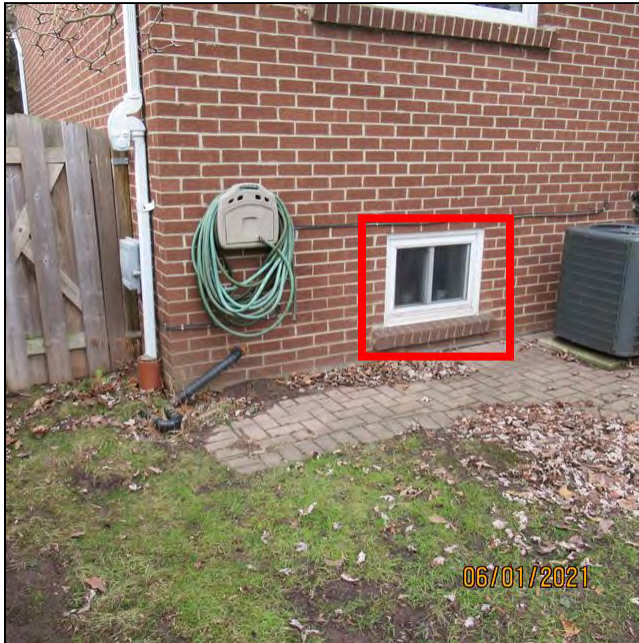
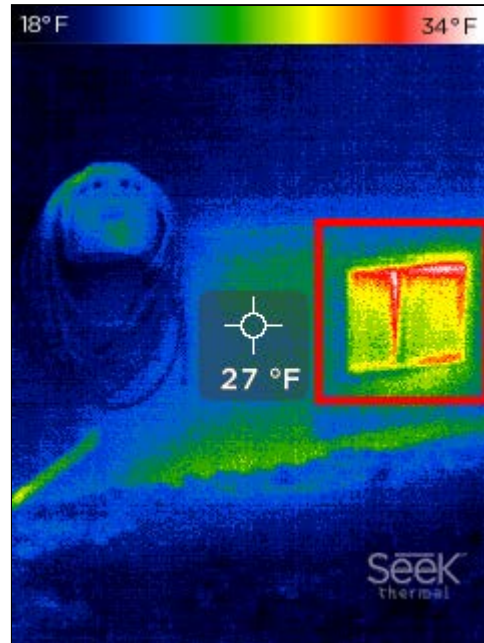
Heat loss observed around window frames. Improved sealing between the window frame and the rough opening will reduce some of the loss. Other loss is related to the window design and wear.

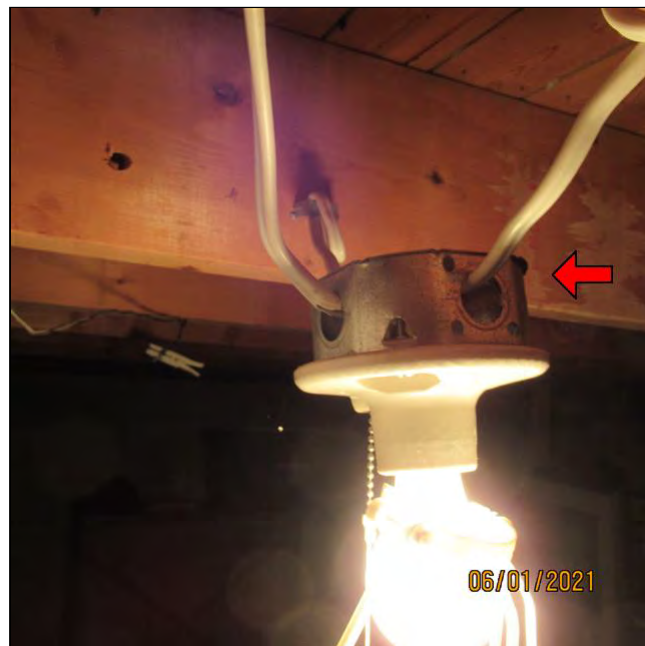
13.13 Item 1(Picture)

Light fixture in the crawlspace is not properly secured. This arrangement places strain on the electrical cables and connections. We recommend review and correction by a qualified contractor.

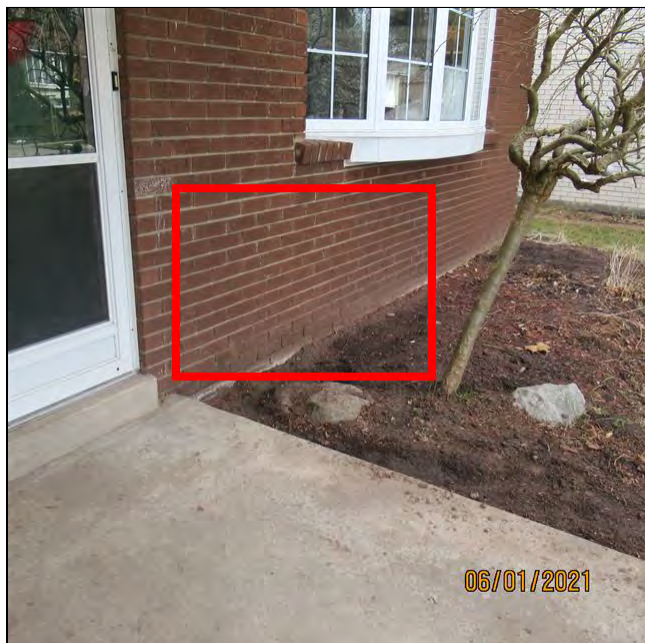
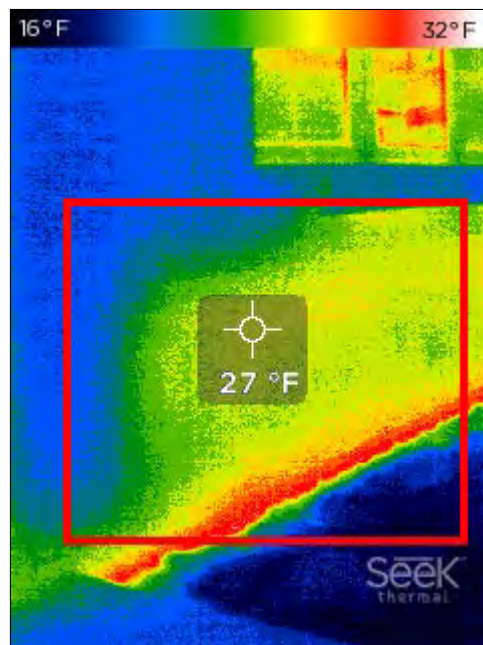
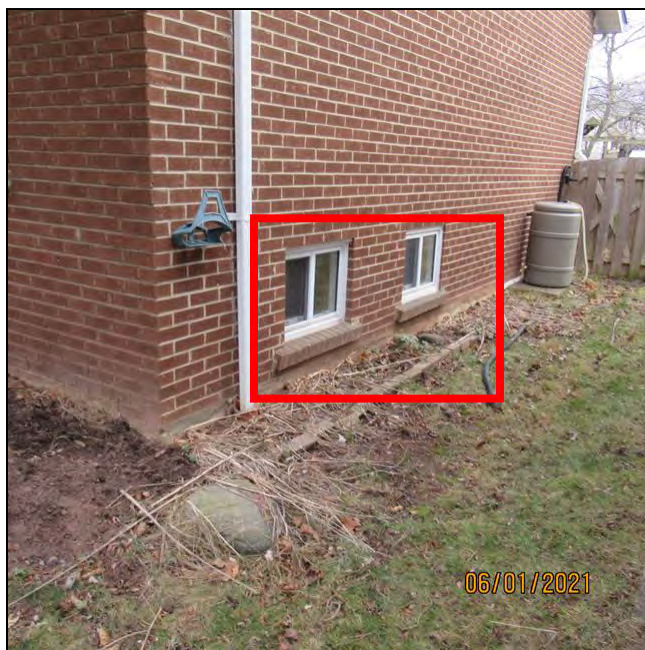
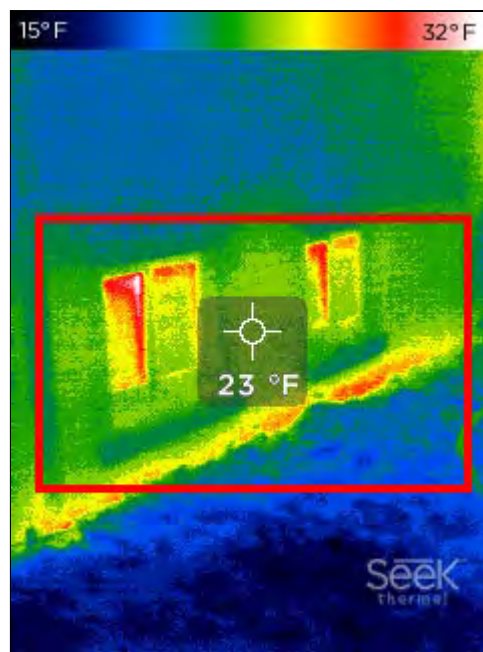
(1) Heat loss observed at the exterior walls with higher heat loss at the sill plate area. We recommend that the walls of the crawlspace be insulated.

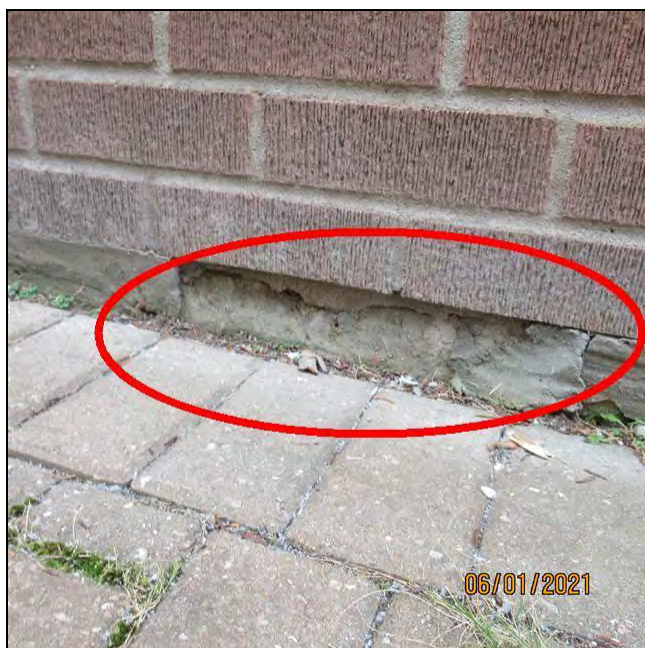
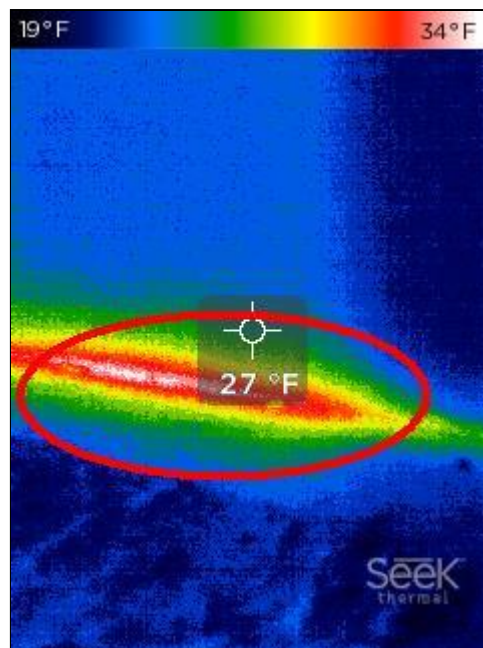
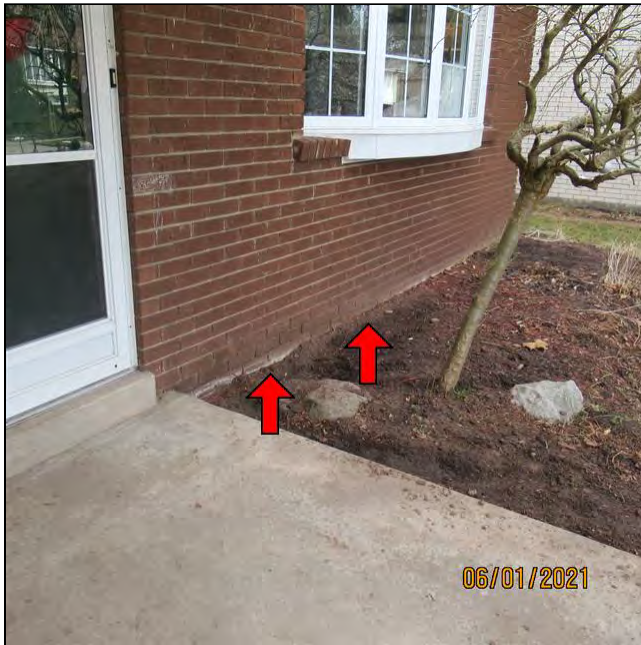
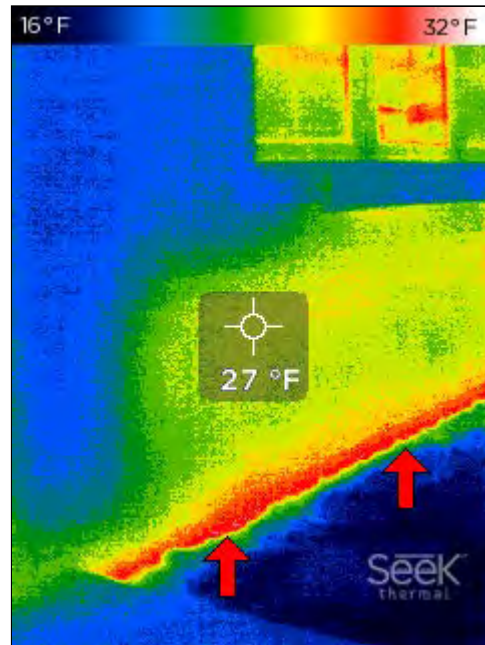
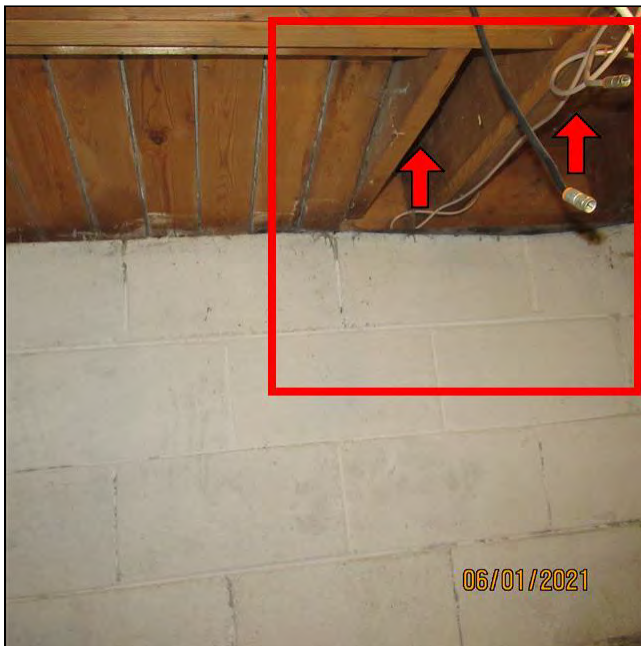
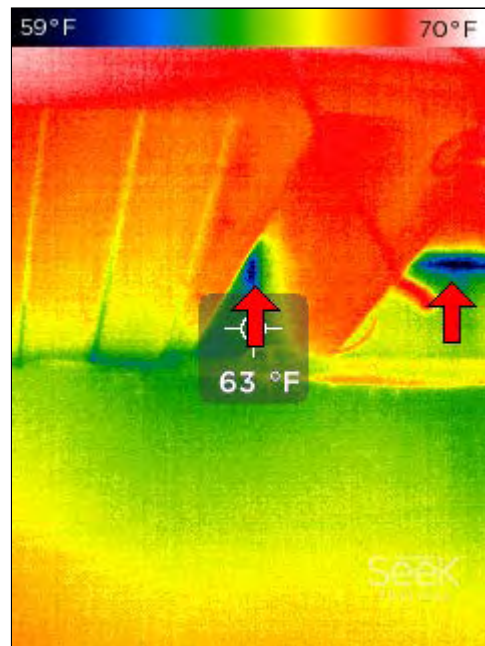
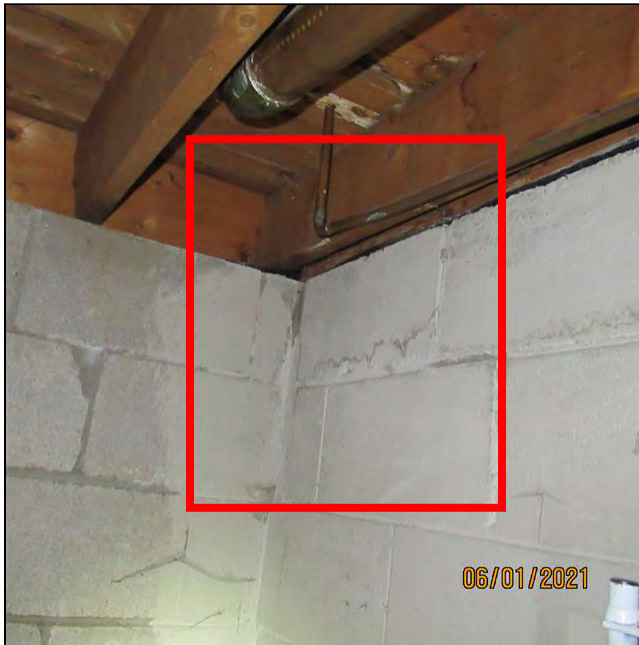
(2) Heat loss observed around sill plate area (especially where it has been exposed by parging failure). Insulating the header and rim plate areas of the basement will reduce such losses. We recommend adding insulation and a vapour barrier (or an approved spray foam insulation product) to the rim joist area to improve energy efficiency and to reduce air infiltration to the home.

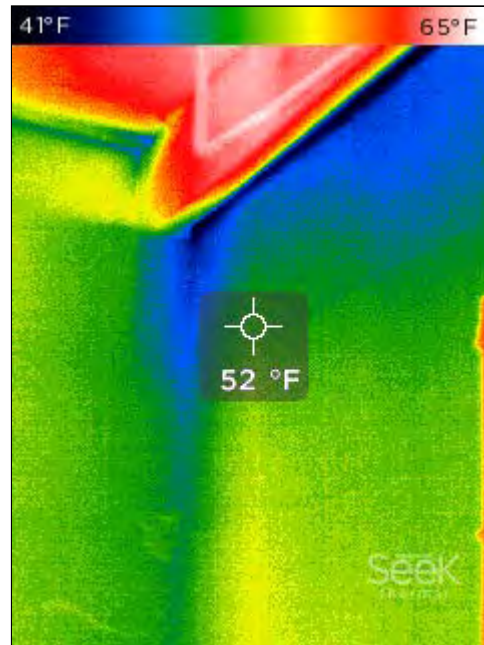
13.15 Item 13(Picture) Air leaking under the sill plate

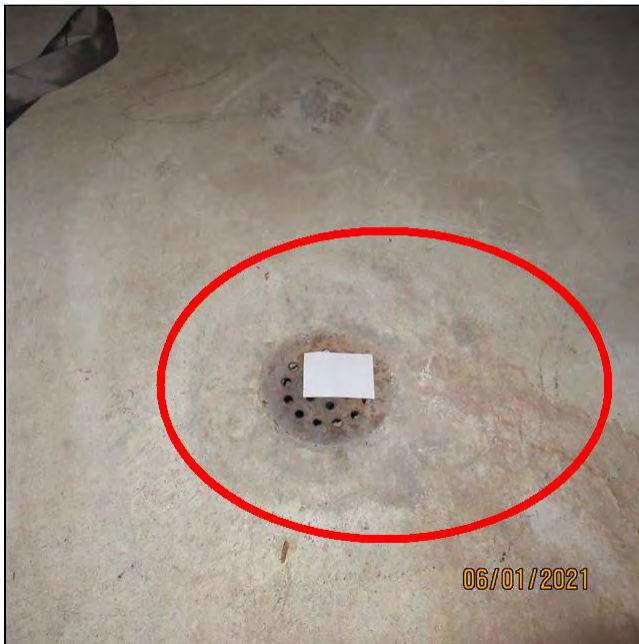
Floor drain was observed at the crawlspace and basement next to the furnace.

13.16 Item 1(Picture) Crawlspace
