SUMMARY REPORT

AmeriSpec Inspection Services of Hamilton, Brantford and Stratford
32 Livingstone Cres
Cambridge ON N3H 5S7
226-341-9569

URGENT REVIEW SUMMARY

Doc #: 010621SH2

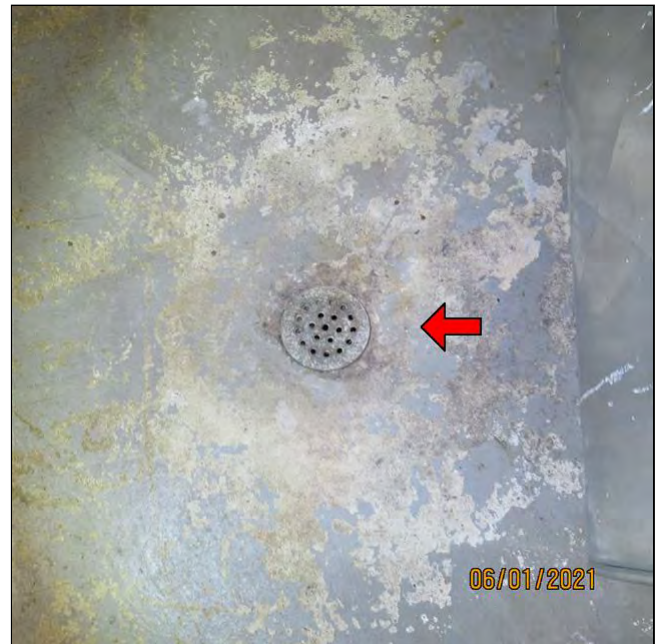
Floor drain was observed at the crawlspace and basement next to the furnace.

13.16 Item 2(Picture) Next to the furnace

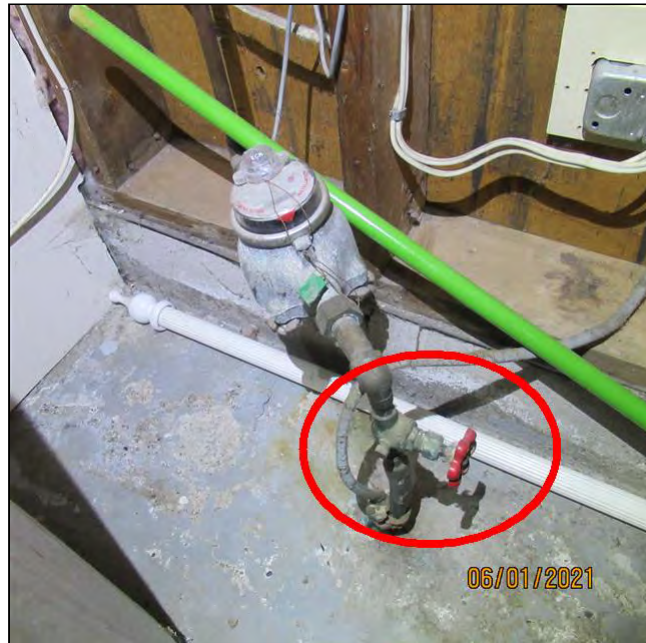
14.0 Item 1(Picture)

Gate-type valve observed. Since main shut-off valves are operated infrequently, it is not unusual for them to become frozen over time. They often leak or break when operated after a period of inactivity. For this reason main shut-off valves are not tested during a home inspection. We suggest caution when operating shut-offs that have not been turned for a long period of time. We recommend that the client consider upgrading the shut-off valve to a high quality ball-type valve which tend to be more reliable than gate valves.

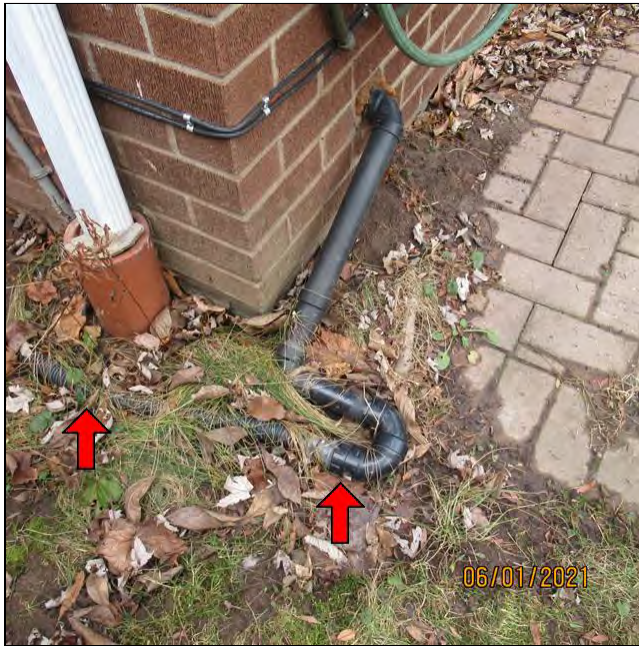
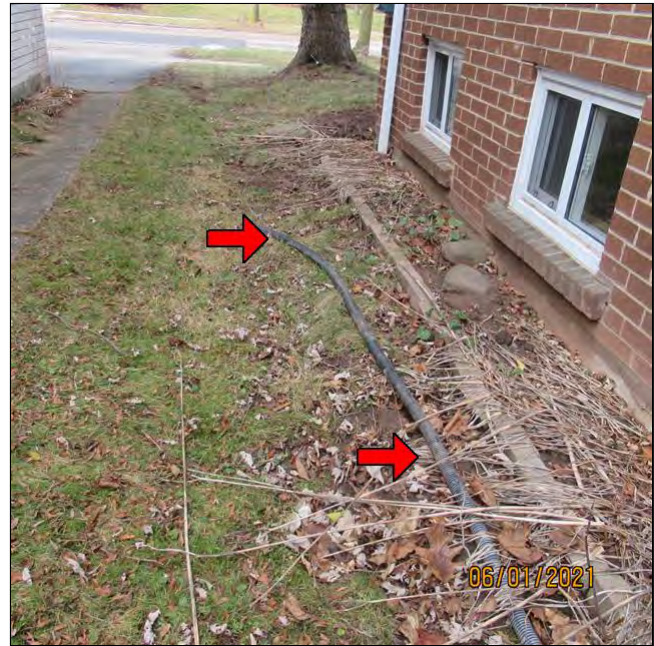
(1) Sump pump drains to the rear right side exterior. The drain pipe is located at the ground surface and is subject to mechanical damage. We recommend review by a qualified contractor for correction to protect the drain and ensure it drains appropriately away from the foundation.

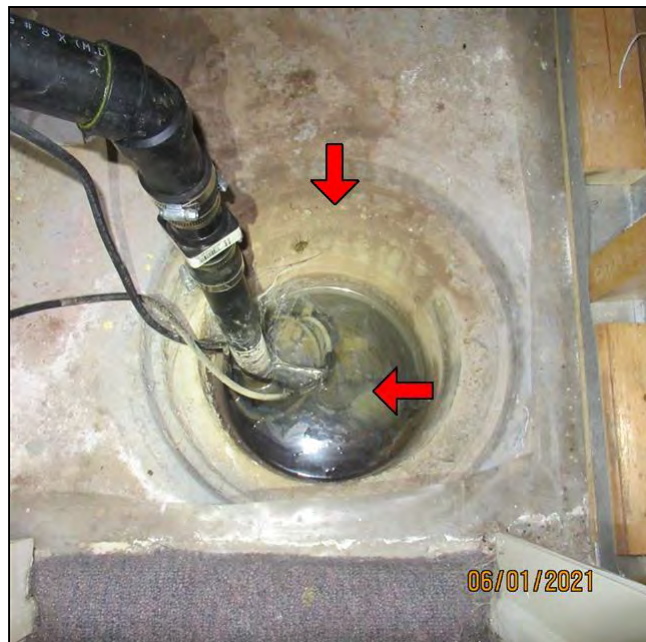
14.4 Item 3(Picture)

(2) Sump pit cover is missing. We suggest installing cover for safety and to limit moisture intrusion into the house from the exposed water surface.

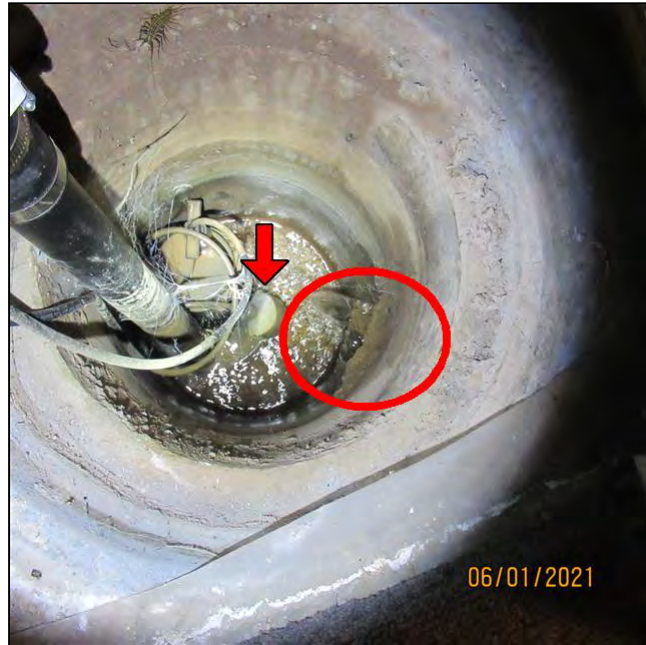
14.4 Item 4(Picture)

(3) The float switch that controls the operation of the sump pump is set to high resulting in water backing up into the weeping tile before the pump switch on to pump the water from the pit. We recommend lowering the sump float switch so that it turns on before the water backs up into the weeping tile outlet.

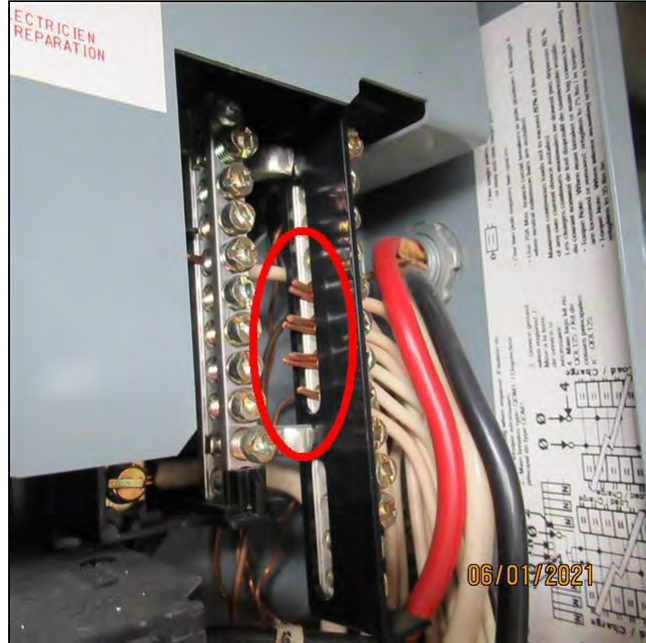
15.5 Item 1(Picture)

Double tapping observed in main electrical panel at the neutral bar. Double tapped neutrals at the breaker panel (i.e. 2 wires on a single pole breaker) prevent circuits from being properly isolated when working on them and are prone to working loose over time resulting in overheating and an increased fire hazard. We recommend review by a qualified electrician for repair or replacement as necessary.

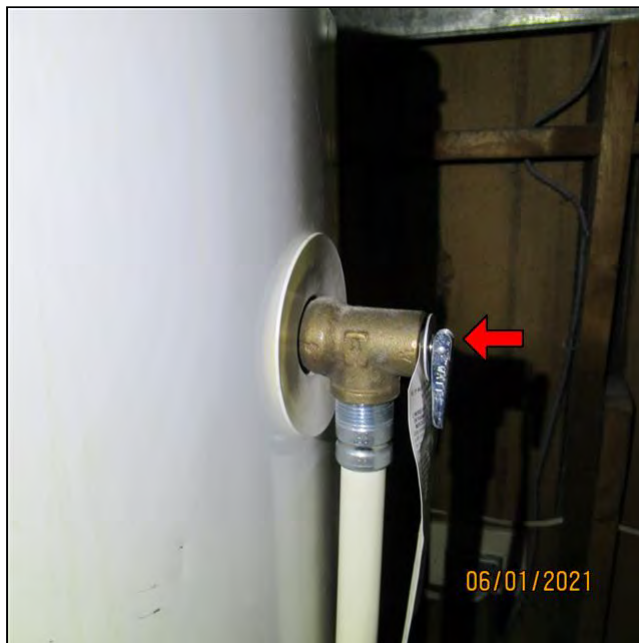
16.0 Item 1(Picture)

The temperature and pressure relief valve was not operated. We recommend testing the valve after arrangements are made for the water flow. If the valve does not operate as intended, we recommend any repairs necessary to assure that the valve can operate under high temperature/high pressure conditions.

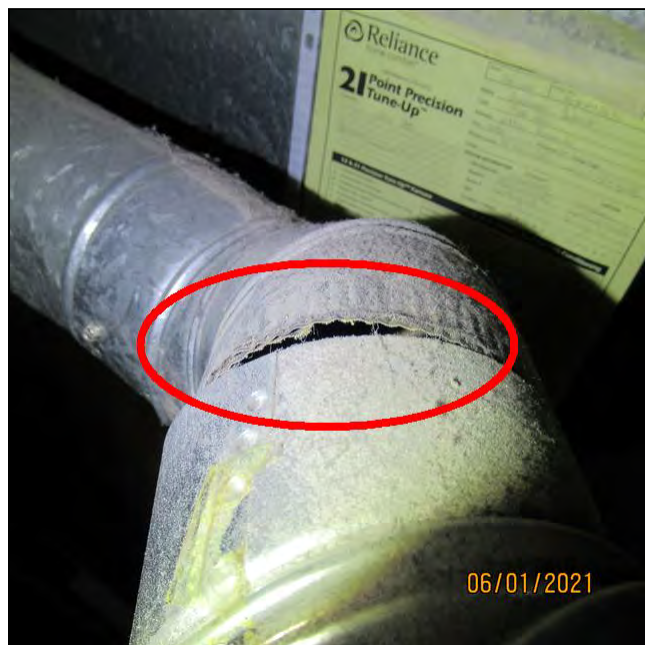
16.2 Item 1(Picture)

Vent pipe is disconnected or poorly fitted, which is a safety concern. We recommend review for repair or replacement, as necessary, prior to close.

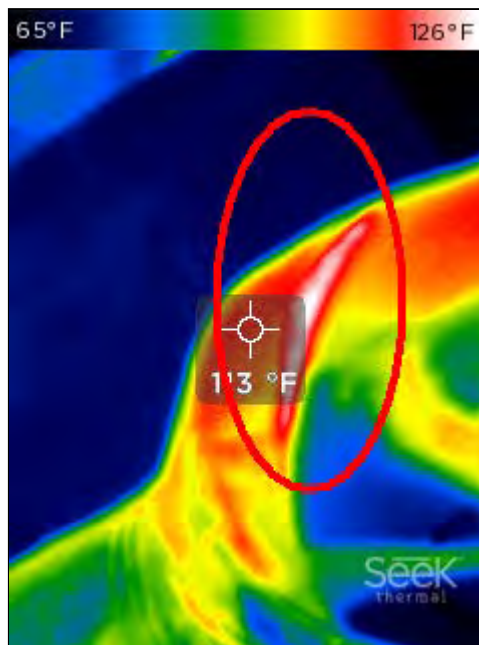
16.2 Item 2(Picture) Combustion air escaping from the water heater vent pipe

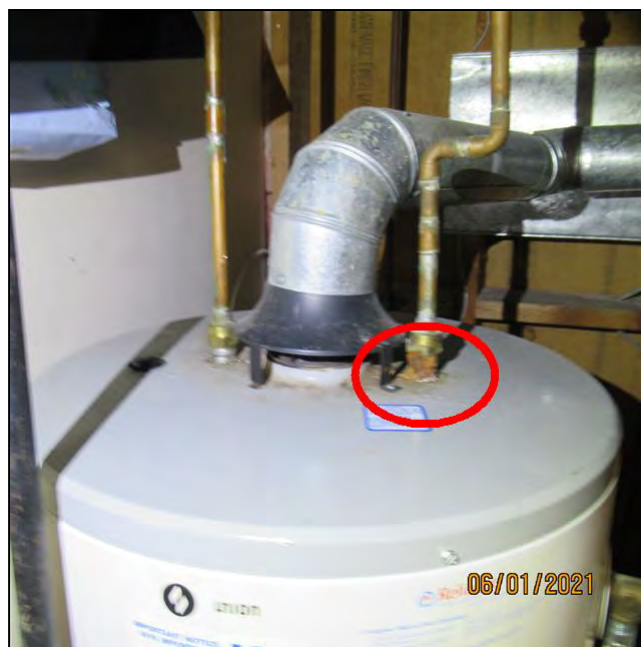
16.3 Item 1(Picture)

(1) Corrosion observed on unit. We recommend further review by a licenced technician.

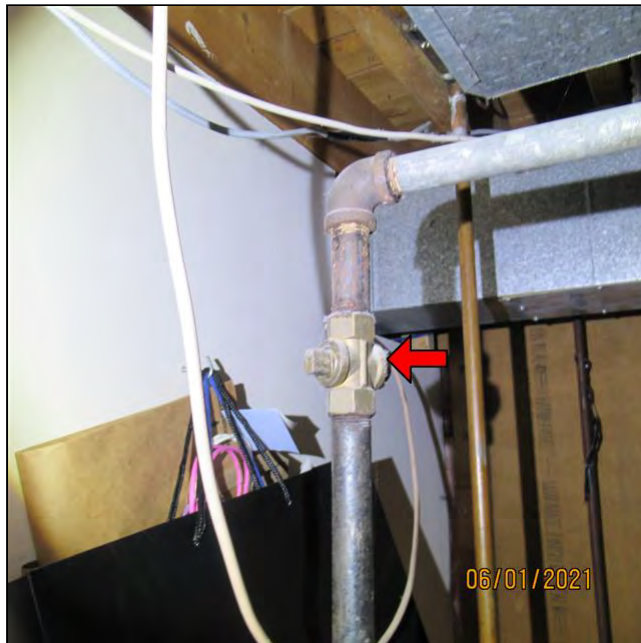
16.3 Item 2(Picture)

(2) Natural gas. Gas shut-off valve was observed near this appliance.

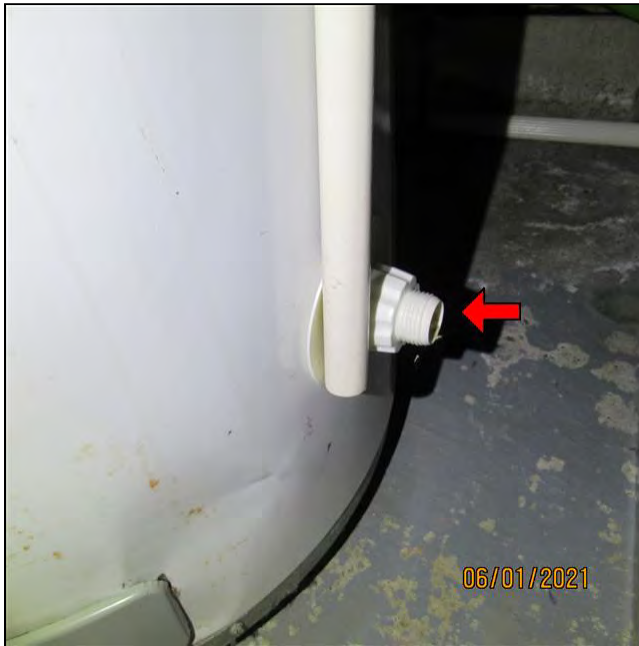
16.5 Item 1(Picture) Drain plug

We recommend draining one bucket of water annually to remove tank residue, thereby extending the life of the unit.

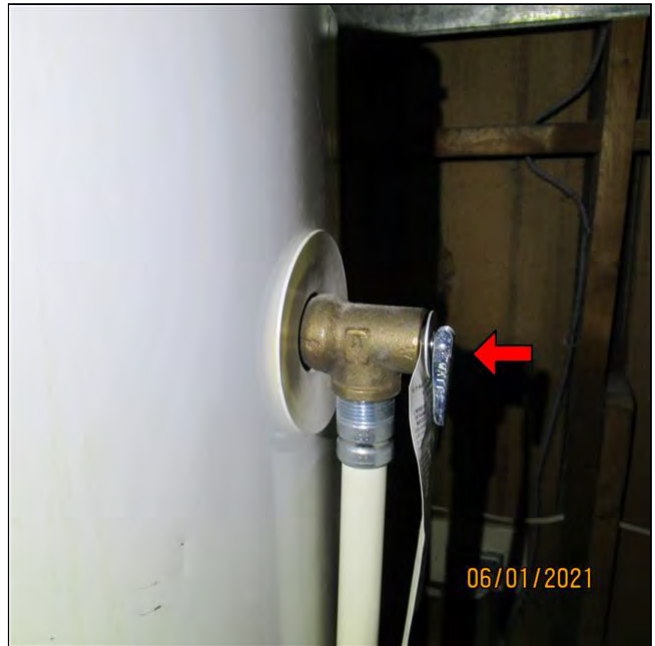
16.5 Item 2(Picture) TPR valve

Since a temperature pressure relief (TPR) valve is operated infrequently, it is not unusual for them to leak or break when operated after a period of inactivity. For this reason, the TPR value valve is not tested during a home inspection. We suggest caution when operating TPR values that have not been tested for a long period of time. When installed new the TRP valve should be tested regularly to ensure free movement in case of emergency. The client should consult with a licenced plumber for testing and operation of the TPR valve on older water heaters.
