## AmeriSpec Home Inspections

Doc #:                      Sample Inspection                      Inspector:                      Ryan Leavitt

# Home Inspection Report

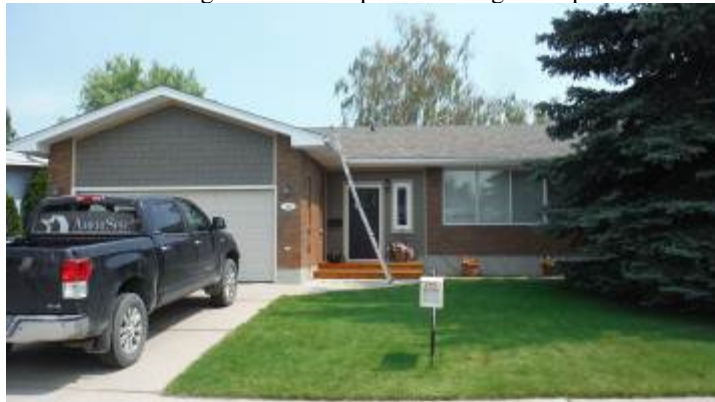
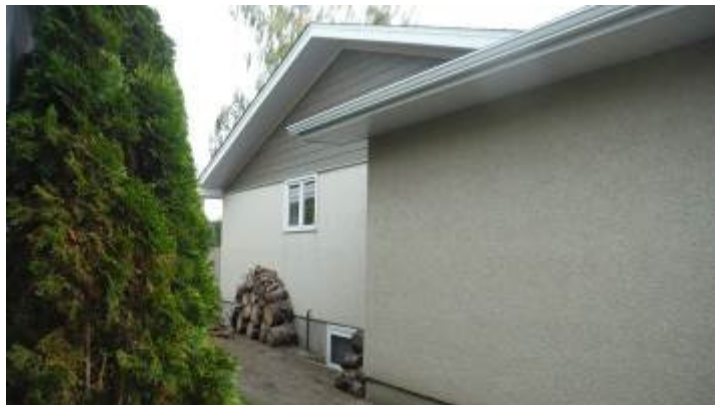
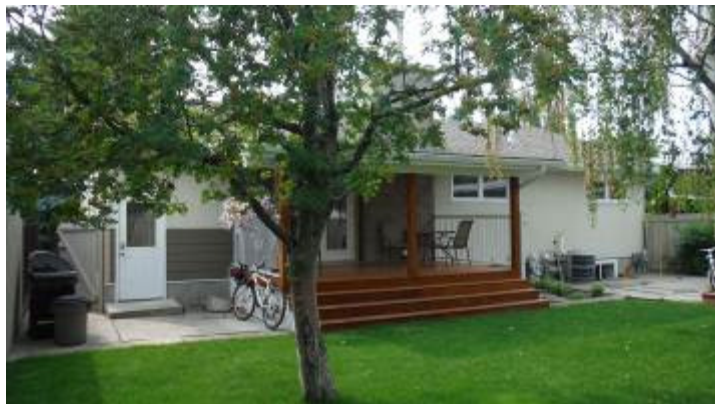
1103. Exterior Wall Cladding

Serviceable. Siding is 100% complete and in good repair.

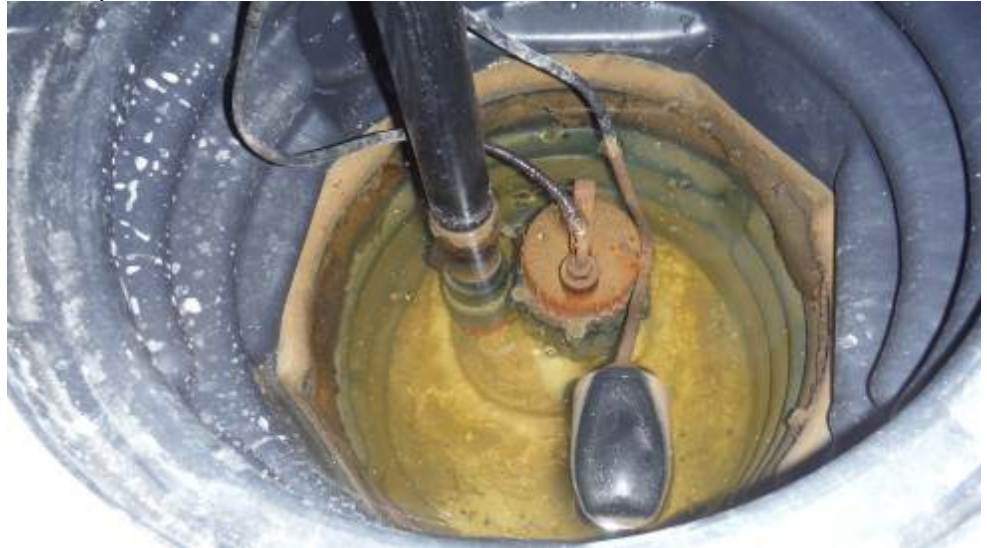
2806. Sump Pump(s)

Tested operable. Located at the basement.

Pump was activated at the time of inspection and found to be in good working condition. We suggest you verify proper operation on an annual basis. Failing pumps can cause basement seepage during heavy rains. A good commercial pump should have an average life expectancy from 7-10 yrs.

Approximately 7 inches of water was observed in the sump pit at the time of inspection.

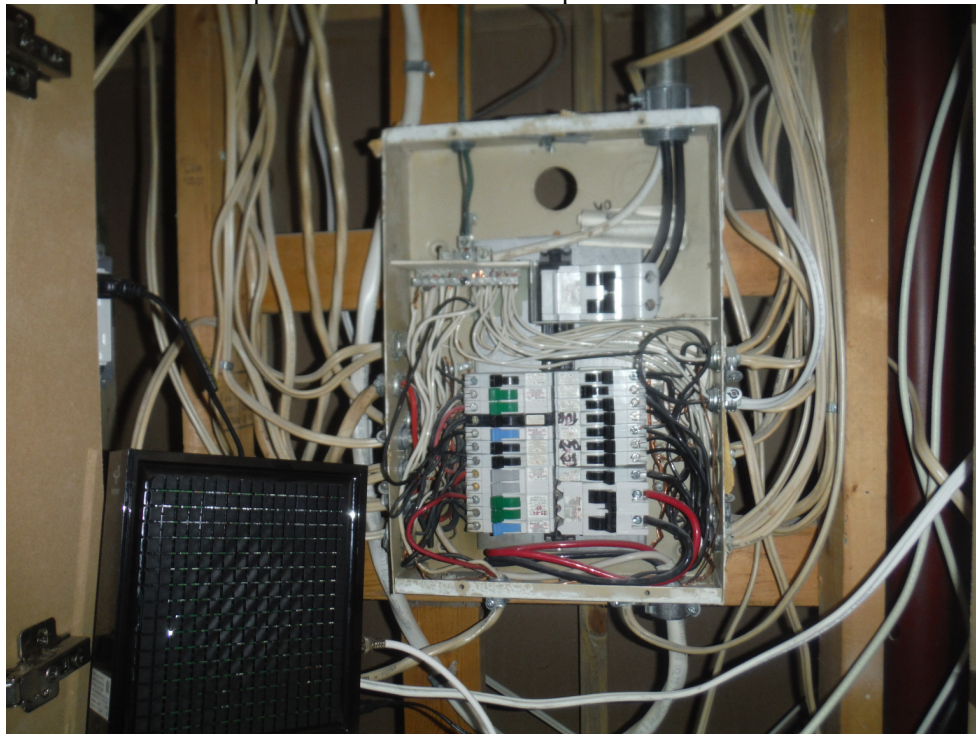
Step #	Component	Comment
2901.	Service	Serviceable. Service entrance is underground.
2902.	Main Electrical Panel & Location	Serviceable. Service entrance cables are copper; Branch circuit wiring is copper; No futures available for expansion. The main electrical panel is located in/at the basement.

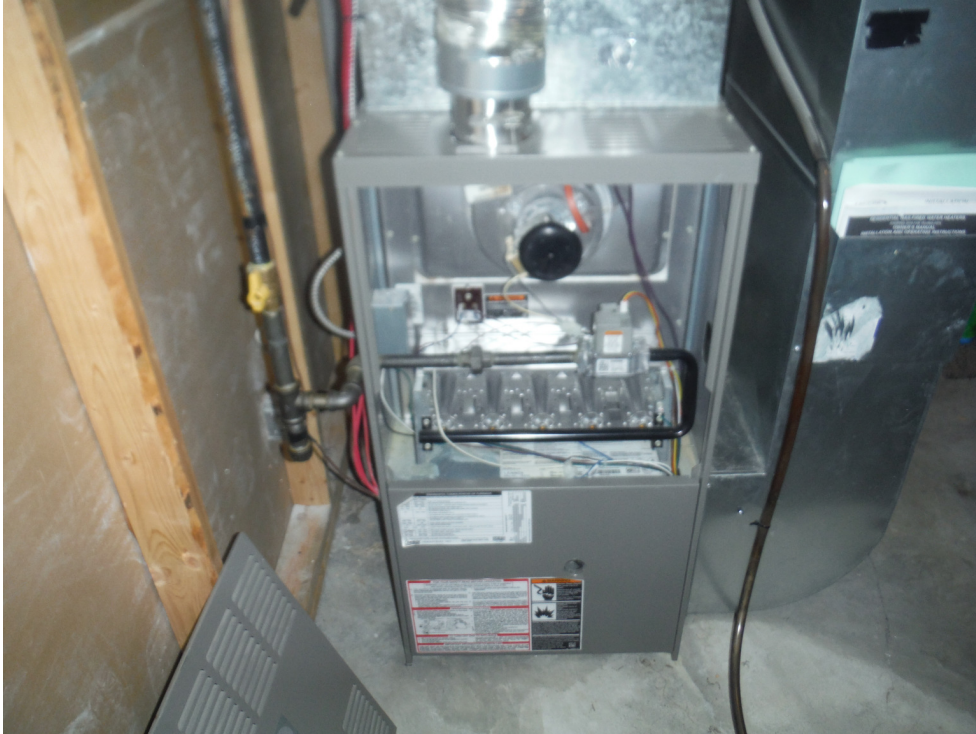
Step #	Component	Comment
3001.	Location of unit	<p>The heating unit is located in the basement and services the entire home.</p> <p>The unit appears to be approximately 3 years old.</p>
3002.	Heating System Design Type/Brand	<p>Manufactured by Lennox.</p>

<p>Mid efficiency furnace.</p>
3003.	Energy Source	Serviceable. Electrical disconnect observed; Natural gas with shutoff valve provided.
3004.	Burner Chambers	<p>Serviceable. Draft test preformed. Test passed at the time of inspection.</p> <p>No CO detected at the time of inspection. A Monoxor II Carbon Monoxide monitor was used to determine if the gas heating appliances were contributing CO to the internal home environment at the time of inspection.</p>
3005.	Fan Motor	Serviceable. The furnace fan and motor appeared to be in good working condition.
3006.	General Conditions	Serviceable. The furnace was tested using normal operating controls and appeared to function properly at time of inspection.

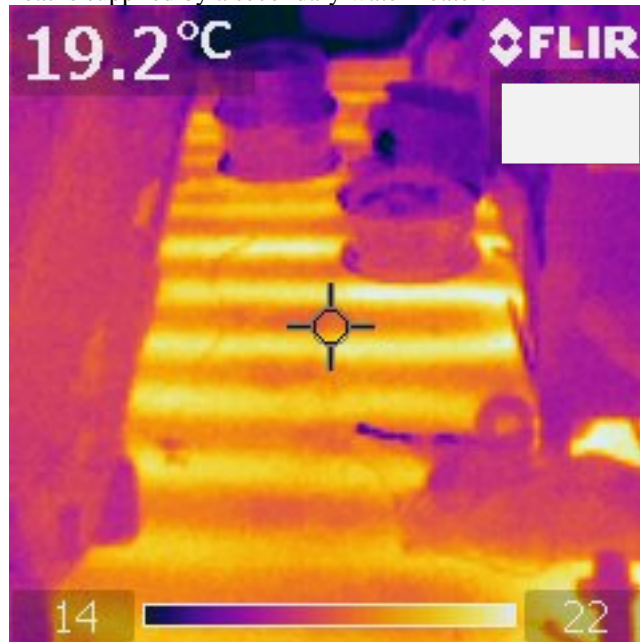
3009. Distribution / Ducting In floor heating for the basement, tested operable with a thermal imaging camera. In floor heat is supplied by a secondary water heater.
